## Headwater Drainage Feature Assessment

4134 16<sup>th</sup> Avenue

Sixteenth Land Holdings Inc.

October 2017 215200

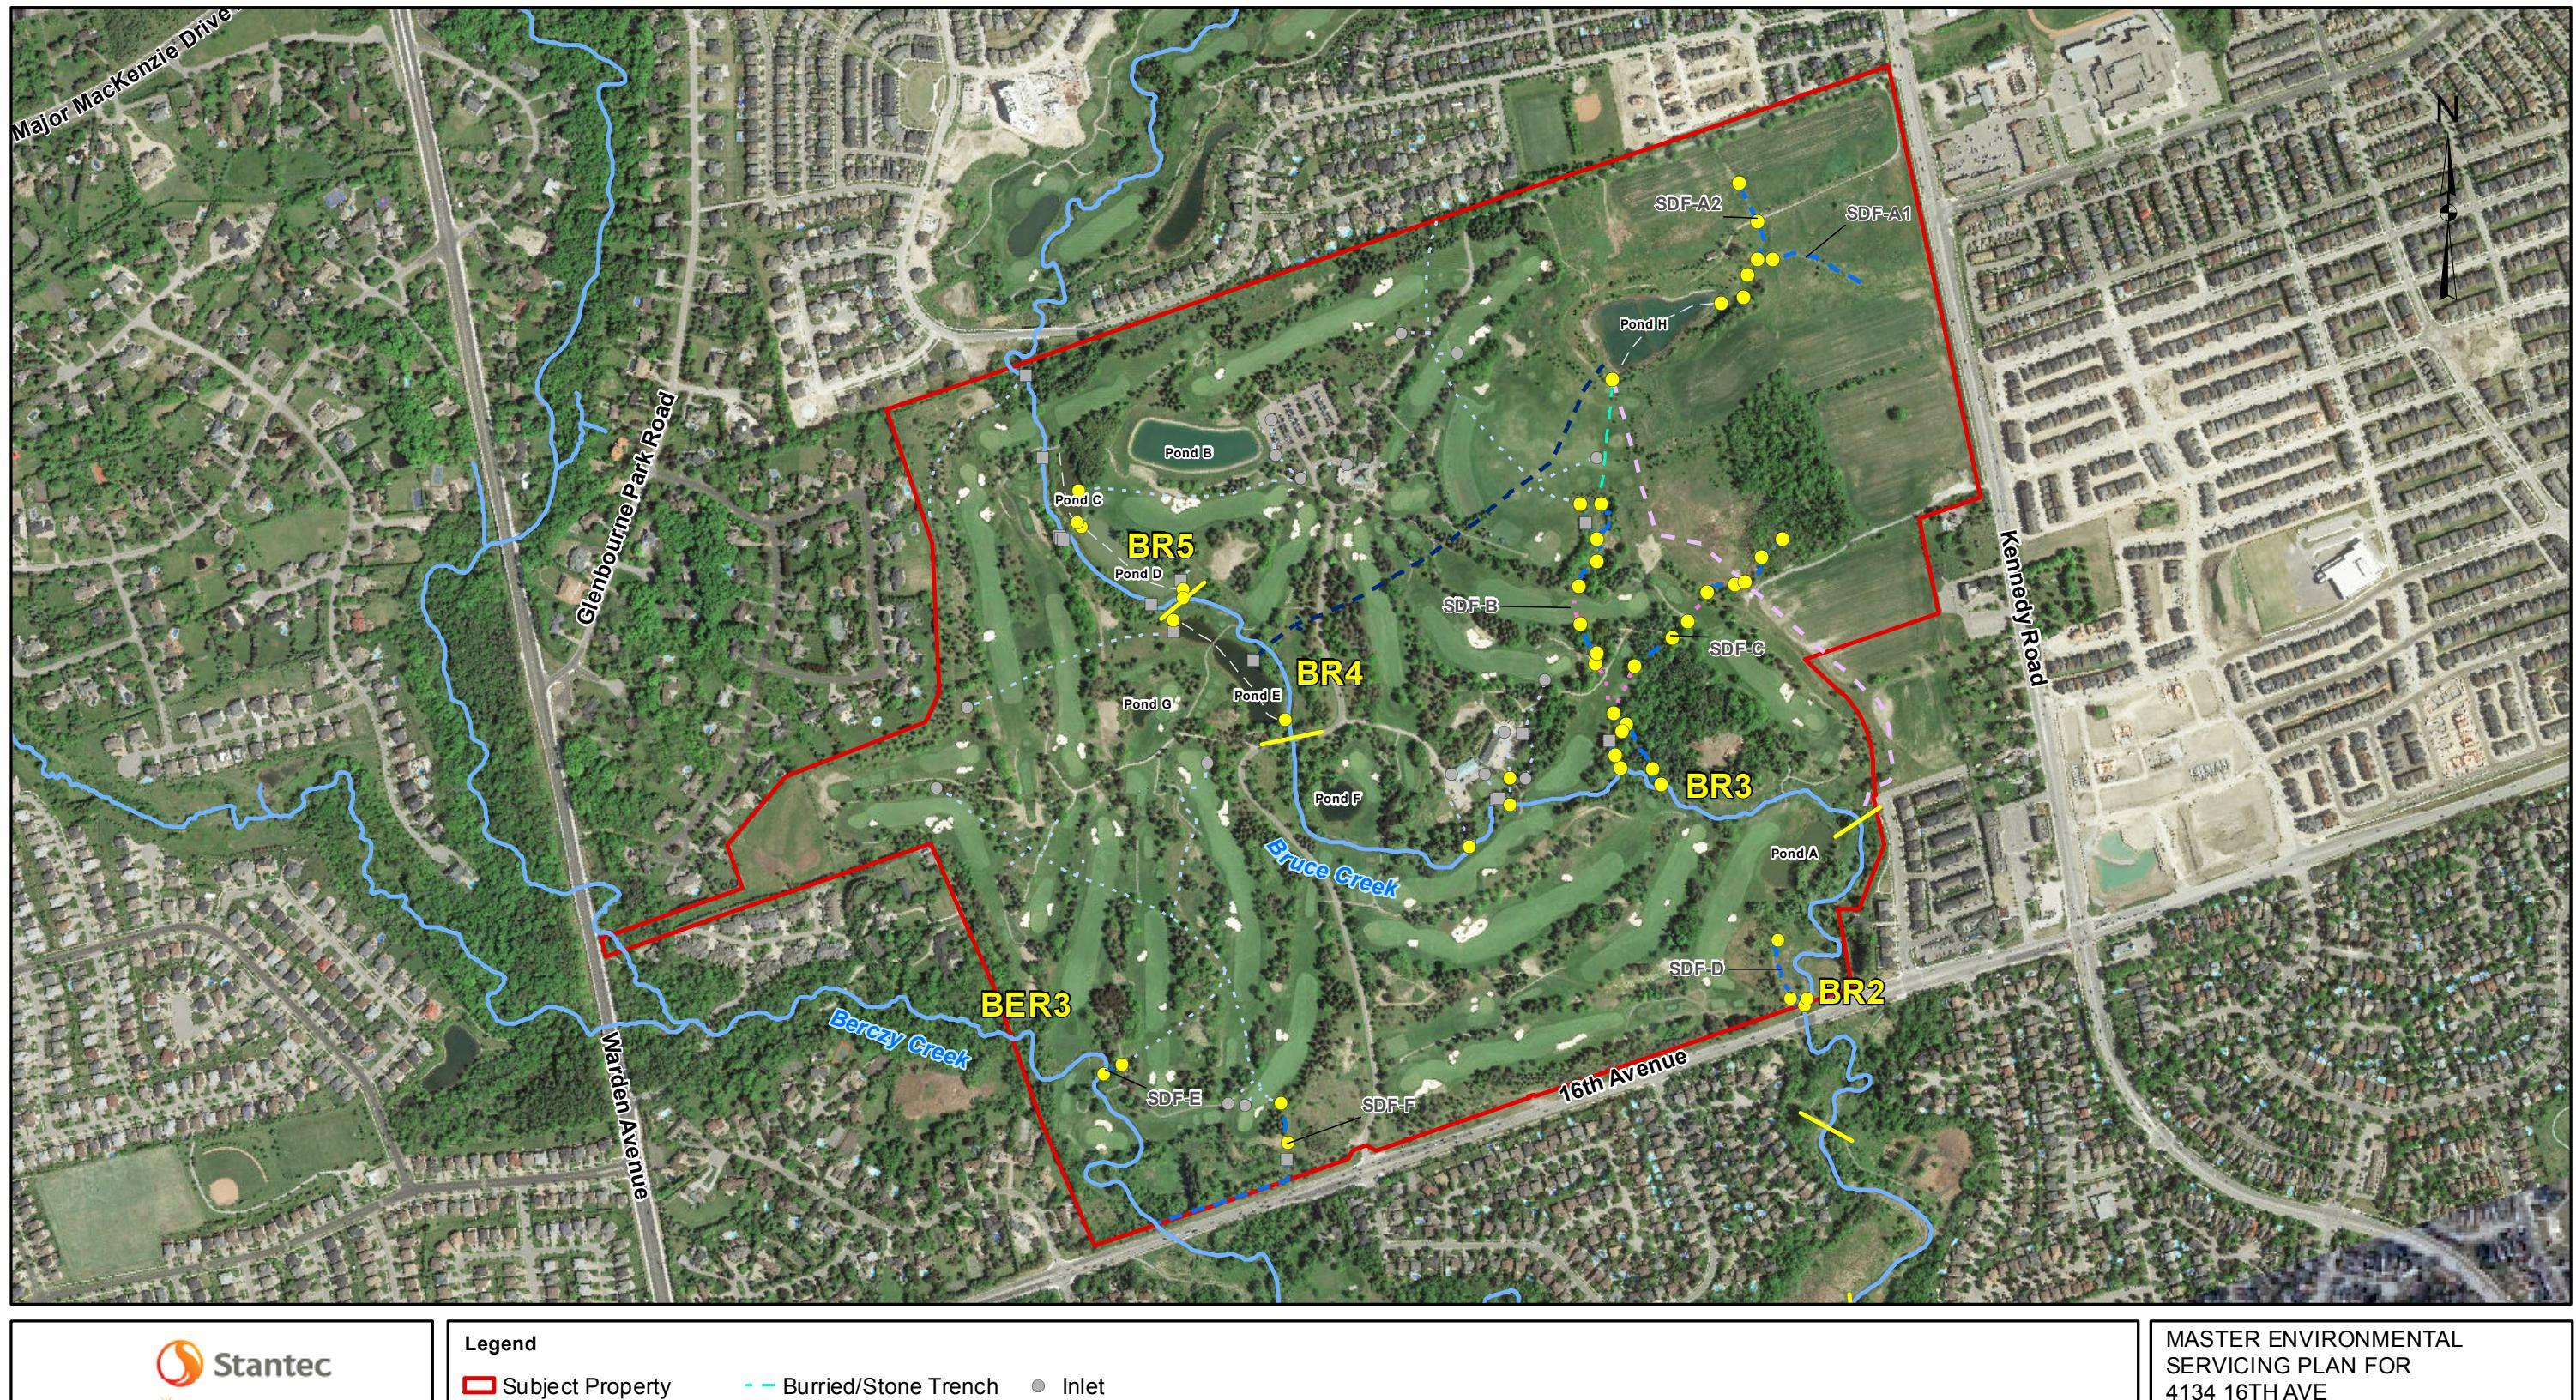
4134 16TH AVE FIGURE 1: Headwater Drainage Feature Analysis

Field investigations took place on July 19, August 3 and August 17, 2016 and April 13, July 28 and September 21, 2017. **Table 1** provides the results of the HDF Analysis, including management recommendations, for each of the features identified on the subject property. Each of these features are identified on **Figures 1a** through **1e**. Photographs of each of the features are provided in a photolog (**Appendix A**).

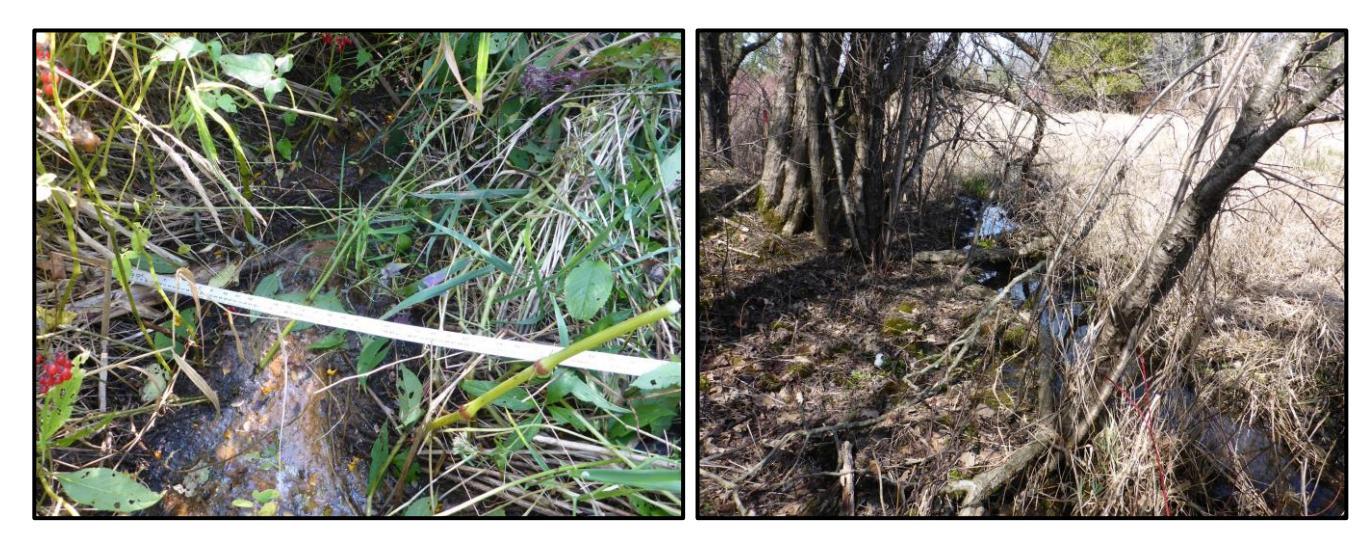
Photo 33 BR3-H2-S9: Upstream view of the feature; standing water, iron staining. Sample Event 3 (September 21, 2017)

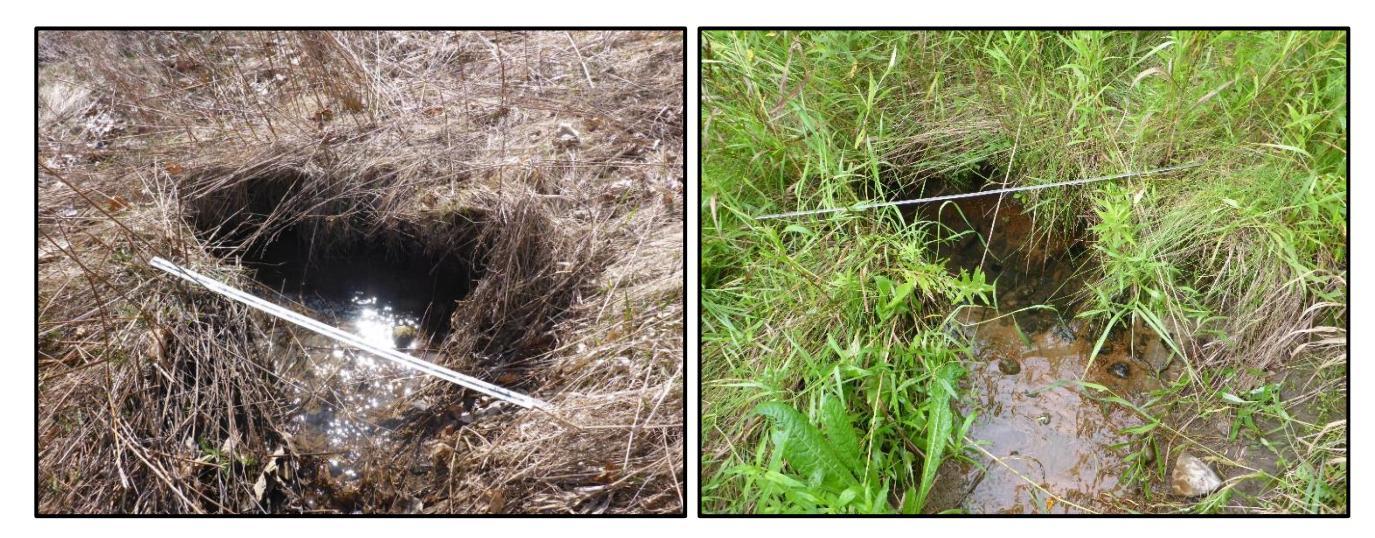
Photo 37 BR3-H2-S11: Upstream view of pipe outlet. Sample Event 1 (April 13, 2017)

Photo 38 BR3-H2-S11: Upstream view of pipe outlet. Corrugated pipe is cracked/leaking Note iron staining. Sample Event 2 (July 28, 2017)

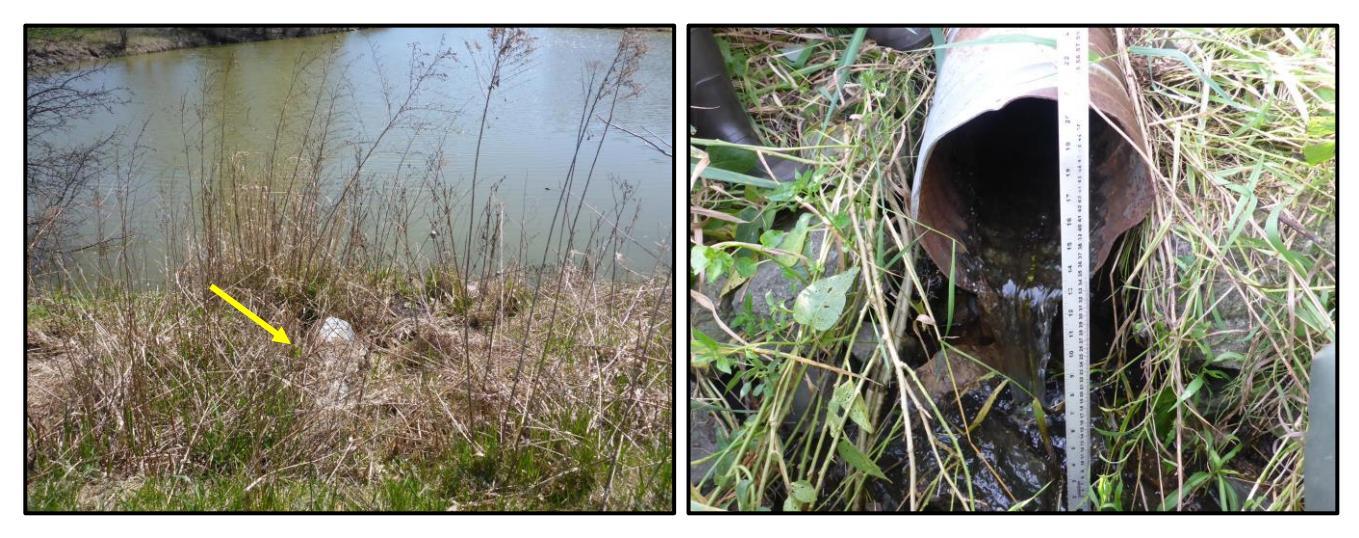
Photo 103 BR5-H1-S3: Downstream view of pipe outlet to Pond D (arrow). Flow conditions could not be determined as the pipe was mostly submerged due to high pond water levels. Sample Event 1 (April 13, 2017)

Photo 104 BR5-H1-S3: Upstream view of pipe outlet; substantial flow conditions. Sample Event 2 (July 28, 2017)

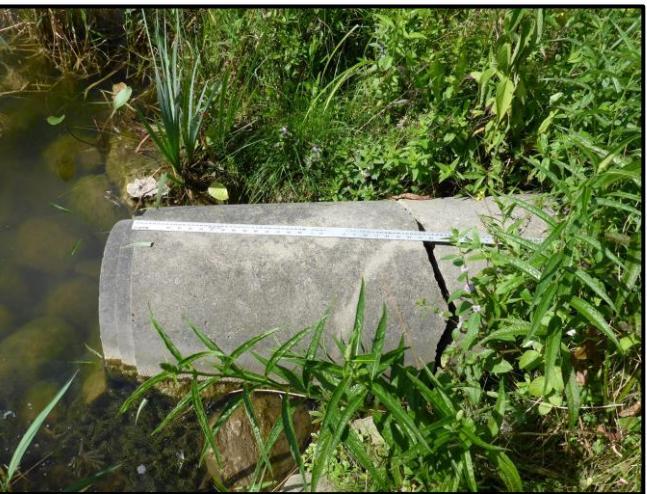
Photo 109 BR5-H1B-S1: View of broken concrete pipe outlet. BR5-H1B-S1: View of broken concrete pipe outlet. Sample Event 1 (April 13, 2017)

Photo 110 Sample Event 2 (July 28, 2017)

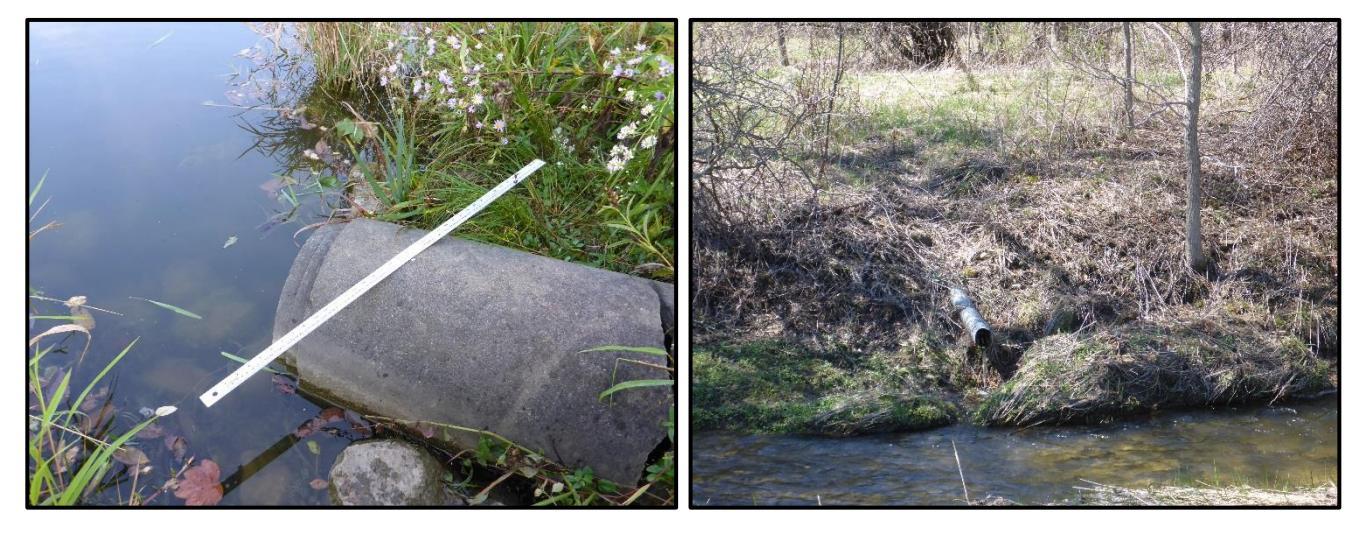
Photo 111 BR5-H1B-S1: View of broken concrete pipe outlet; minimal flow conditions. Sample Event 3 (September 21, 2017)

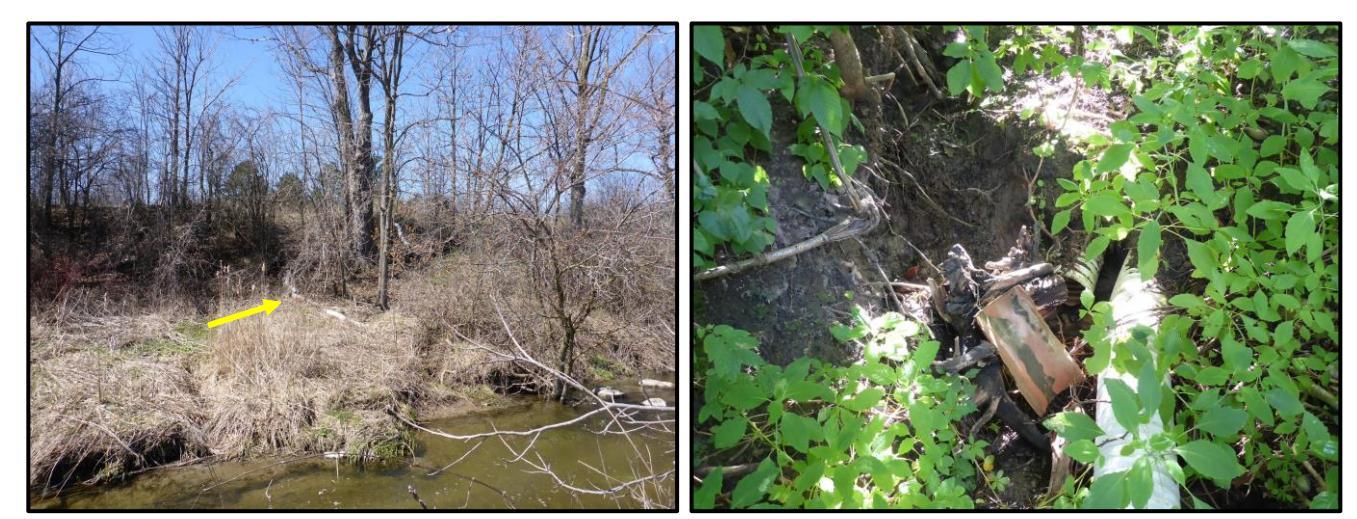
Photo 117 BR5-H4-S1: View of tile outlet on valley wall slope (arrow). Sample Event 1 (April 13, 2017)

Photo 118 BR5-H4-S1: View of broken tile outlet. Sample Event 2 (July 28, 2017)
