GUIDING SOLUTIONS IN THE NATURAL ENVIRONMENT

Fluvial Geomorphology Report in support of a Master Environmental Servicing Plan 4134 16th Avenue, City of Markham

Sixteenth Land Holdings Inc.

September 2016 215200.1

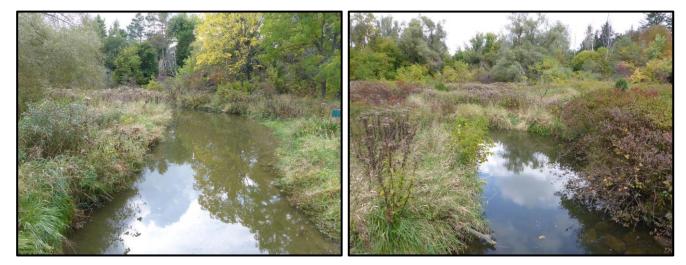
Photo 1 BR-1. Downstream view from pedestrian trail bridge at upstream reach extent. Note widened channel due to backwater from downstream Toogood Pond.

Photo 2 BR-2. Upstream view from pedestrian trail crossing at downstream reach extent.

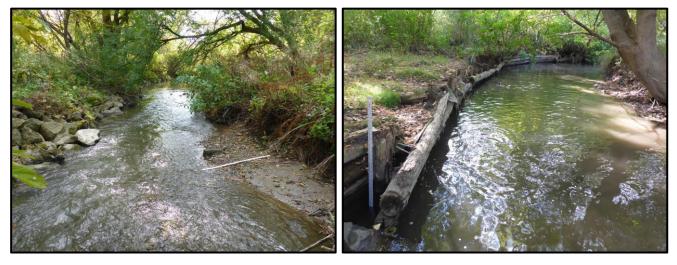
Photo 2 BR-2. Downstream view of general channel conditions. Note stone bank protection on left bank.

Photo 4 BR-2. Looking upstream at failing (undermined and outflanked) cribwall along outside meander bend.

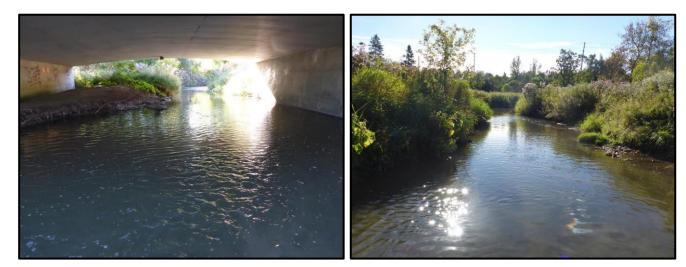
Photo 5 BR-2. Downstream view under 16th Avenue crossing.

Photo 6 BR-2. Basal scour on both side through riffle.

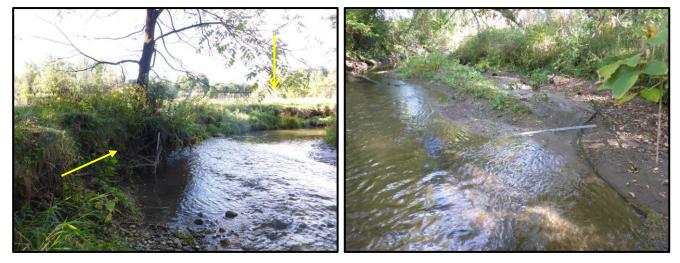
Photo 7 BR-2. Exposed tree roots and slumping banks at outside meander bend viewed downstream.

Photo 8 BR-2. Vegetated bar with chute formation viewed upstream.

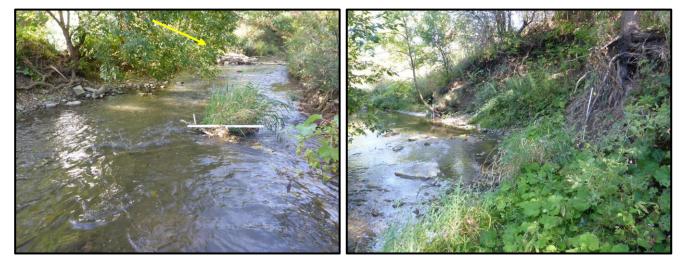
Photo 9 BR-2. Vegetated bar viewed downstream. Note also old bridge footing remains within channel.

Photo 10 BR-2. Valley wall contact on left bank (photo right) viewed upstream.

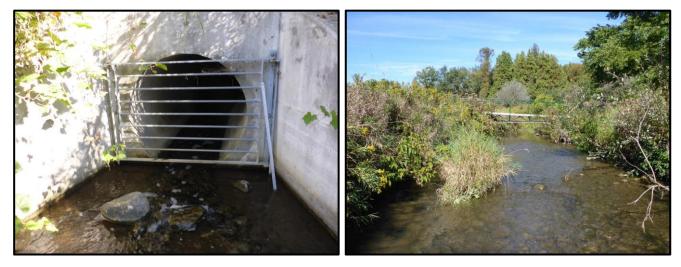
Photo 11 BR-2. 1250 mm storm outfall on left bank.

Photo 12 BR-2. Looking upstream at pedestrian crossing. Note vegetated bar within the channel.

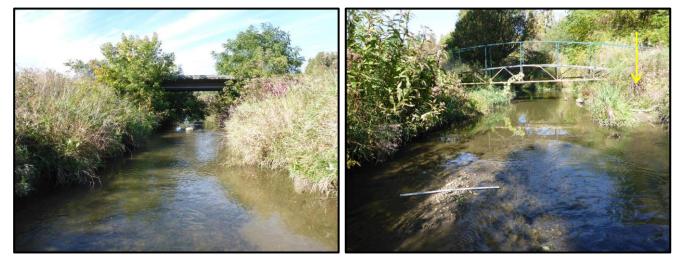
Photo 13 BR-2. Looking upstream toward golf cart path crossing.

Photo 14 BR-2. Looking upstream at pedestrian crossing at upstream extent of the reach. Note the slumping with chute formation in behind.

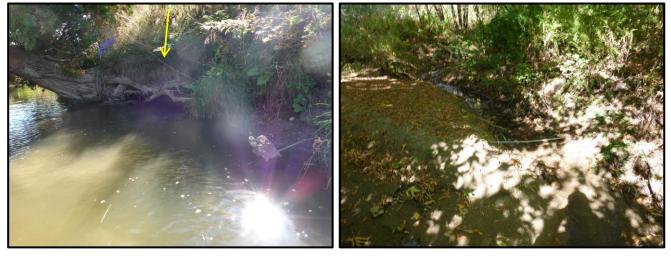
Photo 15 BR-3. Looking downstream at exposed tree roots and under right bank.

Photo 16 BR-3. Looking downstream confluence with SDF-B. Note large sand deposit.

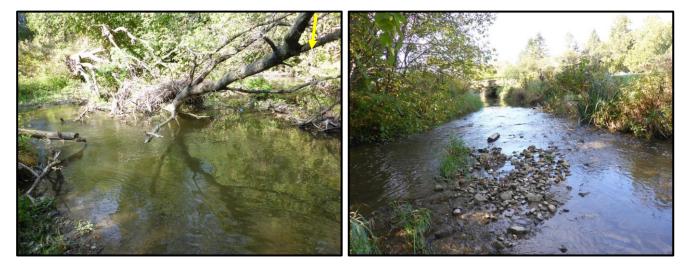
Photo 17 BR-3. Looking upstream at debris jam creating backwater area. Note confluence with drainage feature into backwater area.

Photo 18 BR-3. Looking upstream pedestrian crossing. Note gravel bar within the channel.

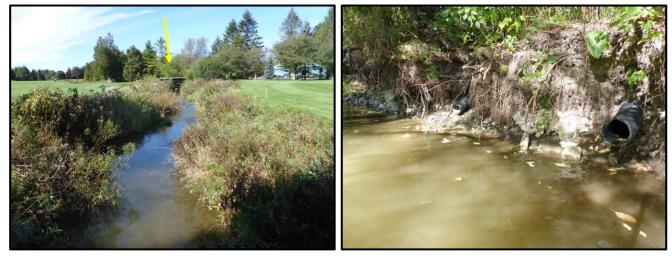
Photo 19 BR-3. Looking upstream from pedestrian crossing at golf cart path crossing. Note manicured grass riparian vegetation.

Photo 20 BR-3. Looking upstream at exposed previously buried pipes in left bank (photo right/centre).

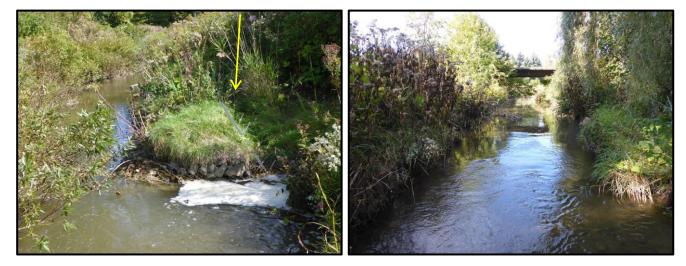
Photo 21 BR-3. Looking downstream at outflanked and undermined gabion basket on right bank.

Photo 22 BR-3. Looking at upstream at golf cart path crossing.

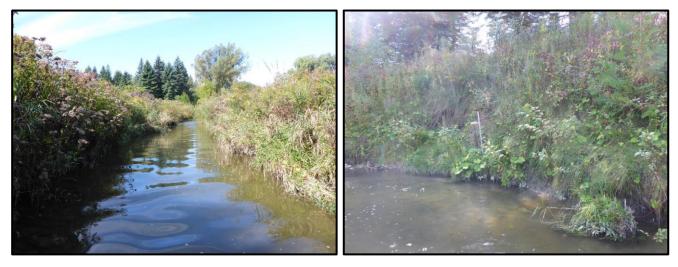
Photo 23 BR-4. Looking at upstream at general reach conditions. Note degree of entrenchment.

Photo 24 BR-4. Looking downstream erosion along right bank.

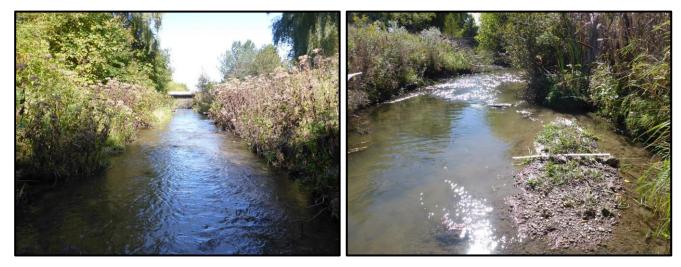
Photo 25 BR-4. Looking upstream at driveway crossing.

Photo 26 BR-4. Looking downstream at bar formation

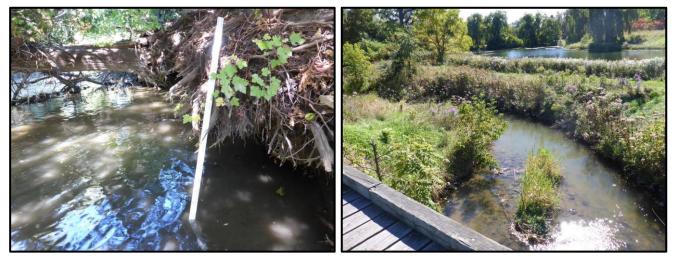
Photo 27 BR-4. Looking downstream at fallen cedar tree, exposed roots and undercut bank.

Photo 28 (Location 28) BR-4. Looking downstream from golf cart path crossing. Note proximity to pond.

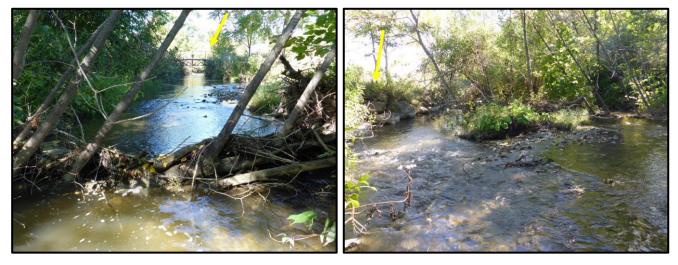
Photo 35 (Location 33) BR-5. Looking upstream at wood debris jam and pedestrian crossing.

Photo 36 (Location 34) BR-5. Looking downstream at island within the channel. Note the armoustone bank treatment along the left bank.

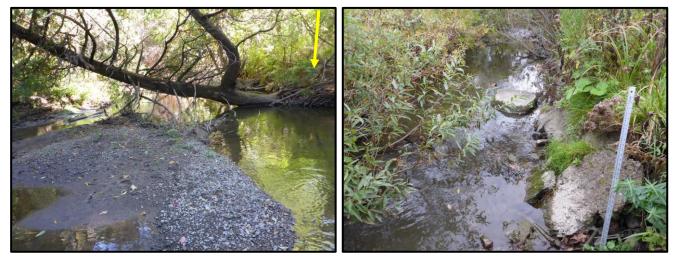
Photo 39 (Location 37) BR-5. Looking downstream of fallen cedar tree and bar formation. Note the confluence with surface drainage feature (D).

Photo 40 (Location 38) BER-3. Looking downstream at ad-hoc bank protection on right bank.

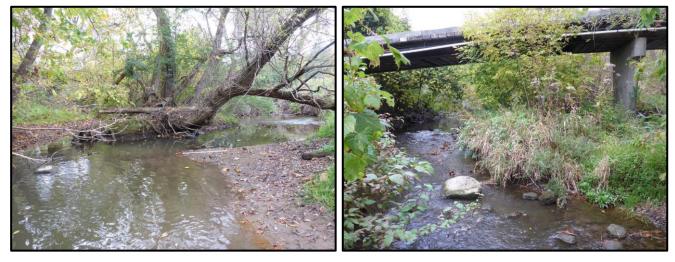
Photo 43 (Location 41) BER-3. Looking downstream at leaning tree with exposed roots at sharp meander bend with a deep pool.

Photo 44 (Location 42) BER-3. Looking upstream at golf cart path crossing.

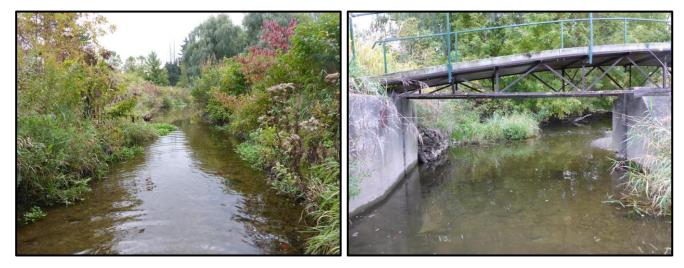
Photo 45 (Location 43) BER-3. Looking downstream at general reach conditions. Note degree of entrenchment.

Photo 46 (Location 44) BER-3. Looking downstream at pedestrian crossing.

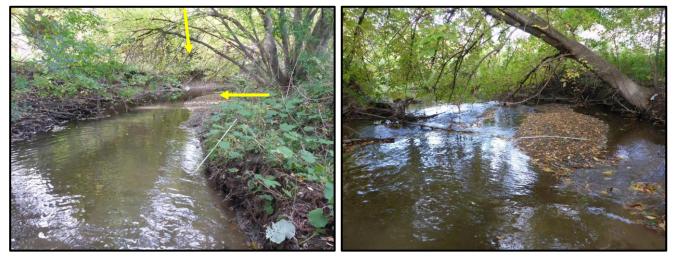
Photo 47 (Location 45) BER-3. Looking downstream at sharp meander bend. Note erosion on outside of bend, point bar formation on inside and basal scour on both sides.

Photo 48 (Location 46) BER-3. Looking downstream at leaning tree and lateral bar.

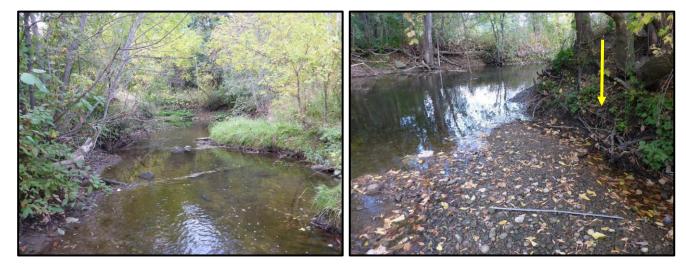
Photo 49 (Location 47) BER-3. Looking downstream toward meander bend and general conditions.

Photo 50 (Location 48) BER-3. Looking upstream at meander bend. Note point bar formation on left bank (photo right) and scour on inside bend.

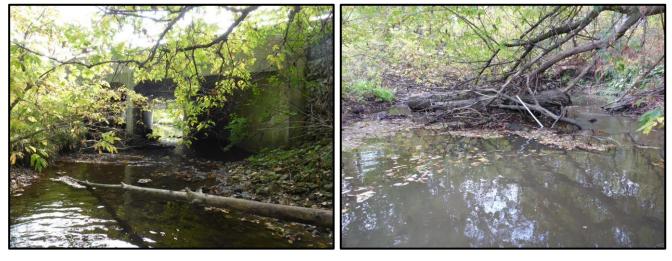
Photo 51 (Location 49) BER-3. Looking downstream at 16th Avenue Road crossing.

Photo 52 (Location 50) BER-4. Looking downstream at large wood debris jam.

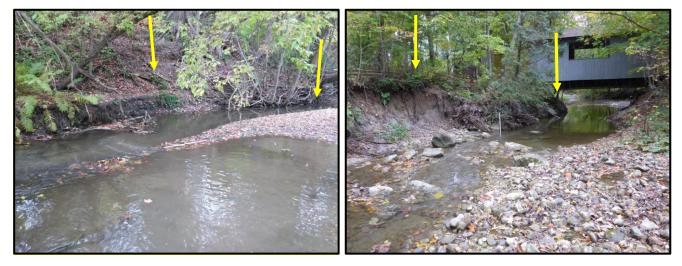
Photo 55 (Location 53) BER-4. Looking downstream at lateral bar and valley wall contact on left bank. Note also misalignment of thalweg.

Photo 56 (Location 54) BER-6. Looking downstream at a bridge crossing at the downstream extent assessed. Note the large deep scour pool and failing footings under the bridge and the erosion on right bank (photo left).

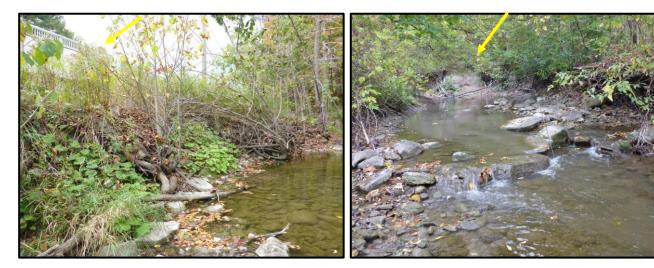
Photo 57 (Location 55) BER-6. Looking upstream at meander bend against Warden Avenue bridge.

Photo 58 (Location 56) BER-6. Looking upstream at boulder step-pool. Note outer bank erosion on meander bend in background.

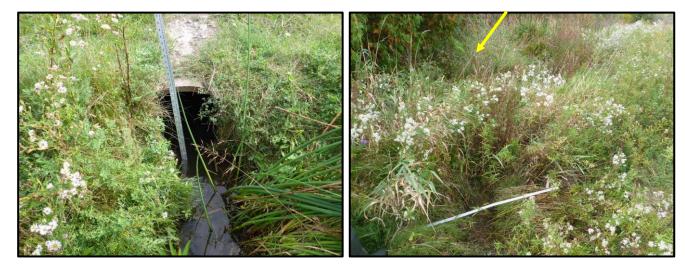
Photo 61 (Location 59) SDF-C. 500 mm metal culvert under farm crossing.

Photo 62 (Location 60) SDF-C. Looking downstream within the wetland. Note heavy degree of vegetation and poorly defined flow path.

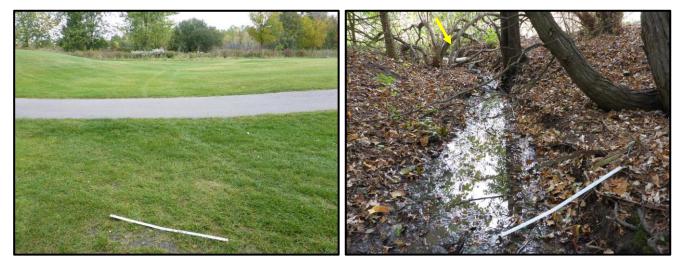
Photo 63 (Location 61) SDF-C. Looking downstream across the golf green. Feature is piped.

Photo 64 (Location 62) SDF-C. Looking upstream at tile pipe outlet to flow path. Note minimal flow and standing water.

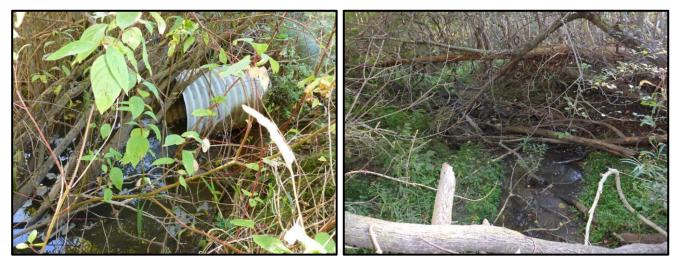
Photo 75 (Location 73) SDF-BC. Looking upstream at perched culvert pipe from under golf green.

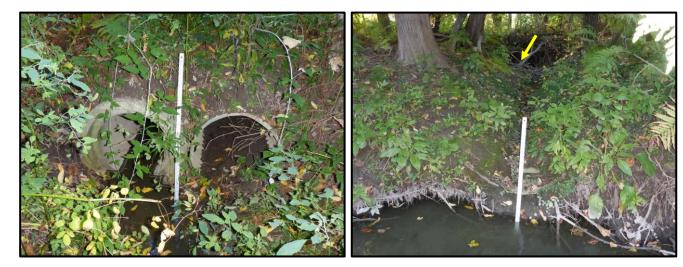
Photo 81 (Location 79) SDF-BC. Looking upstream at culvert under cart path within the woodlot.

Photo 82 (Location 80) SDF-BC. Looking upstream at confluence with BR-3. Note 0.4 m drop to creek bed.
