Class Environmental Assessment for Mount Joy Creek Flood Mitigation

First Public Information Centre (PIC)

May 5th, 2025

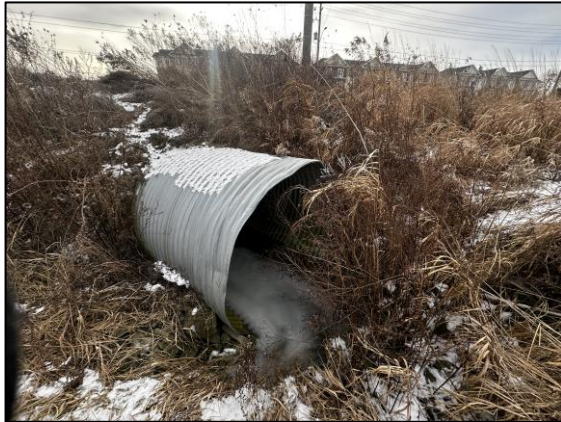
Upstream of Major MacKenzie Drive

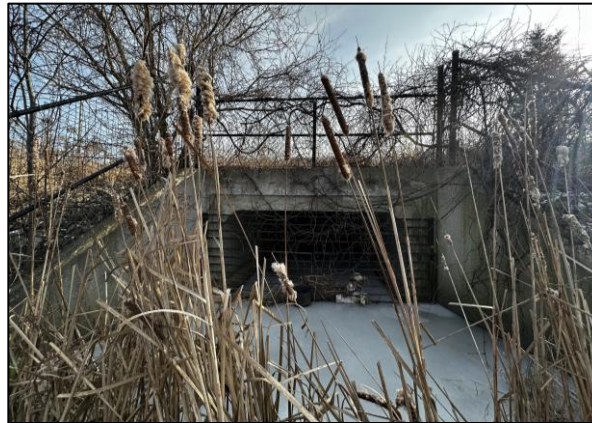
Upstream of Harvard Way

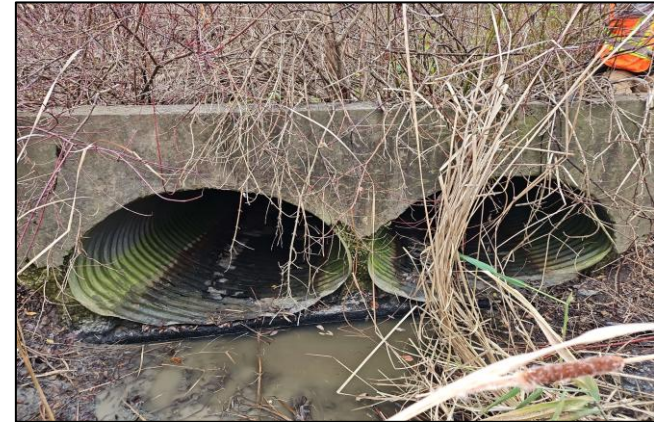
Upstream of 9833 Markham Road

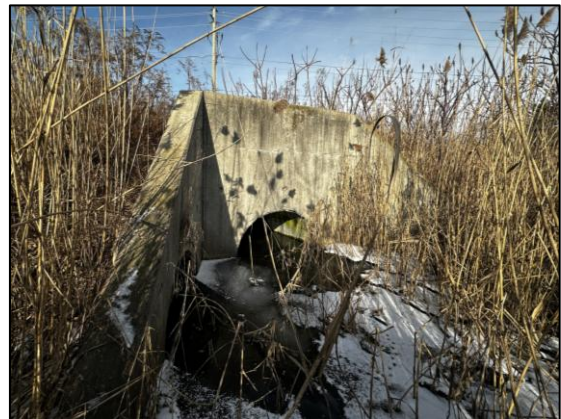
Downstream of Major MacKenzie Drive

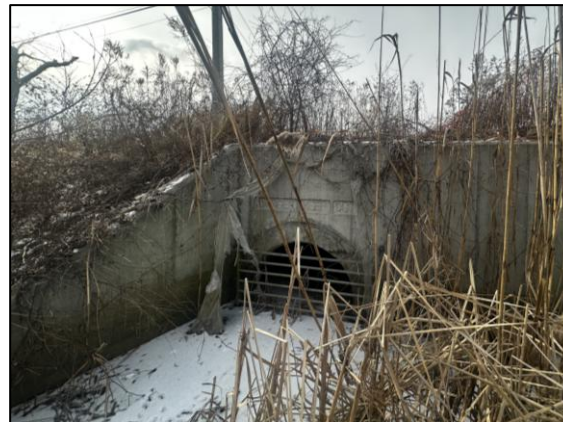
*Downstream of Harvard Way /
Markham Road*

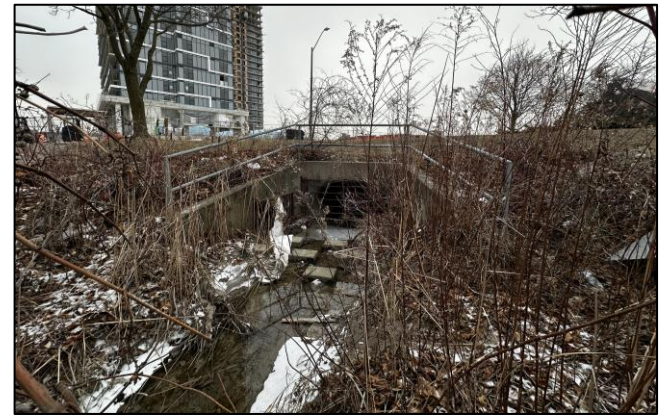
Downstream of Anderson Avenue

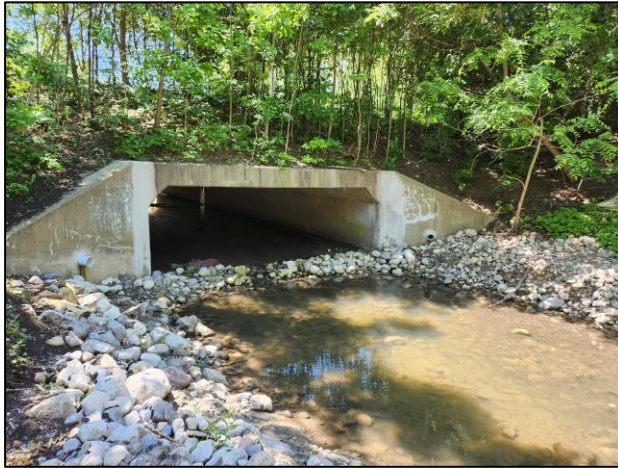
Increased Culvert Size – Box Culvert

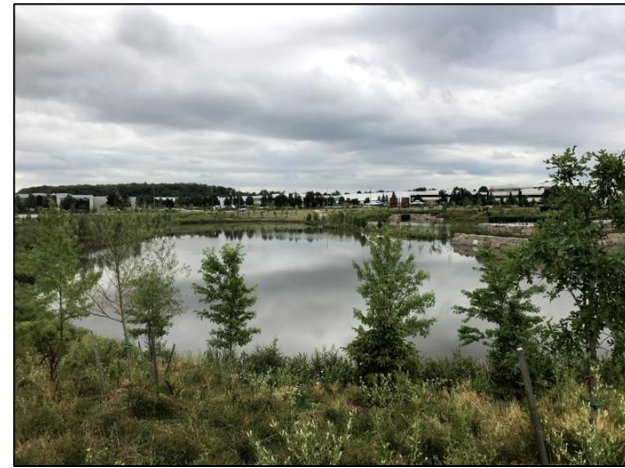
Stormwater Management Pond

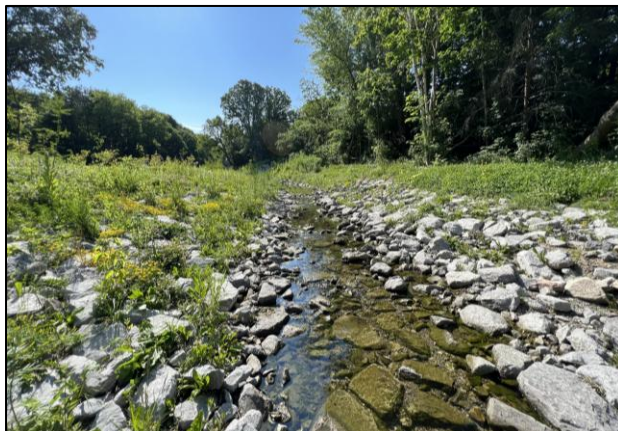
Restored Open Channel

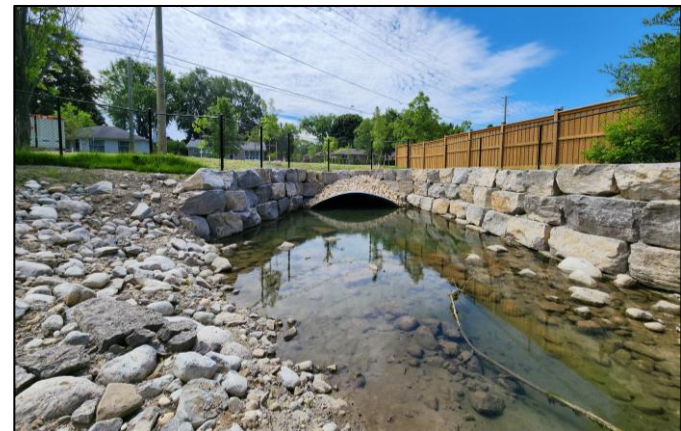
Restored Culvert
