Part 2 Appendices

Best Practices Summary

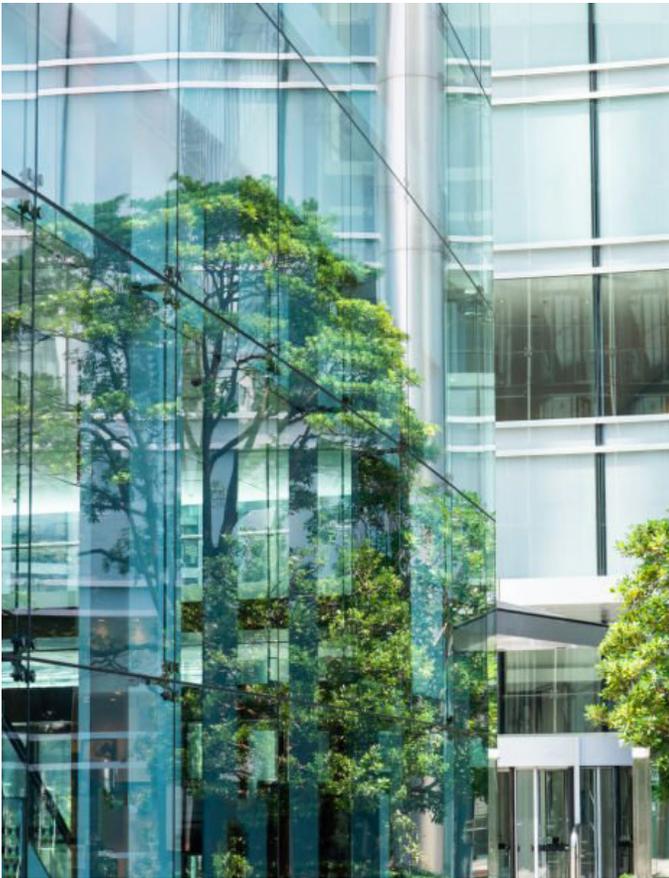
Figure A-4: Birds may fly into glass that reflects vegetation

Surfaces that reflect habitat are seen as habitat by birds, resulting in bird-window collisions. Reflective surfaces can include glass, polished marble (especially dark colours as it is more reflective), or polished stainless steel. Birds may fly into glass that reflects vegetation, sky, or water. Birds may even attack their own reflection in reflective surfaces.

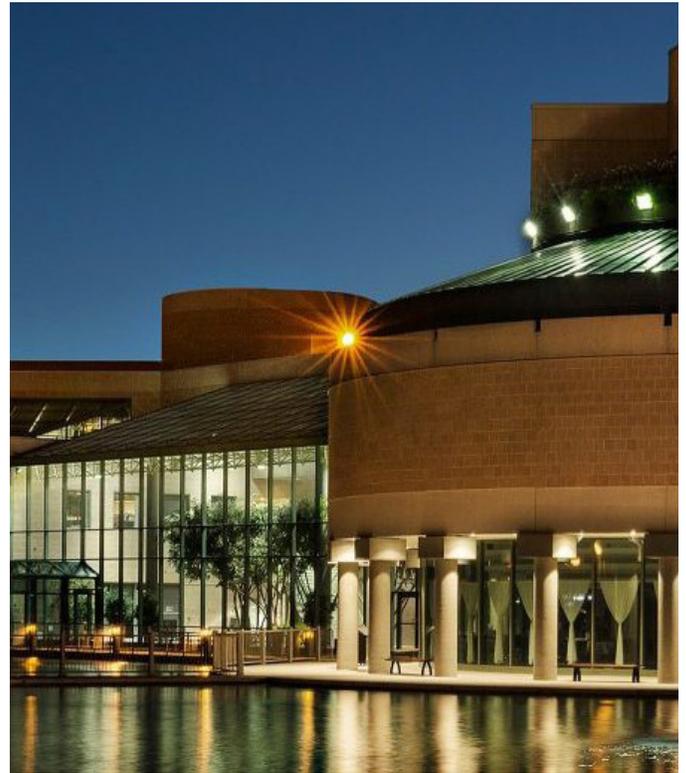
Figure A-5: A bird that see habitat through the glass may fly into the glass

Both research and anecdotal evidence indicate that birds do not see glass as a barrier (Klem and Mesure 2013, pers. comm.). A bird that sees habitat through glass may fly into the glass as if it were not there. Habitat can include trees, flowers, water, sky, etc. Birds may fly into glass if they can see what they perceive as habitat inside the glass (e.g. house plants), or if they can see habitat on the other side of the glass (for example vegetation, sky or water through link ways, courtyards, bus shelters, plexiglass barriers on verandas, etc.).

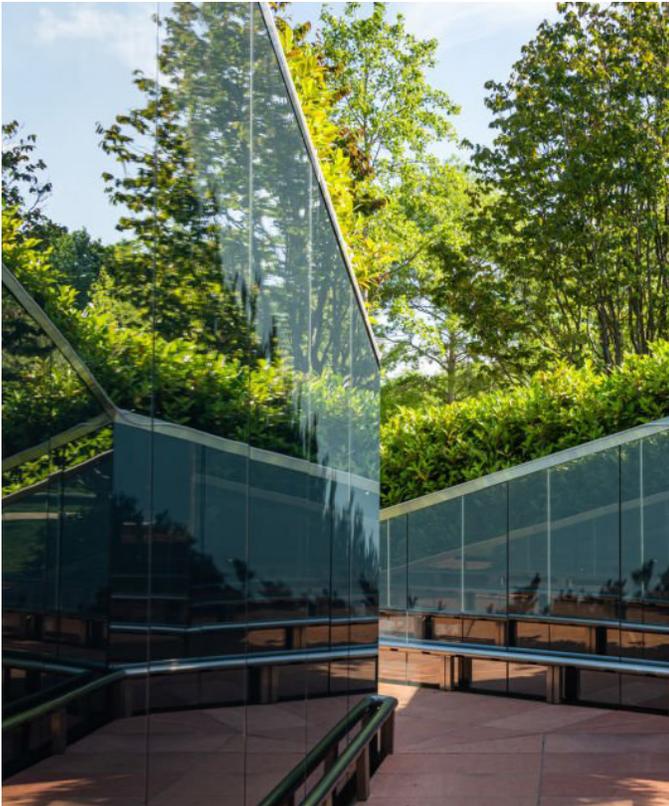
Figure A-9: Glass reflects elements perceived as habitat such as sky

Almost any type of surface associated with buildings largely composed of glass significantly increase the risk of bird-window collisions. If the glass is transparent, it can be perceived as leading to habitat. If it is reflective, it generally reflects elements perceived as habitat such as sky, vegetation or water.

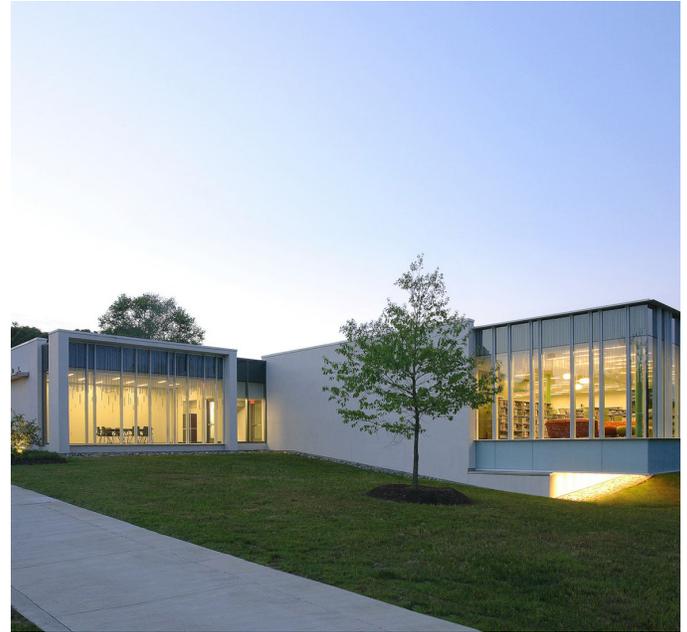
Figure A-10: Size of a building is not necessarily associated with numbers of collisions

The size of a building is not necessarily associated with numbers of collisions: except in the case where the amount of glass is proportionally high in relation to the size of the building. The surface area of glass is one of the most important factors in predicting the number of bird-window collisions. The larger the glass surface, the higher the bird-window collisions (Hager et al. 2013).

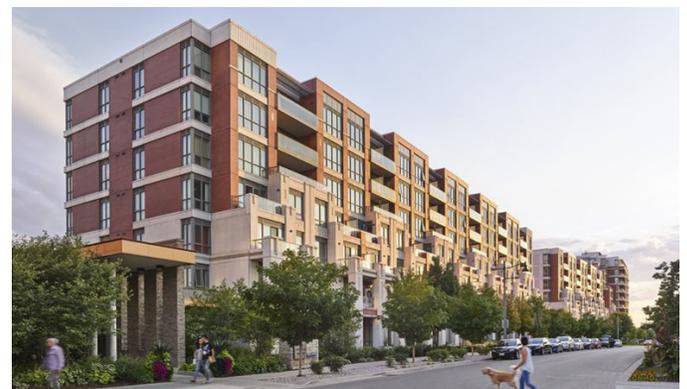
Figure A-11: Building orientation is not necessarily associated with numbers of collisions

Though each façade of a building tends to have a unique “signature” when it comes to bird-window collisions, there is little information on the effect of orientation. For example, there is no evidence that south-facing façades are more likely to have bird-window collisions than north-facing façades.

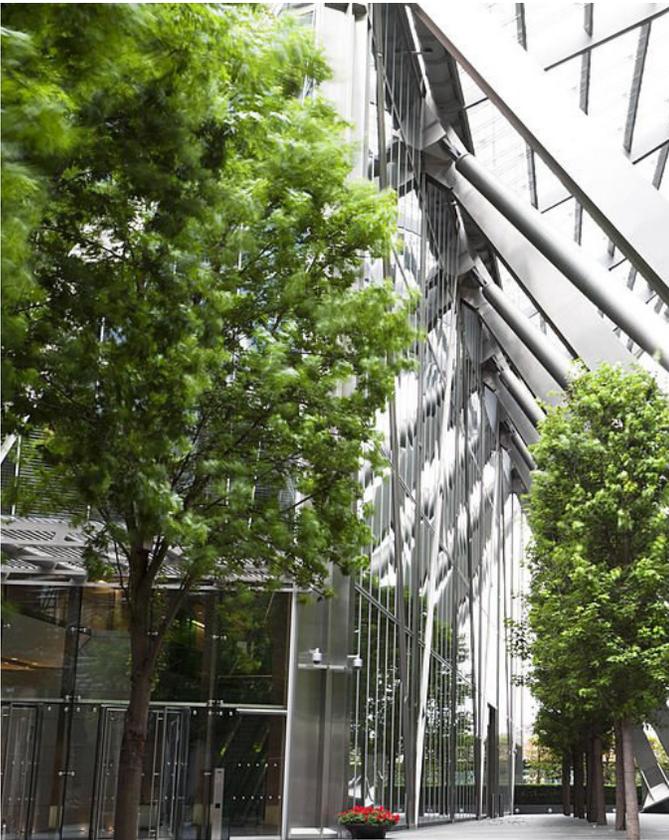
Figure A-14: Bird are attracted to vegetation in courtyards

Enclosed features such as window-lined courtyards can “trap” birds, especially if the courtyard is highly vegetated, and/or contains a water feature (Mesure 2013, pers. comm.). Birds are attracted to the vegetation within the courtyard and then fly into the surrounding windows.

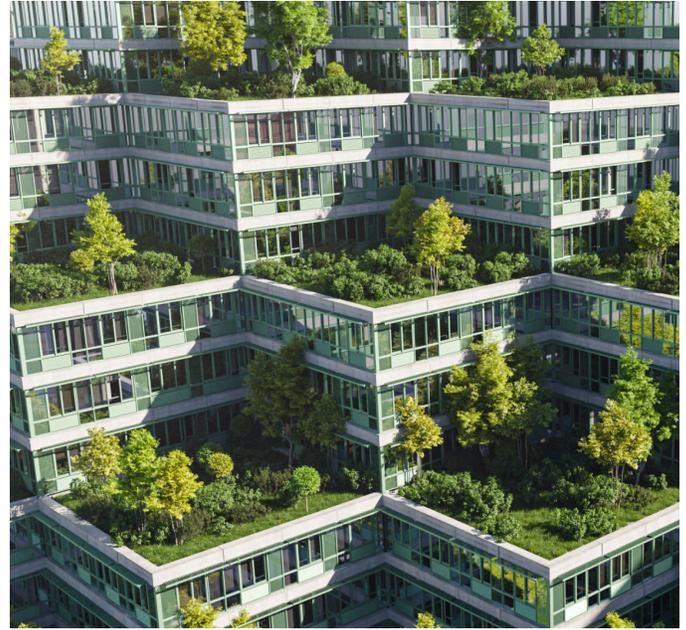
Figure A-15: Bird-Window collisions are most often associated with glass that reflects vegetation

Bird-window collisions are most often associated with glass that reflects vegetation. The reflections can be associated with a natural feature, or can be associated with planted gardens. Both features seem to attract birds and are associated with bird-window collisions. The height of the vegetation is the most important factor in dictating the height at which bird-window collisions will occur. Generally, collisions occur from the ground to the top of the reflected trees (approximately 16m from finished grade is considered to be the height). However, if a building is next to a slope, the height of the reflected vegetation may be greater than when the building is on flatter ground. Moreover, the height of mature trees in a natural area can reach 25m or more. In this case, bird-window collisions will occur at higher levels of the building. Where there is glazing adjacent to green roofs and/or other rooftop vegetation, the bird collision mitigation strategy should be applied to a height of 16m from the surface of the green roof.

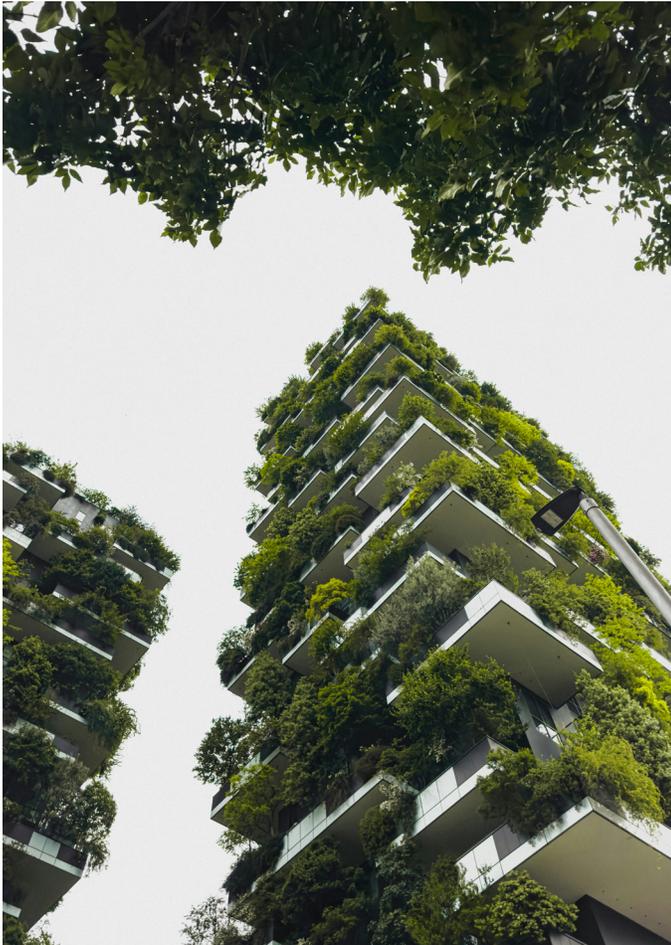
Figure A-16: Green roof, living walls, and gardens could attract birds and associate with numbers of collisions

Green roofs adjacent to glass may attract birds and these birds may become involved in bird-window collisions. As with vegetation on the ground, it is the height of the vegetation that dictates the height of bird-window collisions. Vegetation on green roofs is generally adapted to shallow soils so is usually composed of grasses and herbaceous plants, possibly with a few shrubs. These generally do not reach the height that trees can reach, so reflections in the glass may potentially only reach few metres above the roof. However, some roof gardens have planted trees or other design feature (e.g. transparent glass railings) which can make them especially high-risk for bird-window collisions.

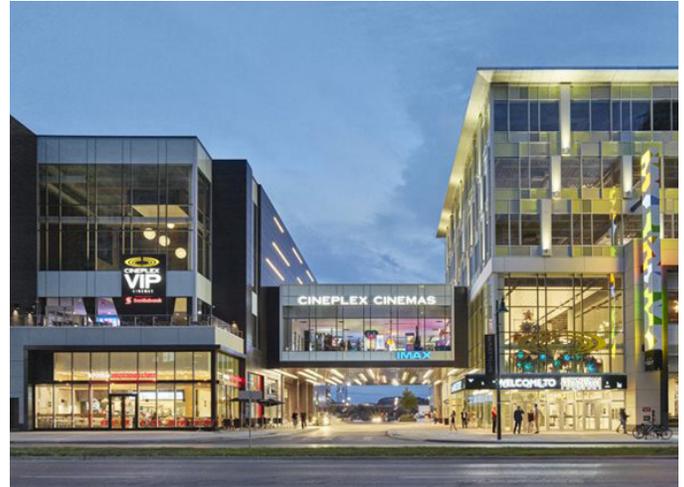
Figure A-17: Migrating birds are attracted to artificial urban light

The science of bird-window collisions is evolving. While it used to be thought that night lighting was primarily responsible for collisions, it is now known that most collisions occur in the daytime potentially within Markham (Mesure 2013, pers. comm.). There may be an interaction between night lighting and daytime bird collisions, which is poorly understood (Sheppard 2013, pers. comm.). Lighting may draw birds to seek habitat in cities where they are at risk of collisions. It is possible that the majority of nighttime bird collisions occur only in bad weather, where rain and fog cause birds to come down to the height of buildings (Gelb & Delacretaz 2009); and predicting locations and numbers of these collisions may be very difficult. Night collisions are much more prevalent in Toronto near the waterfront (Mesure 2013, pers. comm.). It is worth considering flight patterns of birds in relation to buildings of various heights, especially relative to night lighting within cities.

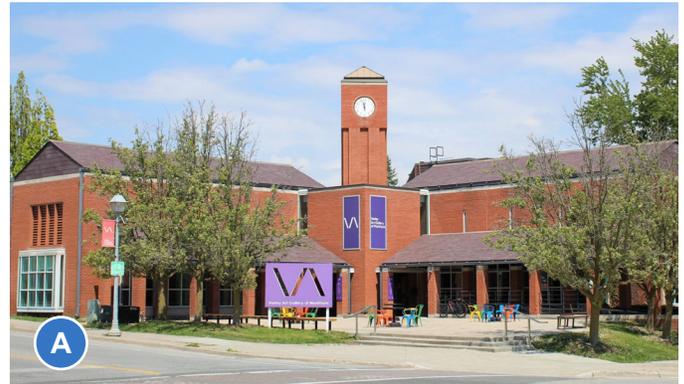
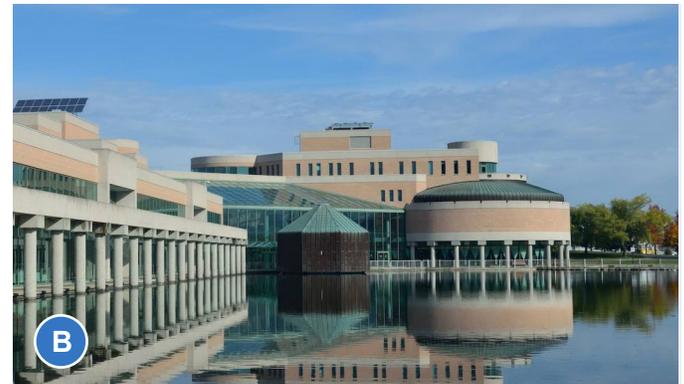
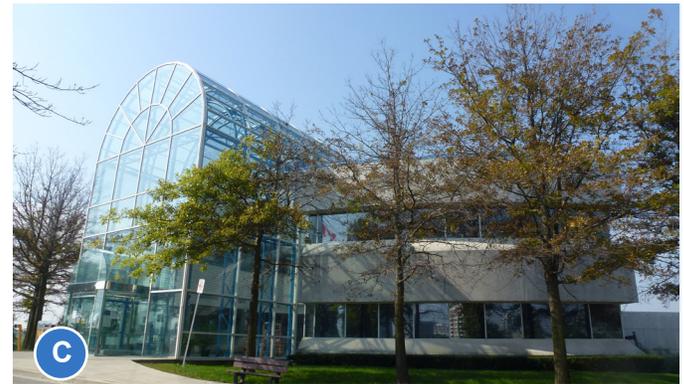
Figure B-2: Implementation of bird-friendly measures on public buildings in Markham

- A. Fred Varley Art Gallery
 - B. Markham Civic Centre
 - C. 8100 Warden Avenue
-

A pattern of horizontal dotted stripes printed onto transparent film was applied to the Fire and Emergency Services building at 8100 Warden Avenue in 2009 and 2010. The treated areas included a large transparent glass atrium at the entrance as well as two storeys of narrow, mirrored office windows, located on both sides of the atrium, where reflected vegetation were responsible for numerous bird-window collisions. Though the treatment proved to be effective at reducing collisions, the initial treatment had degraded and was thereby replaced with a white die-cut dotted pattern.

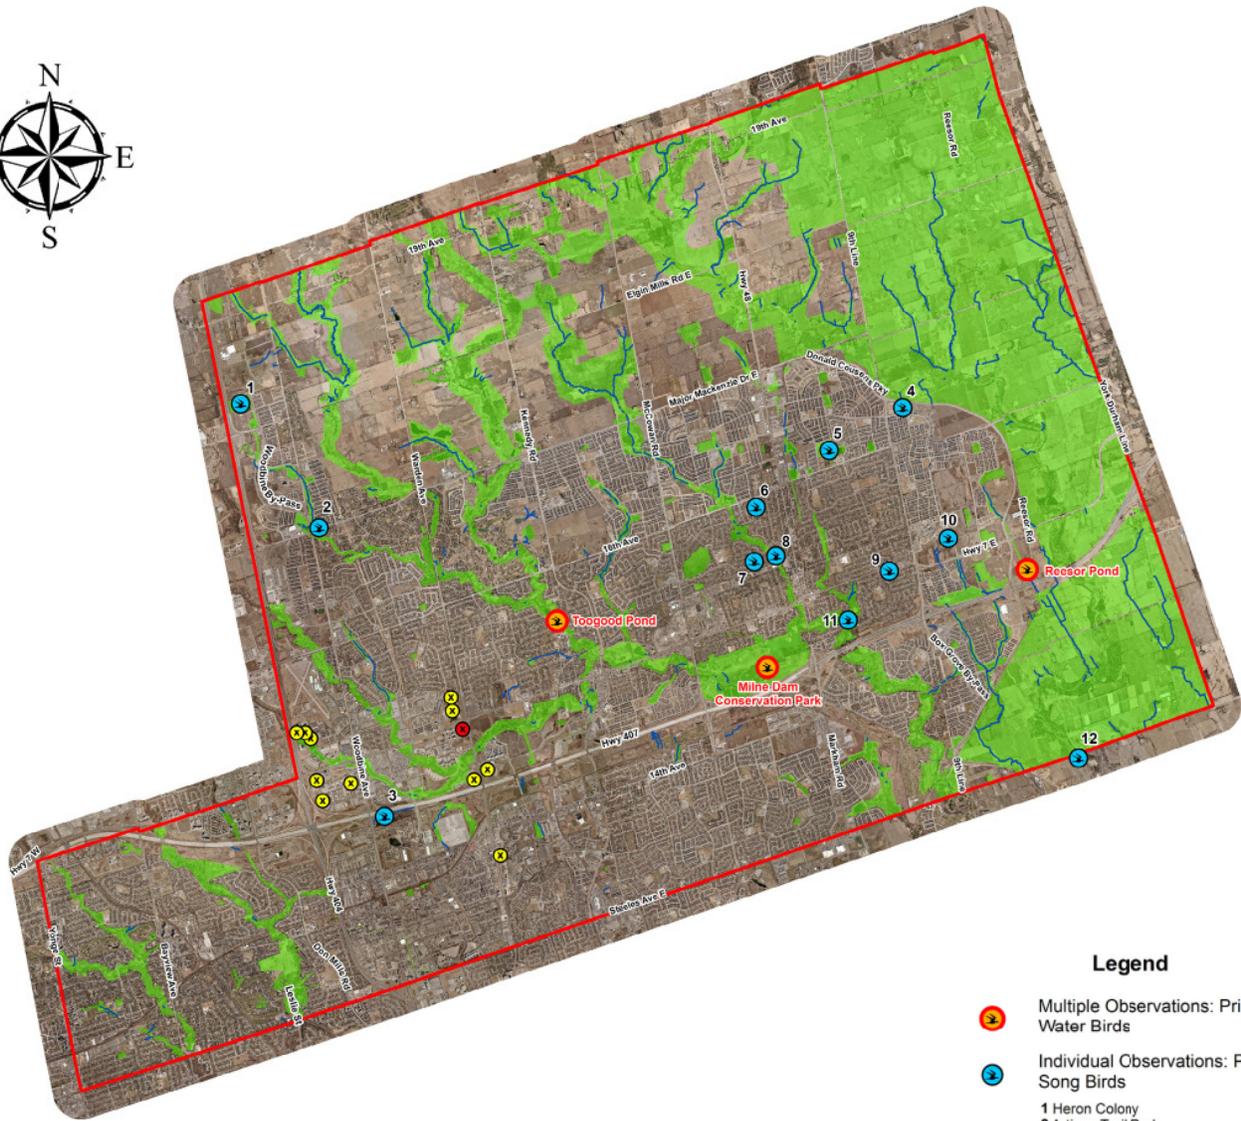
Figure D-3: Markham's proposed Greenway System in relationship to areas where migrants have been observed and bird-window collisions
