Natural Environment Report/ Environmental Impact Study

**in support of a
Master Environmental Servicing Plan
4134 16th Avenue**

Sixteenth Land Holdings Inc.

Beacon Environmental Limited

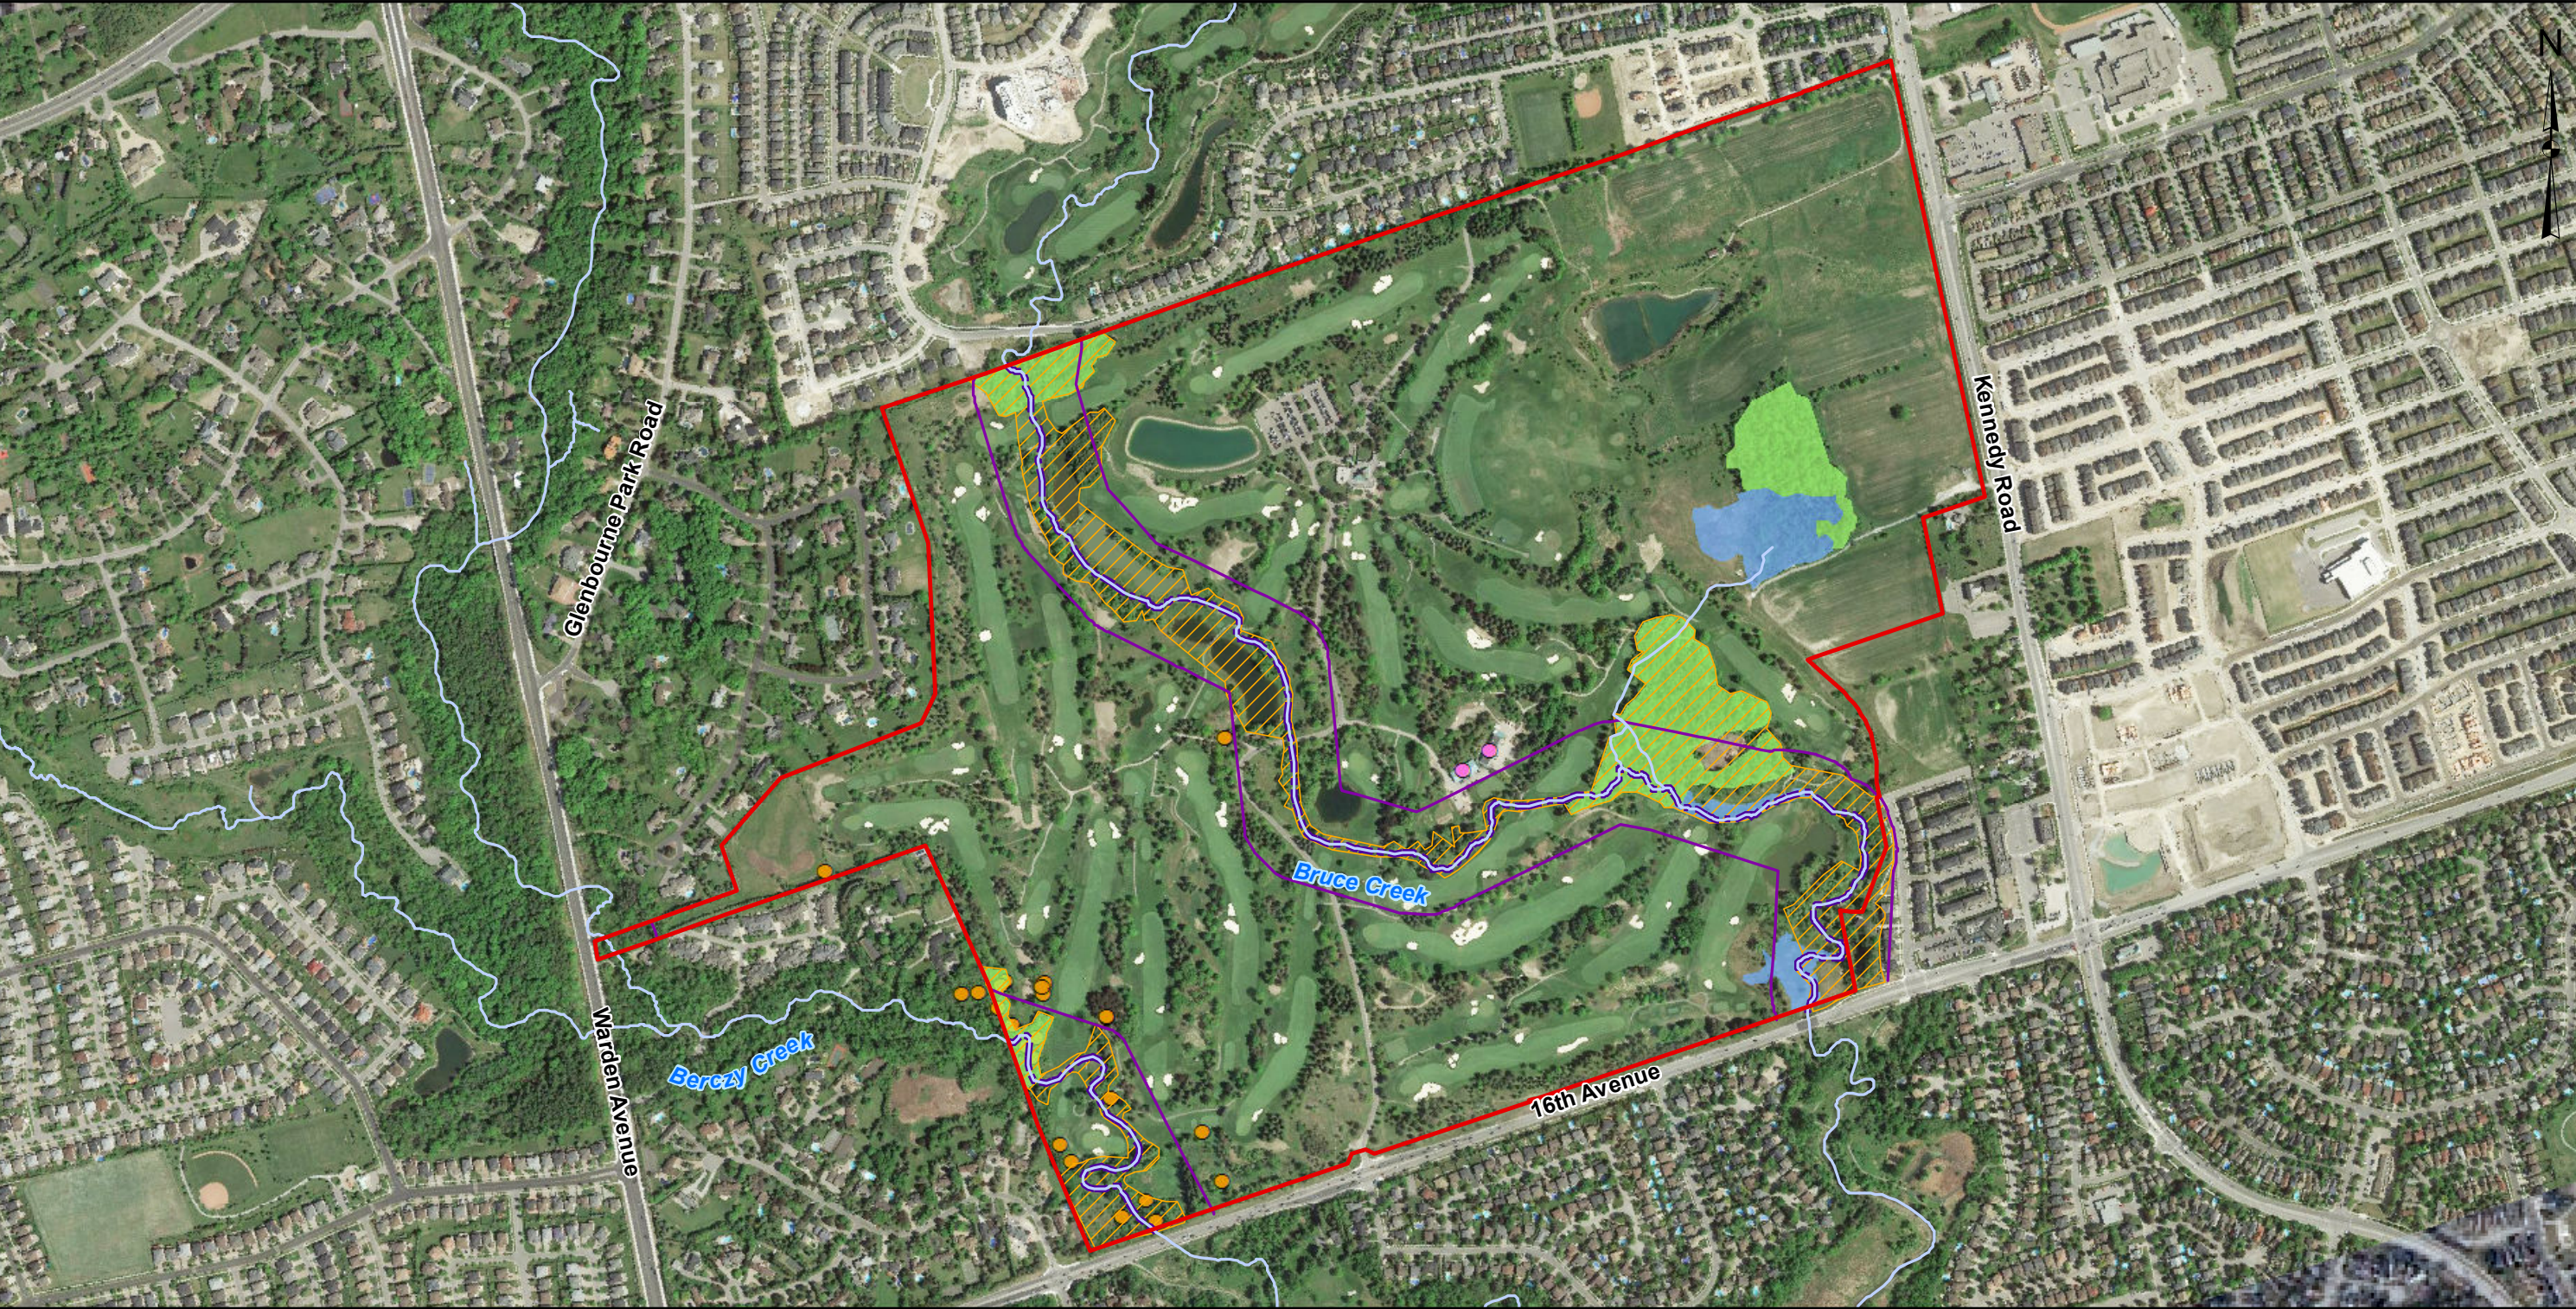
An analysis of the existing conditions within the subject property identifies the following key natural heritage features, which are illustrated on **Figure 5**:
