Wildlife Management Plan

4134 16th Avenue (York Downs Golf and Country Club)

City of Markham

Beacon Environmental Limited

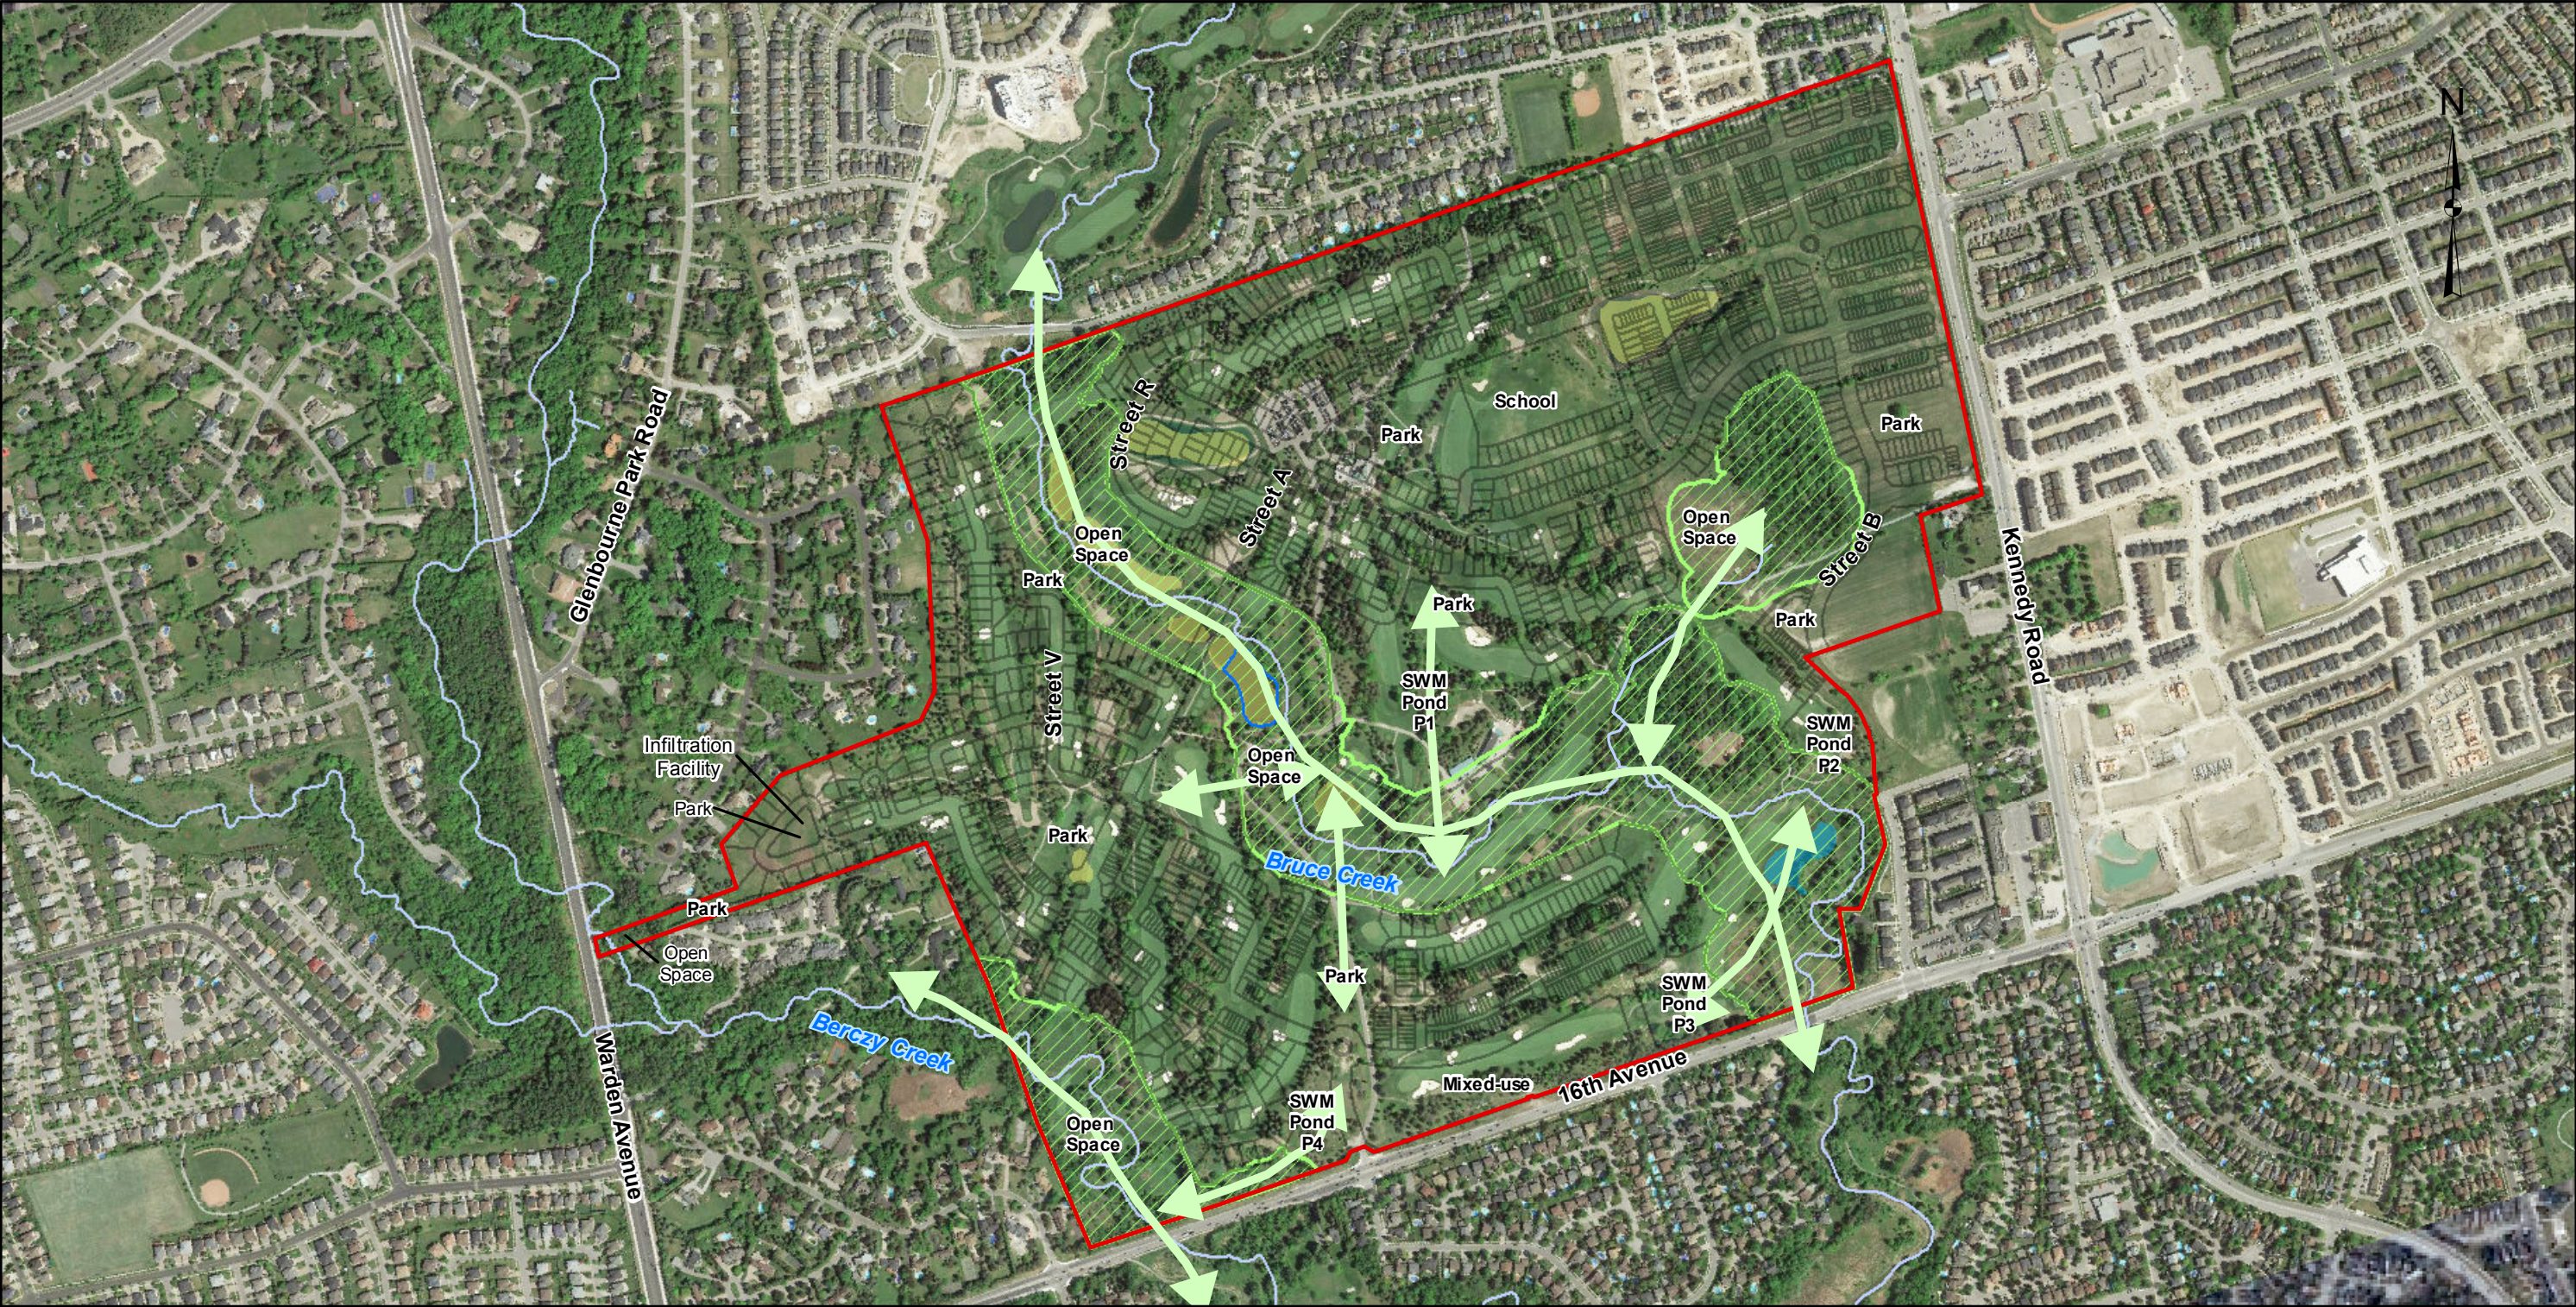
FIGURE 2: Greenway System and

As shown on the development plan (**Figure 2**), the features on the subject property have been maintained with appropriate buffers in order to ensure their continued function, to promote connections to neighbouring wildlife communities and to allow for safe wildlife passage. Animals will be free to travel safely throughout the development and beyond without being isolated to individual areas. This level of

The development has been designed to allow connectivity throughout both valleylands, as well as from these valleylands to adjacent woodlots, parks, and ponds. These ecological linkages are illustrated on **Figure 2**.

Ecological Linkages

As noted in Section 2.2, three trail crossings and one road crossing are proposed over Bruce Creek (**Figure 2**). The road crossing is being designed to avoid any in-water works; however it will likely be subject to a permit under Section 17(2)(c) of the *ESA* as works will need to be undertaken within the regulated habitat of meander belt + 30 m. The conditions of this permit are being discussed with MNRF. Although the installation of the trail crossings will also not require in-water works, the rehabilitation of these crossings (e.g., updating or replacing footings) and the removal of existing crossings not proposed for use with the trail, will require in-water work. These crossings should be removed and the creek banks stabilized and revegetated to provide an increase in natural riparian habitat.

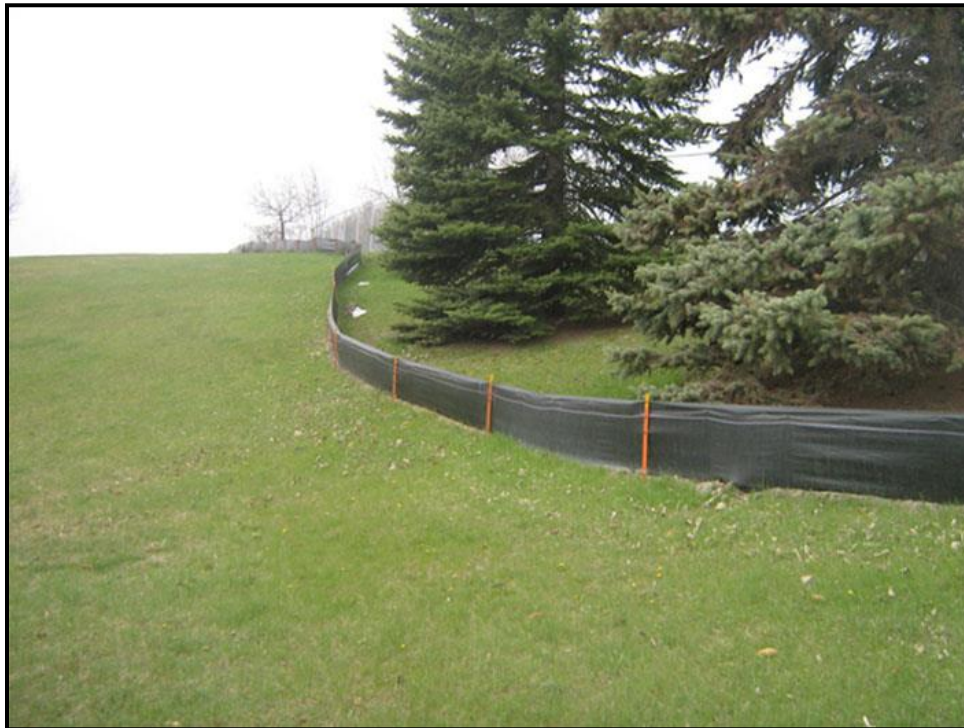
Photo 1. Wildlife Exclusion Fencing

Wildlife exclusion fencing can be used in order to dissuade animals from entering construction zones (**Photo 1**). Exclusion fencing is widely utilized and is proven to be one of the most effective mitigation strategies available. The fencing design should consist of a solid and durable framework able to withstand variable weather conditions. Chain link and snow fence are not recommended as many of the animals meant to be excluded can fit between the gaps of the fencing. MNRF *Best Management Practices for Mitigating the Effects of Roads on Amphibian and Reptile Species at Risk in Ontario* (2016) recommends that hardware cloth or heavy-duty plastic designed for wildlife be utilized, geotextile fence can also be used in non-permanent situations, such as during construction. In case of geotextile fencing, the wooden posts of the fencing are always to be located on the interior side of the fencing. This ensures that no animals have the ability to ascend up the post, reaching the interior side. This also provides optimal panel stability, ensuring that no animals have the ability to push the panels of the fence forward and enter underneath. Page wire fencing with a buried edge and filter cloth will also provide an appropriate barrier.

Exclusion fencing is most effective when it encompasses an entire area, however it can also be utilized in specifically targeted areas such as road crossings when connectivity is not a concern. The intended purpose of the fencing in these situations would be to exclude the animals from high risk areas such as roadways, instead diverting them back to adjacent suitable habitat.

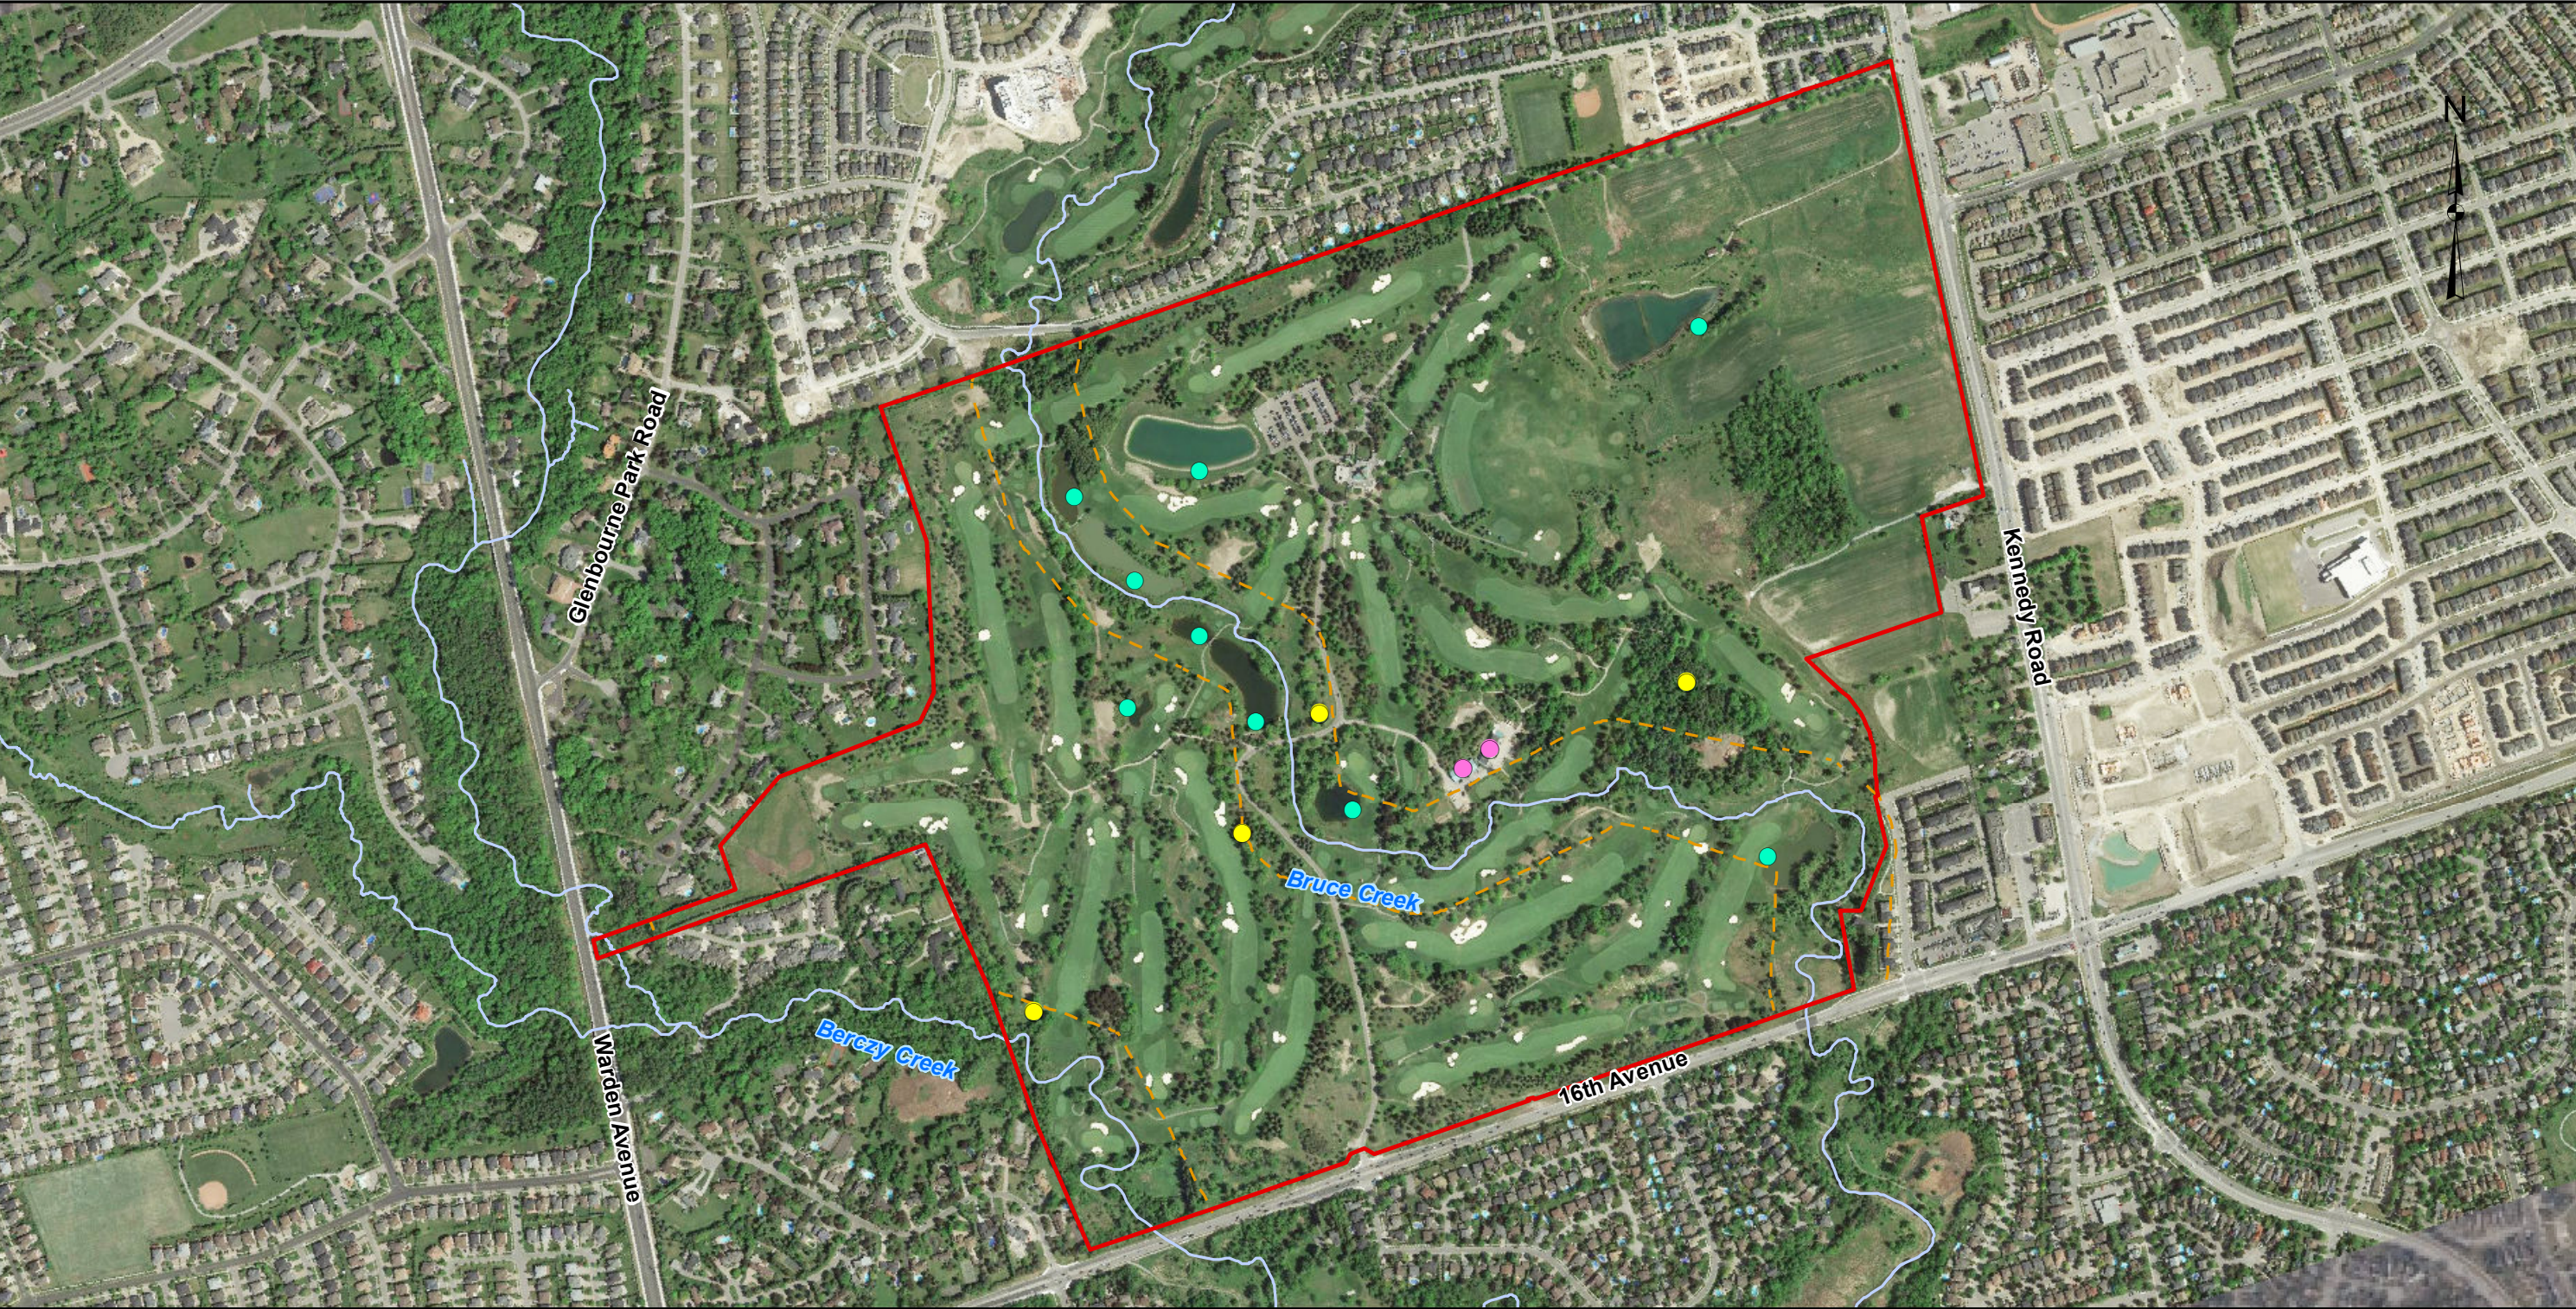
FIGURE 3: Existing Conditions Wildlife

Both Bruce and Berczy Creek have been identified by MNRF as occupied Redside Dace habitat (**Figure 3**). The Redside Dace is a small colourful minnow that reaches a maximum length of about 12 cm. This species is listed as Endangered by COSSARO and is therefore protected under the Ontario *Endangered Species Act* (ESA, 2007). It has also recently been uplisted to Endangered on Schedule 1 under the federal *Species at Risk Act* (SARA; 2002), and therefore receives protection from Fisheries and Oceans Canada (DFO). Due to the presence of this fish species, stricter than normal mitigation strategies will be implemented during the construction process. These creeks will have extensive erosion and sediment control measures installed and closely monitored. Sedimentation of the watercourse can be very detrimental to fish species, damaging their gills and impeding their ability to feed. The Ministry of Natural Resources and Forestry (MNRF) regulates Redside Dace habitat, and DFO protects fish. These agencies will be consulted and discussions will be ongoing to ensure all works are in compliance with the *ESA* and *SARA*.

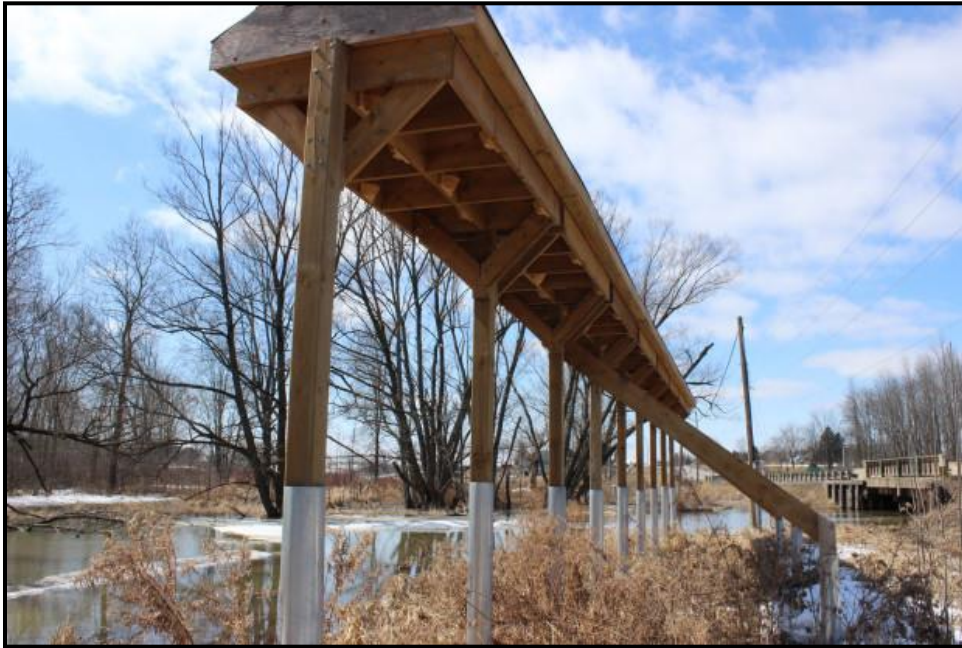
Photo 4. Barn Swallow Nesting Structure

Two single nests were found within the subject lands, observed on separate maintenance buildings in the central portion of the site. These buildings will be removed during construction but nesting structures will be installed to compensate for their removal, through the MNRF Notice of Registry Process (**Photo 4**). Nest boxes may also be placed within park structures (i.e., gazebos) to allow for additional nesting opportunities throughout the site.

Additional nests are located offsite immediately to the west. The Barn Swallows using these nests, as well as any that may inhabit the newly created nesting structures, will continue to forage over the open spaces (e.g., valleylands, park blocks, and SWM ponds as discussed above) within the development.

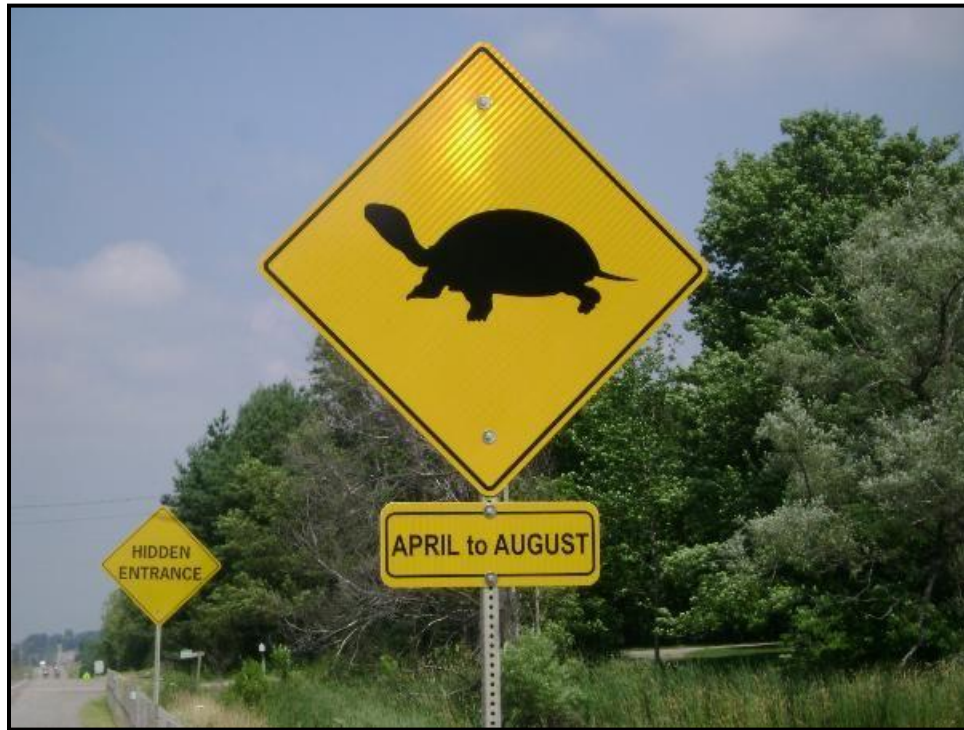
Photo 5. Example of “Turtle Crossing” Sign

Animal road crossing signs such as the one seen in **Photo 5** are most effective when placed in areas of high wildlife usage. Overabundance of these signs can lead to inattention by drivers. Basic information, such as the months of the year that are applicable to the warning, is useful information to include as it heightens and confirms the sense of urgency felt by drivers within those months.
