German Mills Meadow and Natural Habitat (Former Sabiston Landfill) Site - Status Update

**General Committee
February 3, 2014**

Asset Management Department

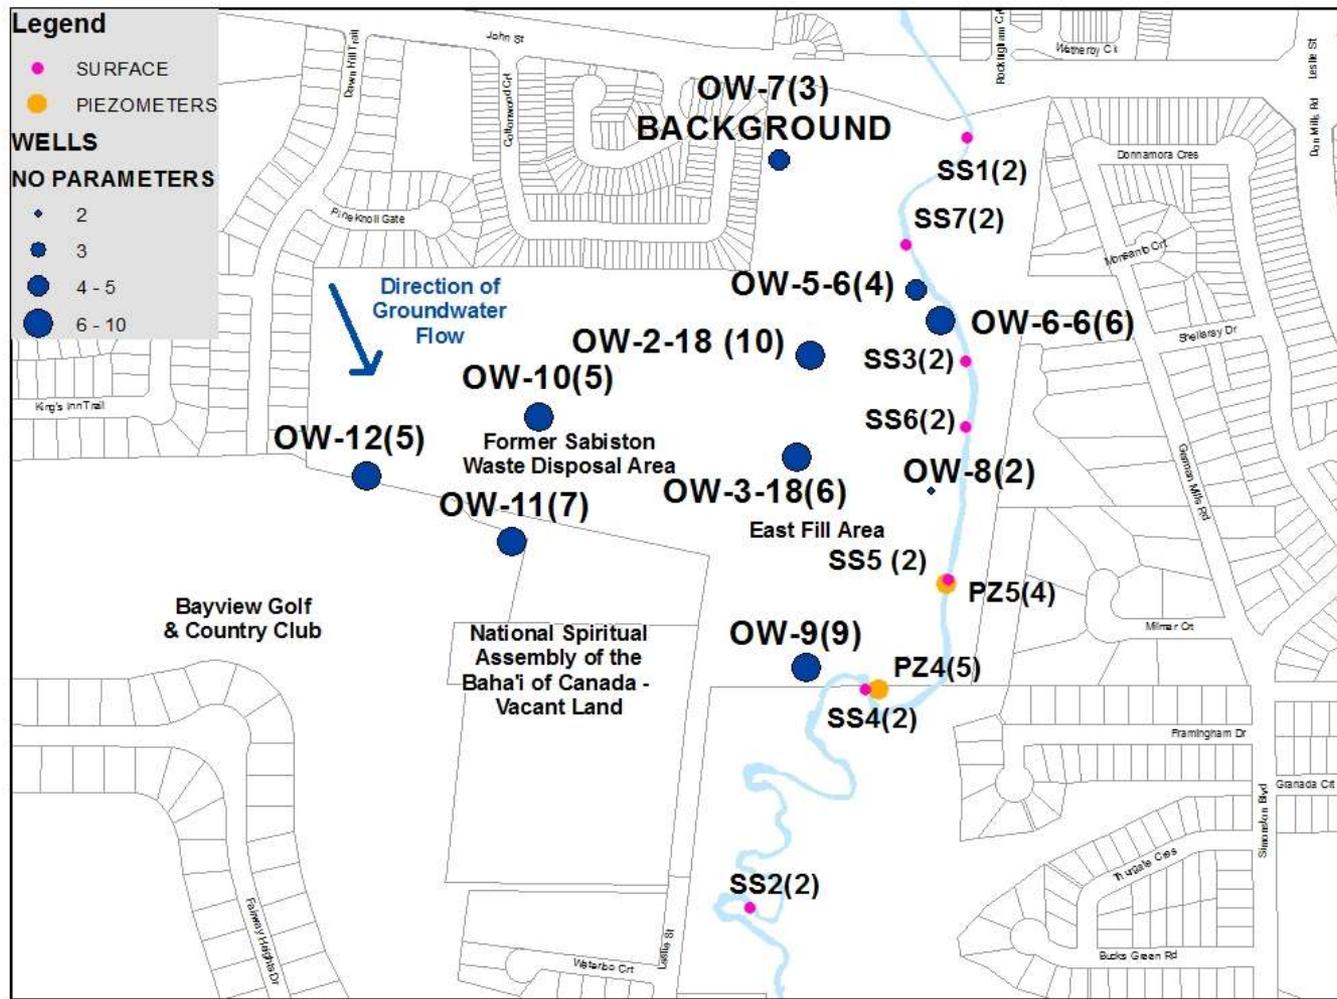
Figure shows direction of groundwater flow, and size of the “blue dot” showing number of parameters that exceeded the ODWQS or PWQOs Standards

OW-10(5) = 5 parameters

- **Water quality samples collected since 2003**
- **Compared water quality samples**
 - Background / up-gradient of the landfill (OW-7)
 - Within the landfill and east-fill (OW-10, OW2-18, OW3-18)
 - Adjacent to German Mills Creek (OW5-6, OW6-6, OW-8)
 - Down-gradient of the landfill (OW-9, OW-11 and OW-12)
- **Results of monitoring program**
 - Landfill still producing leachate
 - Groundwater quality down-gradient has higher concentrations of leachate contaminants compared to background/up-gradient levels

- Contaminants exceeding the Ontario Drinking Water Quality Standard (ODWQS) and the background levels at down-gradient wells

- o arsenic, chloride, total dissolved solids (TDS) , iron, sodium, dissolved organic compounds (DOC), vinyl chloride, tri-chloroethene (TCE) and di-chloroethene (DCE)

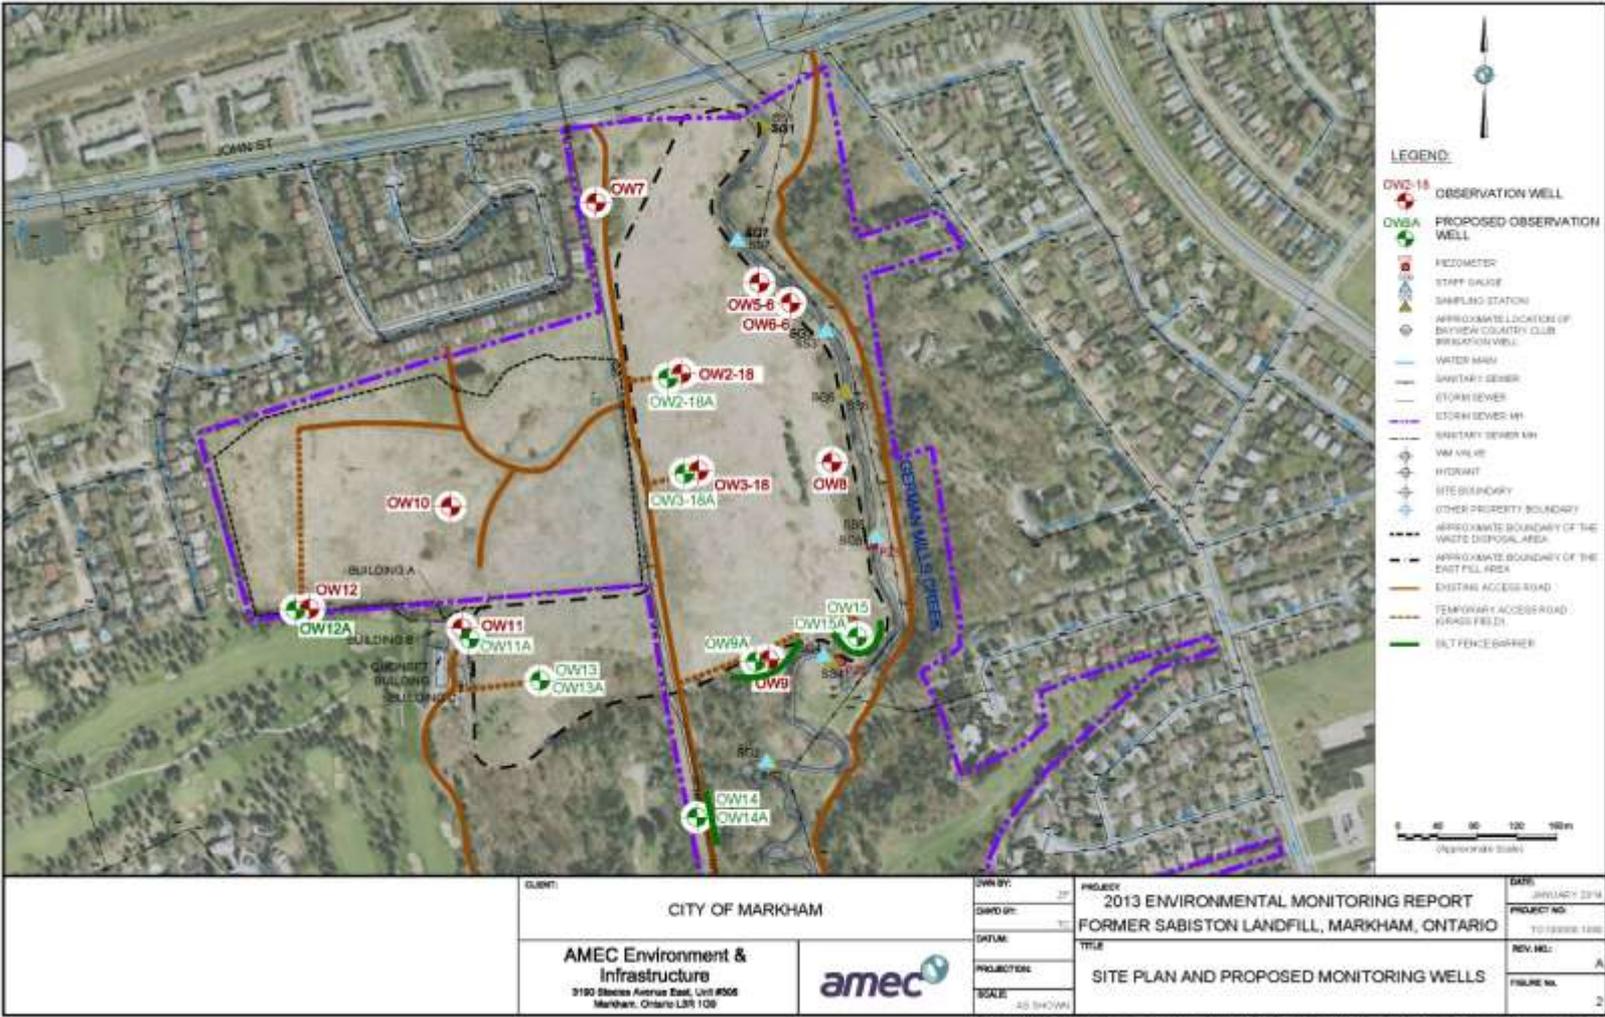
(Location Map)

- **Installation of 11 new monitoring wells at 8 locations**
 - Assess groundwater conditions down-gradient and in the aquifer
 - Installation period: 2 to 3 weeks
 - Affected area is only the path to the well and the well size (1 m²)
 - Noise similar to construction activities
- **Ministry of Natural Resources (MNR) “Letter of Advice” has been received: deadline to complete is April 1, 2014**
- **Toronto and Region Conservation Authority (TRCA) permit has been received**

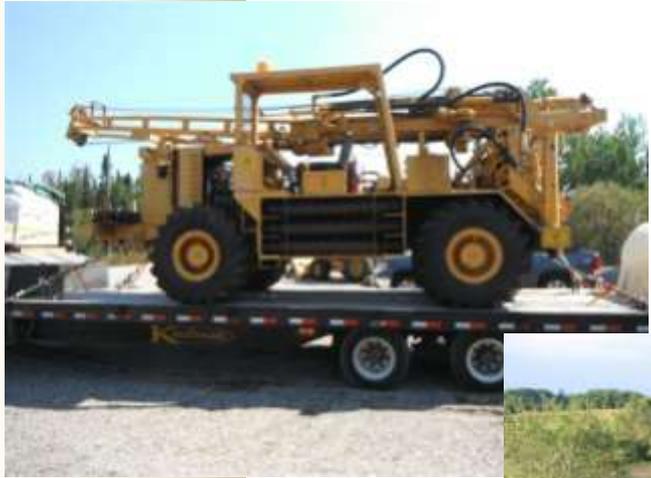
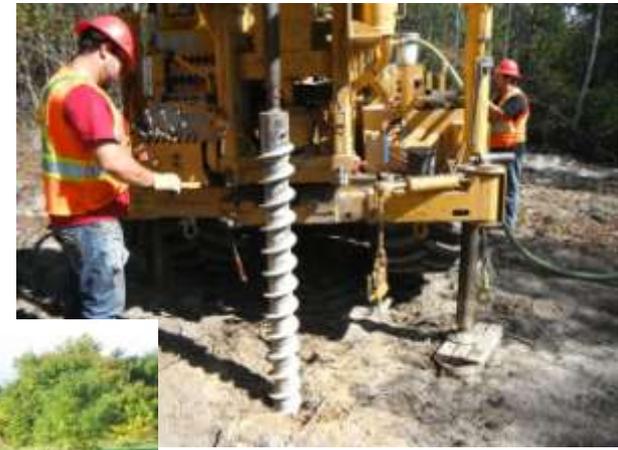
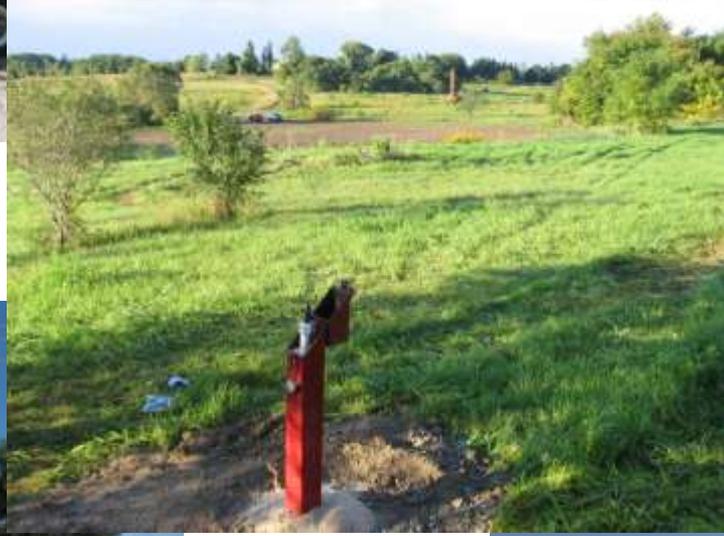
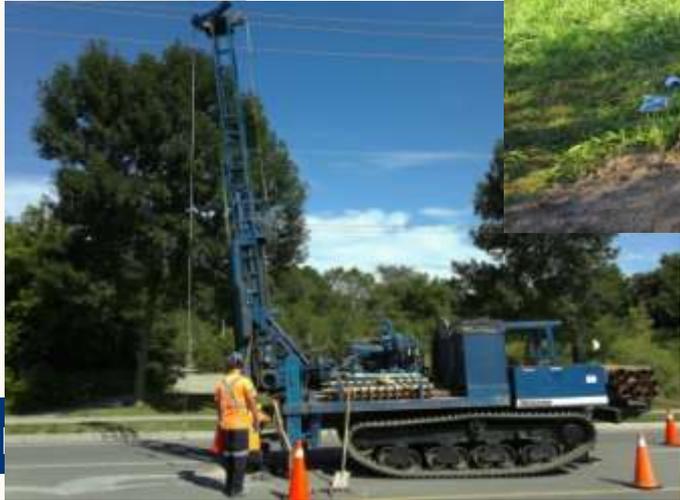
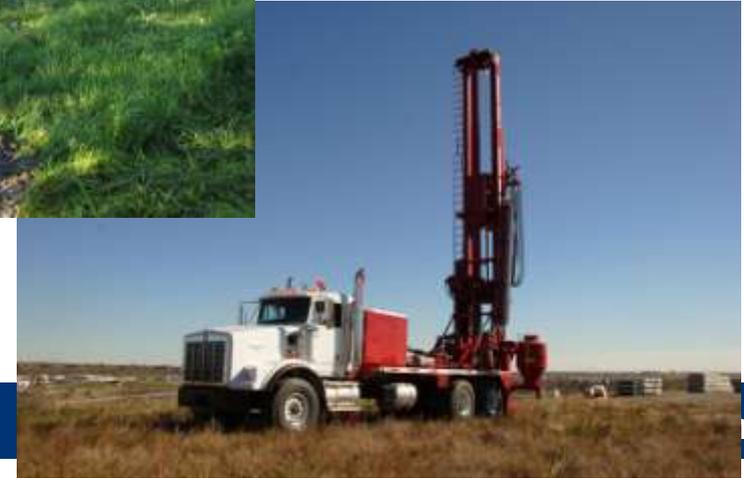
Groundwater Well Installation (Cont'd)

- **Installation work will be monitored by AMEC & a Biologist from Dillon Consulting in accordance with the established Environmental Monitoring Management Plan (EMMP)**
- **Sensitive to protection of the natural habitat:**
 - Proposed locations are in grassed areas (no trees or shrubs clearing)
 - Installation to take place outside of ground bird nesting period
 - Consideration to sensitive bird species: Eastern Meadowlark and Bobolink
 - Ensure grass seed mix is suitable, properly laid and germinates
 - Work will be completed in accordance with requirements of the Toronto and Region Conservation Authority (TRCA) and Ministry of Natural Resources (MNR)
 - Installation of wells will have no significant impact on the surrounding natural environment
