## Headwater Drainage Feature Assessment

4134 16<sup>th</sup> Avenue

Sixteenth Land Holdings Inc.

October 2017 215200

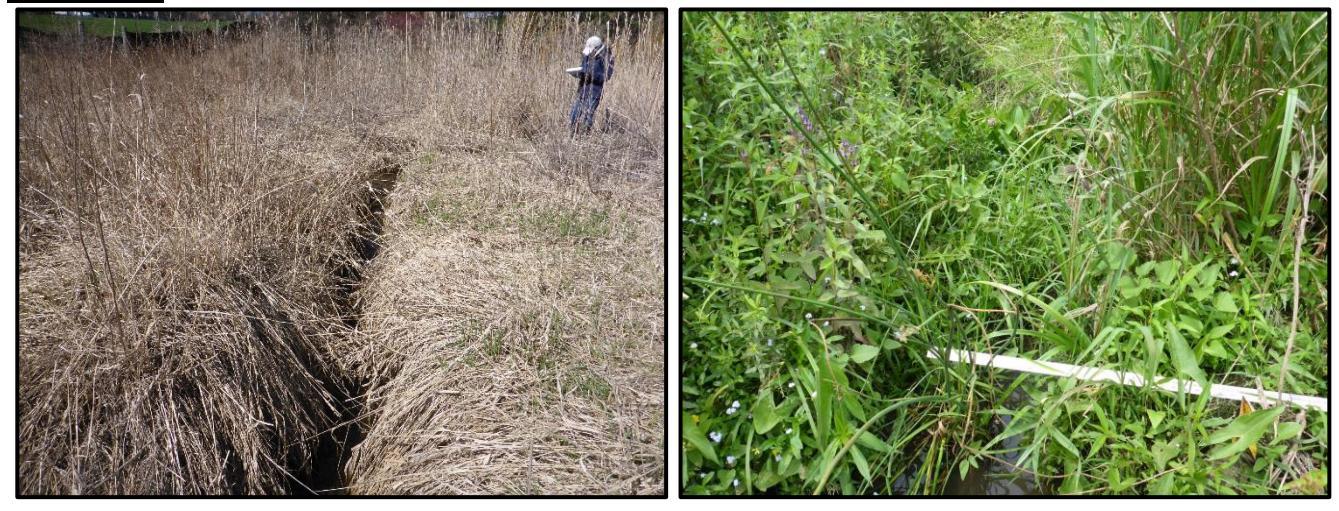
Photo 1 BR2-H1-S1: Upstream view of feature from confluence with Bruce Creek. Sample Event 1 (April 18, 2017)

Photo 2 BR2-H1-S1: Downstream view of feature. Sample Event 2 (July 28, 2017)

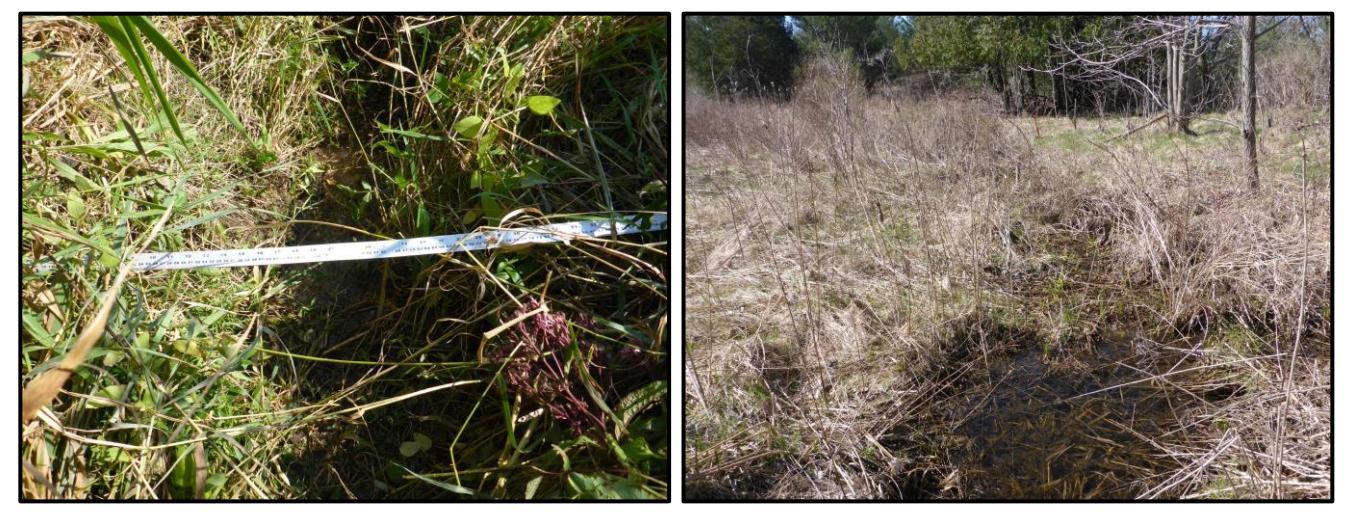
Photo 3

BR2-H1-S1: Upstream view of feature near confluence with Bruce Creek. Note standing water from backwatering of Bruce Creek debris jam. Sample Event 3 (September 21, 2017)

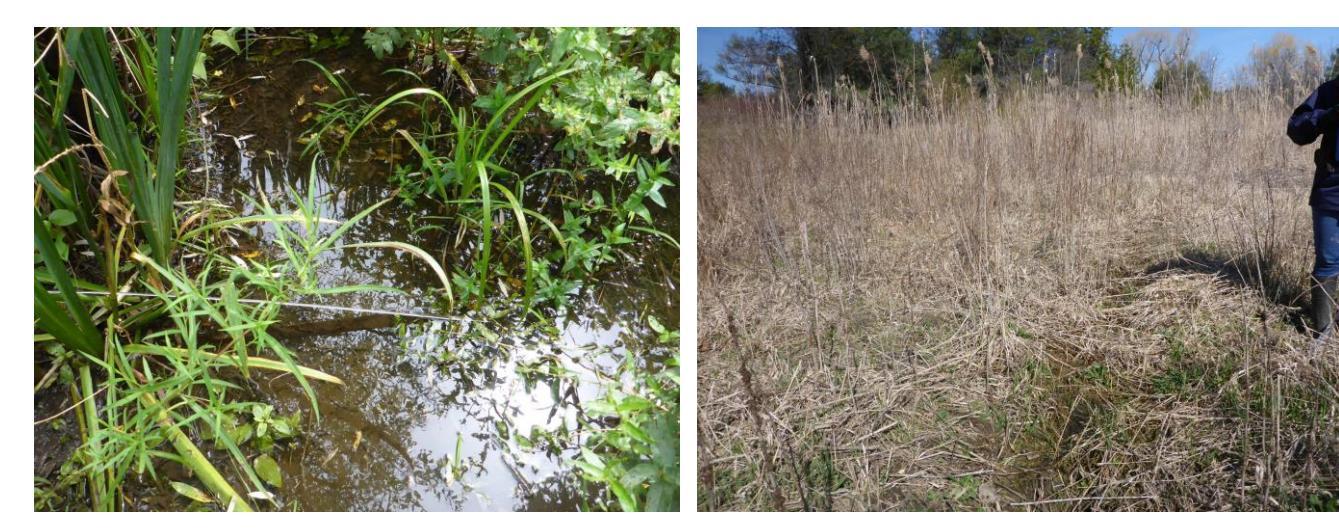
Photo 5 BR2-H1-S2: Downstream view of feature. Note standing water. Sample Event 2 (July 28, 2017)

Photo 6 BR2-H1A-S1: Upstream view of feature. Note standing water. Sample Event 1 (April 18, 2017)

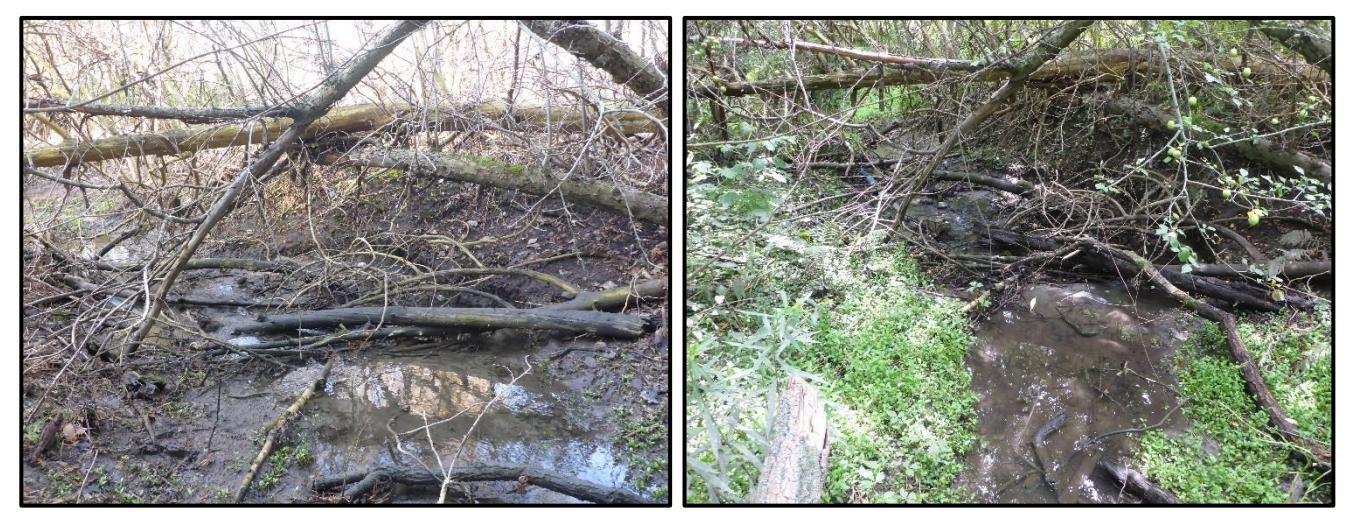
Photo 7

BR3-H2-S1: Downstream view of feature. Sample Event 1 (April 13, 2017)

Photo 8 BR3-H2-S1: Downstream view of feature. Sample Event 2 (July 28, 2017)

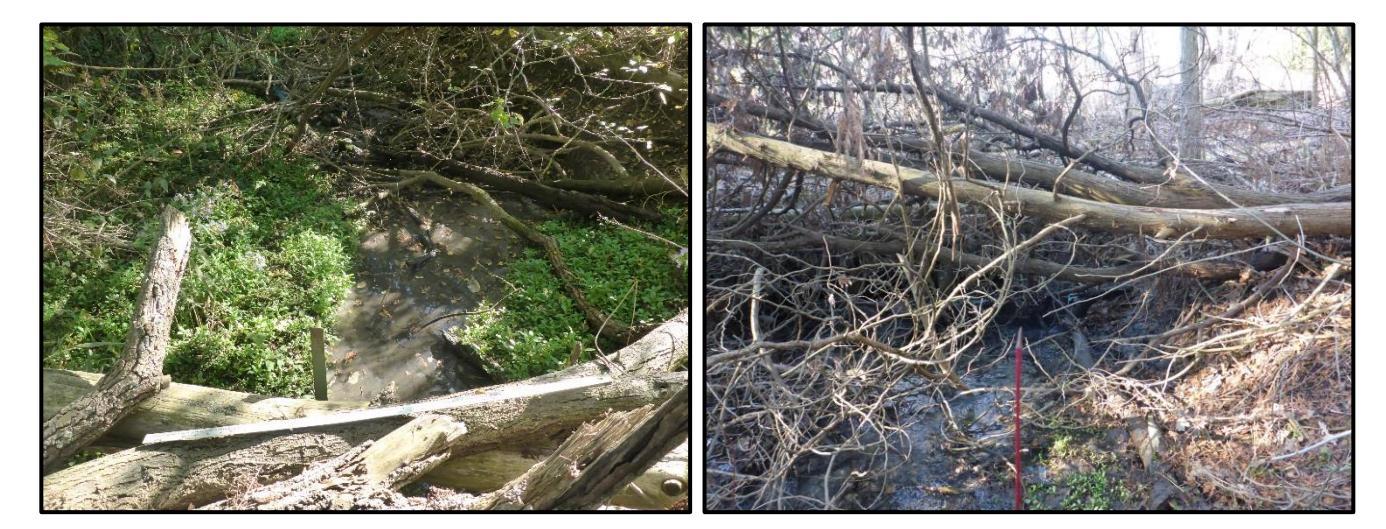
Photo 9 BR3-H2-S1: Downstream view of feature from reach break. Sample Event 3 (September 21, 2017)

Photo 10 BR3-H2-S2: Upstream view of feature. Sample Event 1 (April 13, 2017)

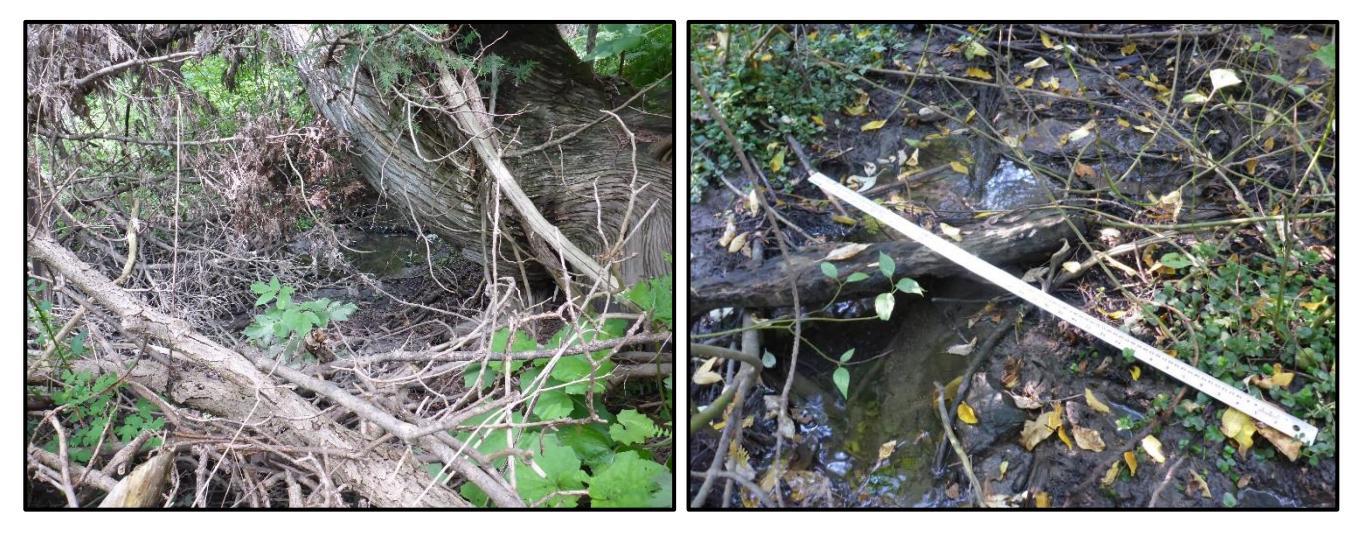
Photo 11

BR3-H2-S2: Upstream view of feature. Sample Event 2 (July 28, 2017)

Photo 12 BR3-H2-S2: Upstream view of feature. Sample Event 3 (September 21, 2017)

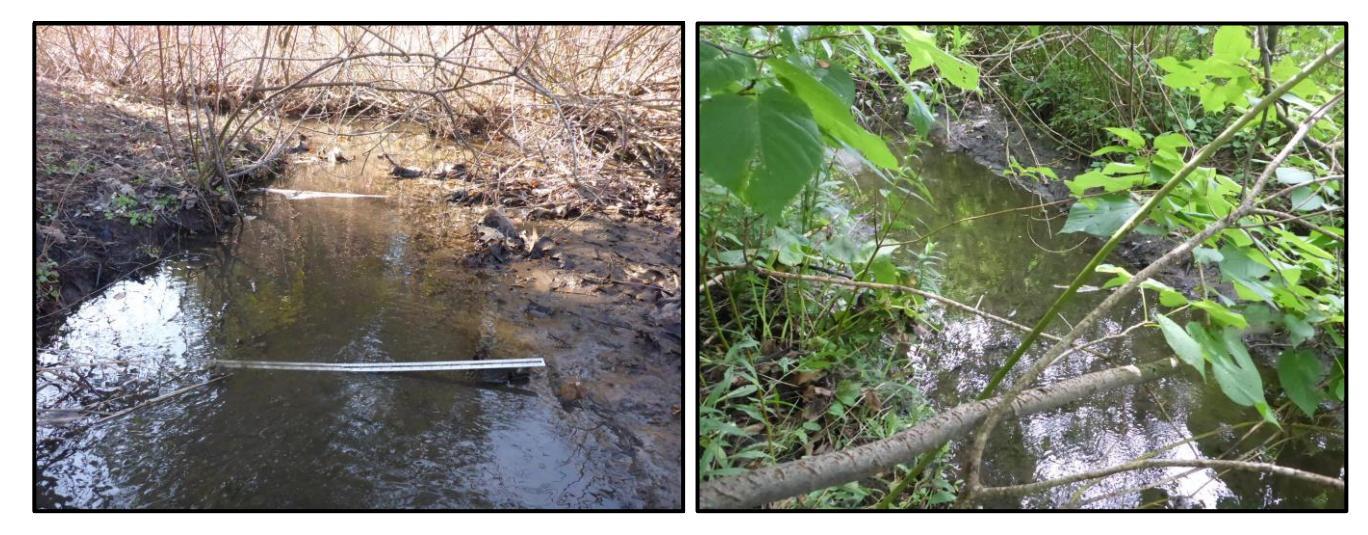
Photo 13 BR3-H2-S3: Downstream view of channelized feature type. Sample Event 1 (April 13, 2017)

Photo 14 BR3-H2-S3: Upstream view of channelized feature type. Sample Event 2 (July 28, 2017)

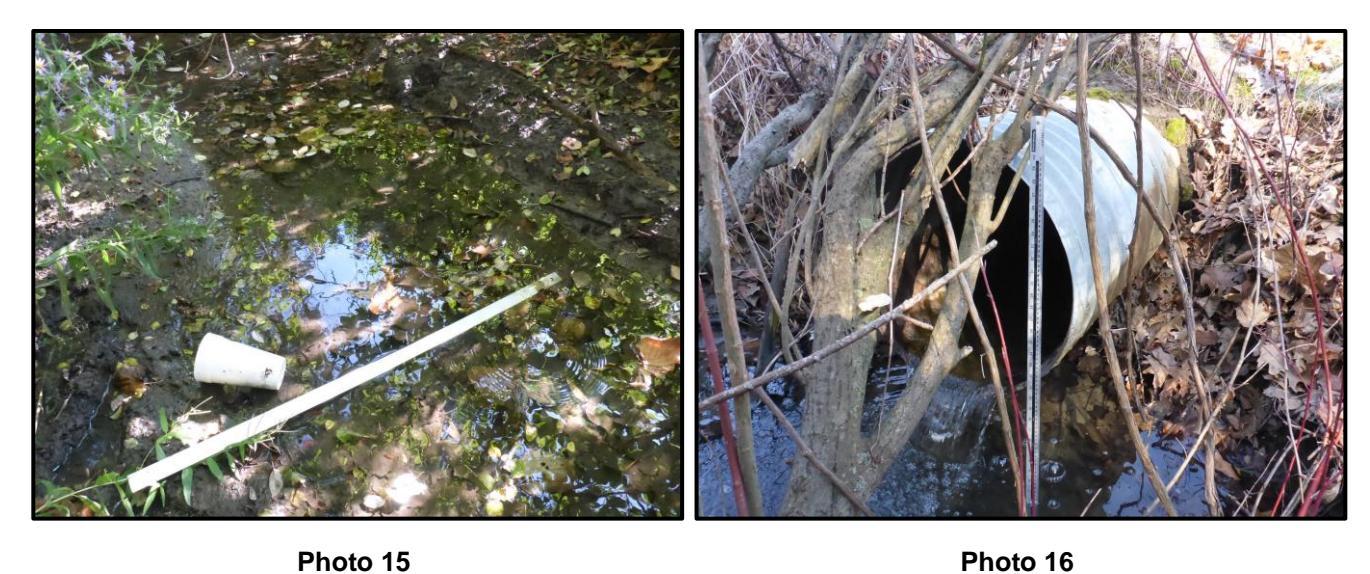
Photo 15

BR3-H2-S3: Downstream view of feature towards reach break; minimal flow. Sample Event 3 (September 21, 2017)

BR3-H2-S4: Downstream culvert outlet. Sample Event 1 (April 13, 2017)

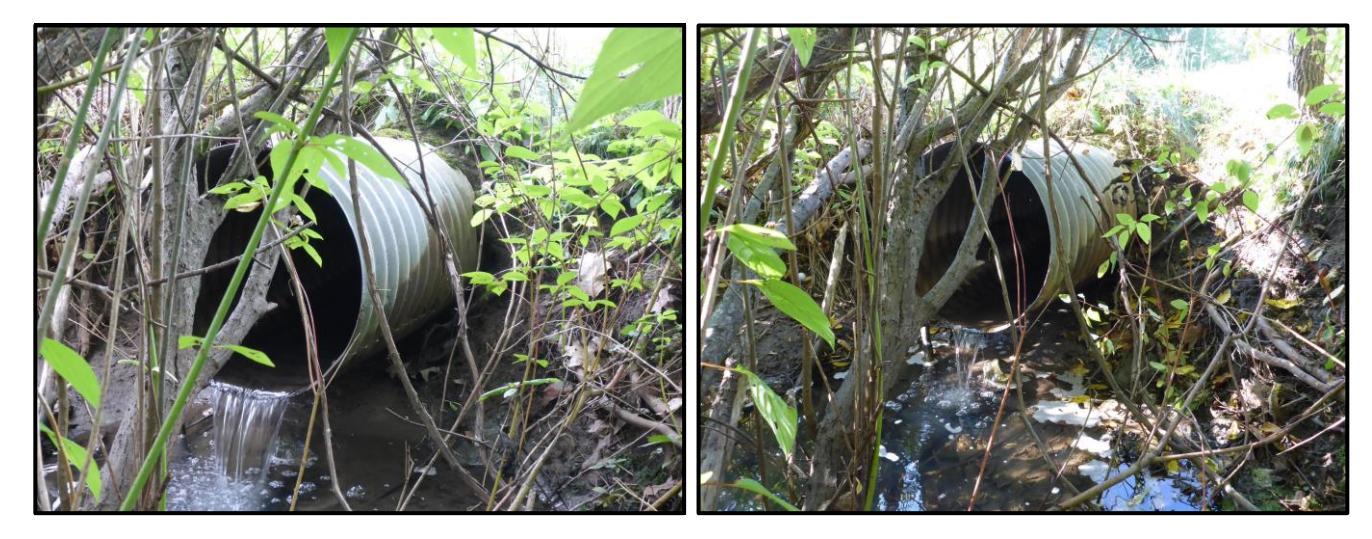
Photo 17 BR3-H2-S4: Downstream culvert outlet. Sample Event 2 (July 28, 2017)

Photo 18 BR3-H2-S4: Downstream culvert outlet. Sample Event 3 (September 21, 2017)

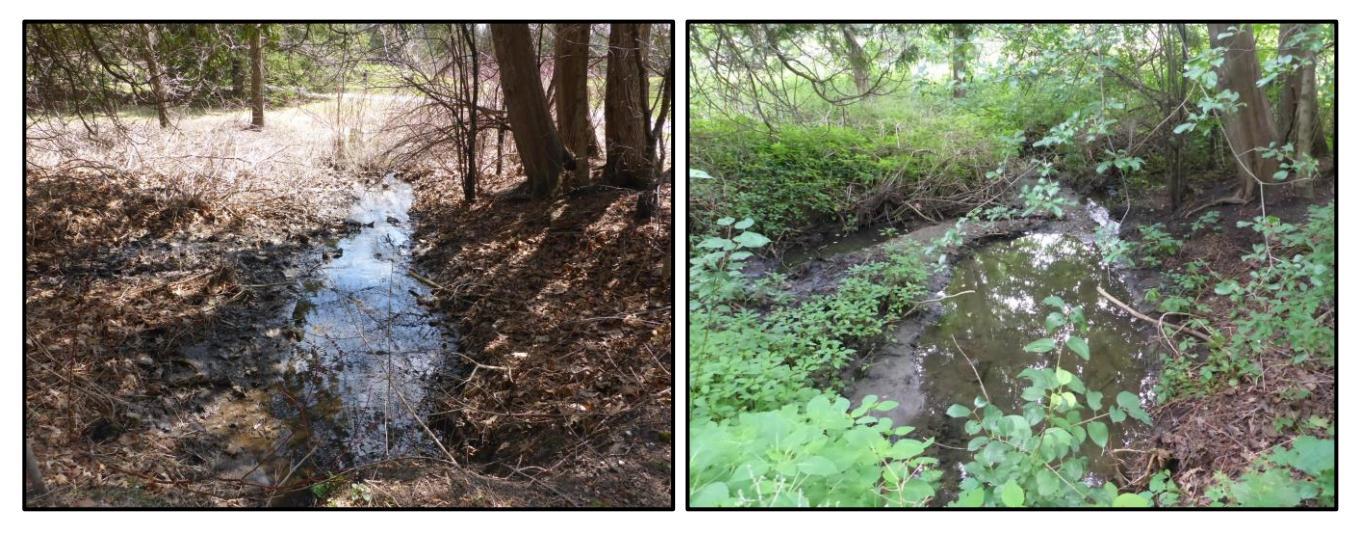
Photo 19

BR3-H2-S5: Downstream view of the feature. Sample Event 1 (April 13, 2017)

BR3-H2-S5: Downstream view of the feature. Sample Event 2 (July 28, 2017)

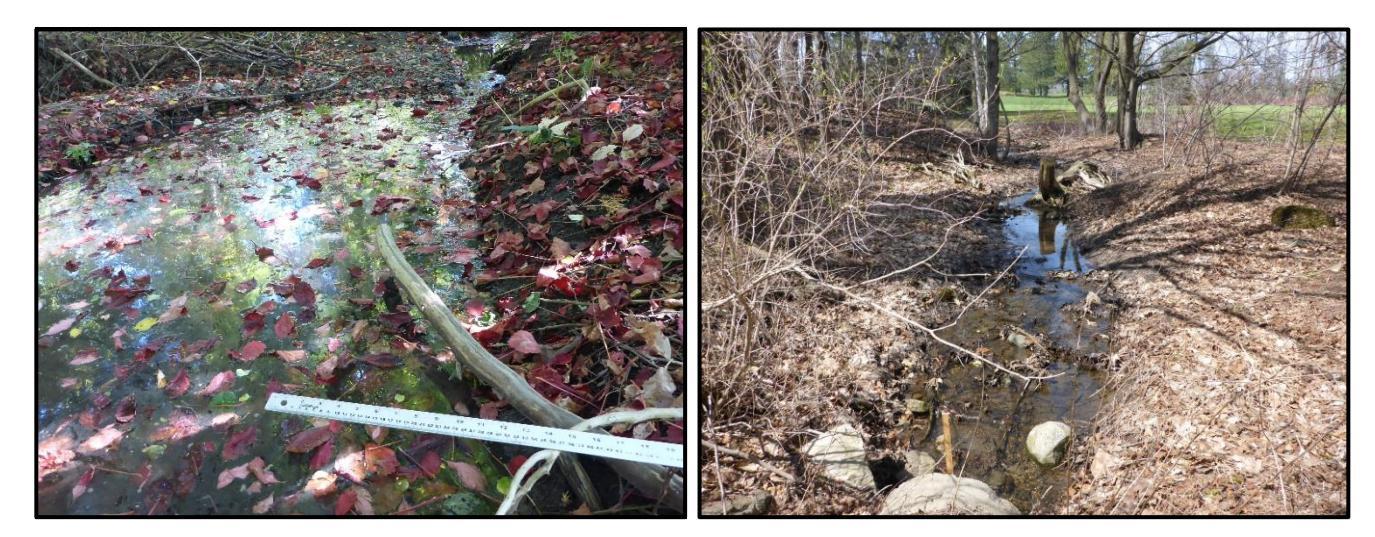
Photo 21 BR3-H2-S5: Downstream view of the feature. Sample Event 3 (September 21, 2017)

Photo 22 BR3-H2-S6: Upstream view of feature. Sample Event 1 (April 13, 2017)

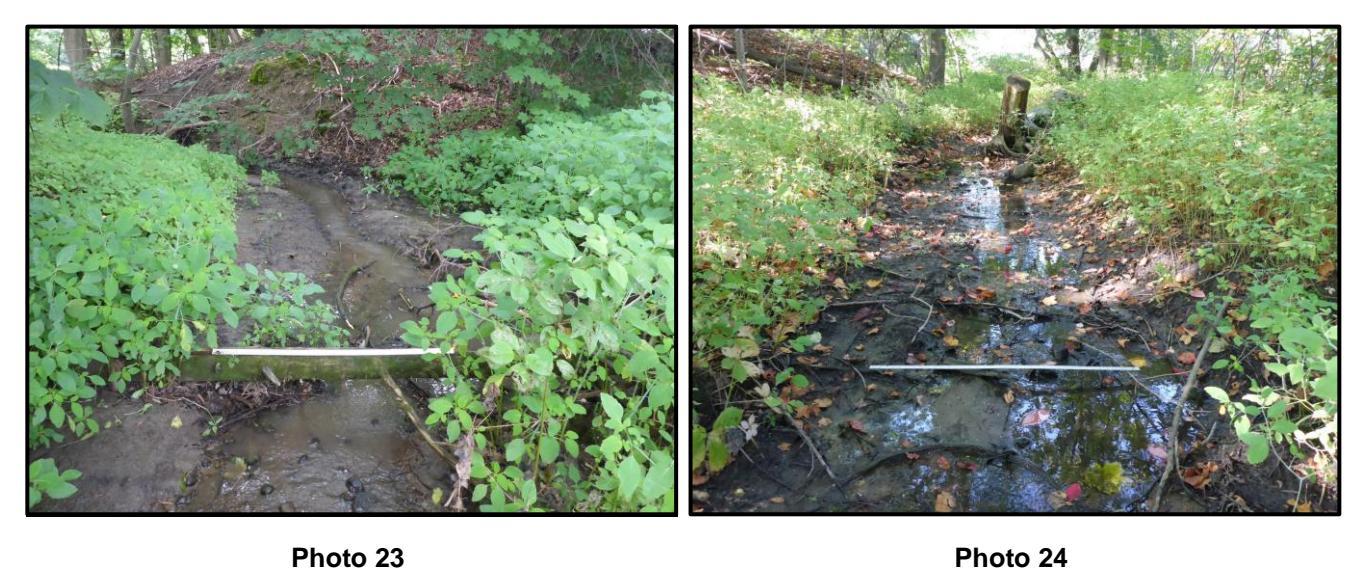
Photo 23

BR3-H2-S6: Downstream view of feature. Sample Event 2 (July 28, 2017)

BR3-H2-S6: Downstream view of feature. Sample Event 3 (September 21, 2017)

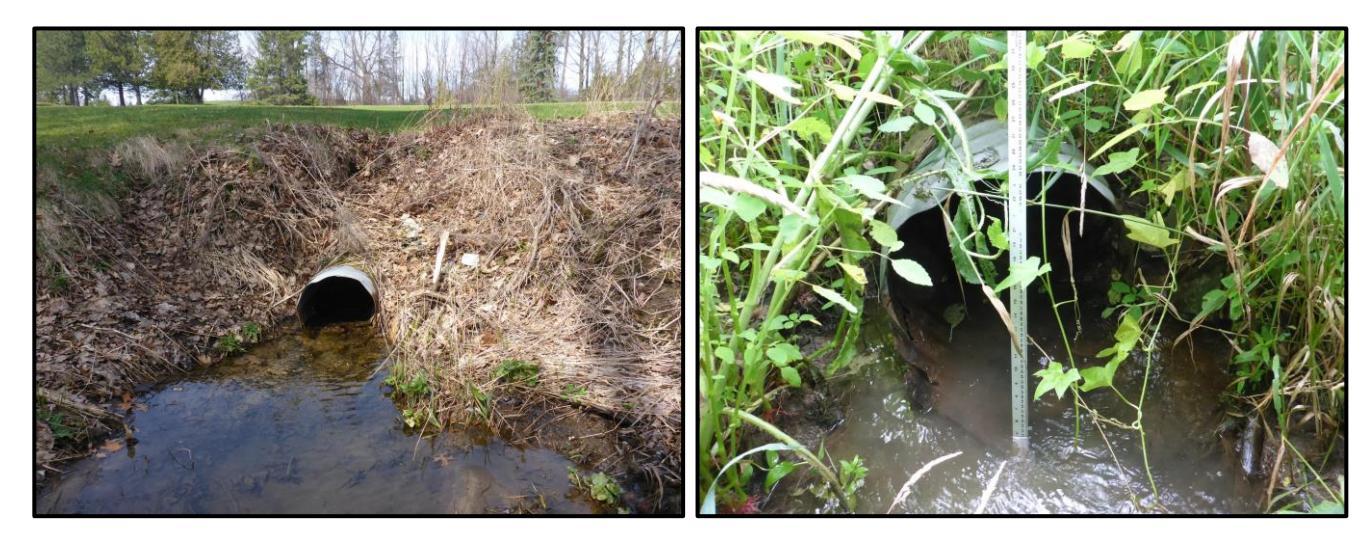
Photo 25 BR3-H2-S7: Upstream view of culvert outlet. Sample Event 1 (April 13, 2017)

Photo 26 BR3-H2-S7: Upstream view of culvert outlet. Sample Event 2 (July 28, 2017)

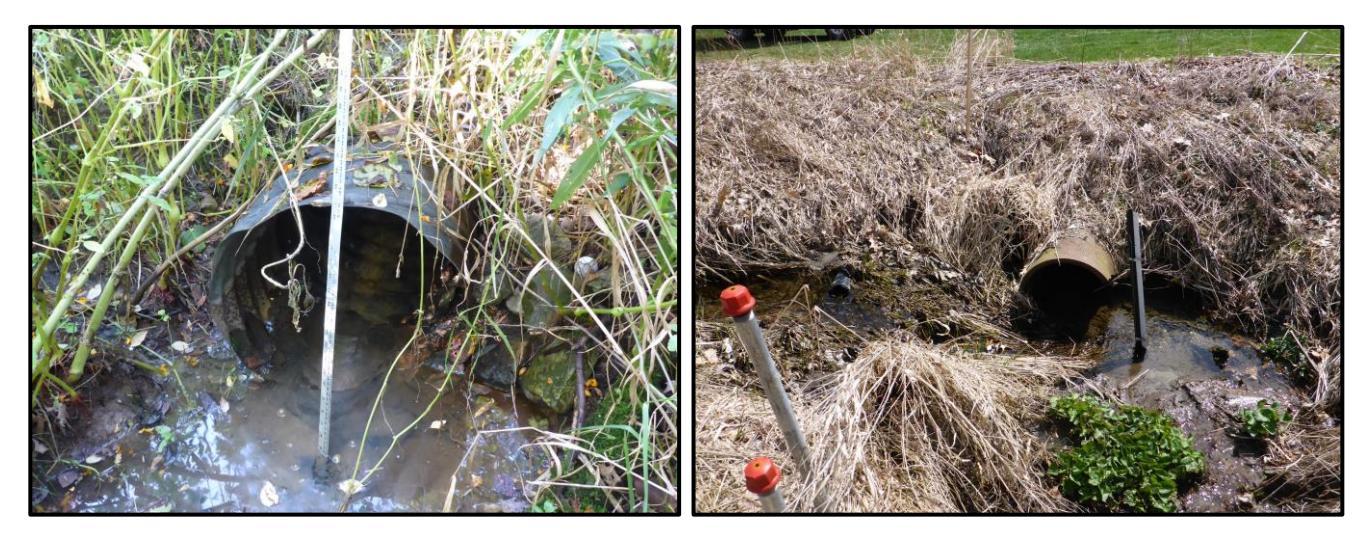
Photo 27

BR3-H2-S7: Upstream view of culvert outlet. Sample Event 3 (September 21, 2017) Photo 28

BR3-H2-S8: Downstream view of feature at downstream reach extent. Sample Event 1 (April 13, 2017)

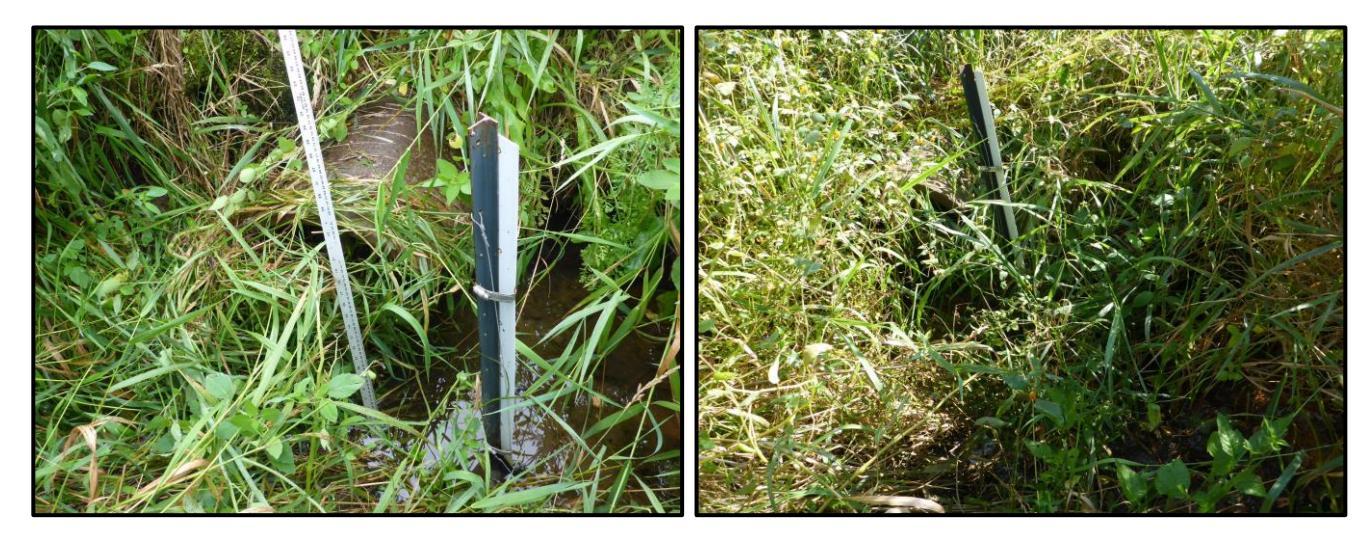
Photo 29 BR3-H2-S8: Downstream view of feature at downstream reach extent. Sample Event 2 (July 28, 2017)

Photo 30 BR3-H2-S8: Downstream view of feature at downstream reach extent. Sample Event 3 (September 21, 2017)

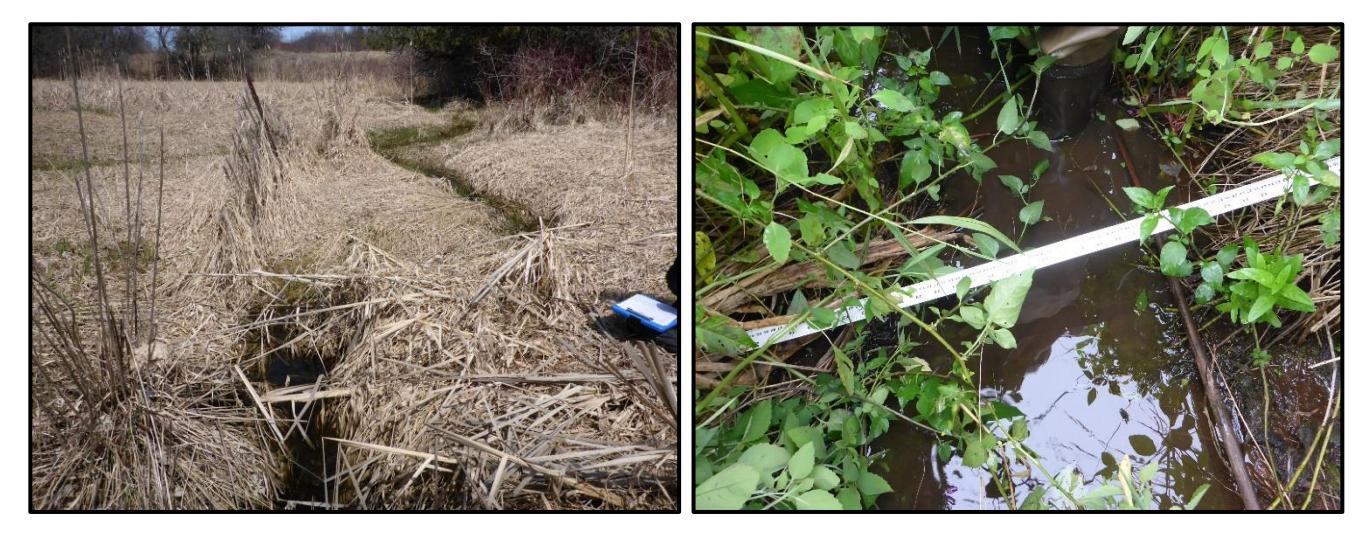
Photo 31 BR3-H2-S9: Upstream view of feature. Sample Event 1 (April 13, 2017)

Photo 32 BR3-H2-S9: Upstream view of feature. Sample Event 2 (July 28, 2017)

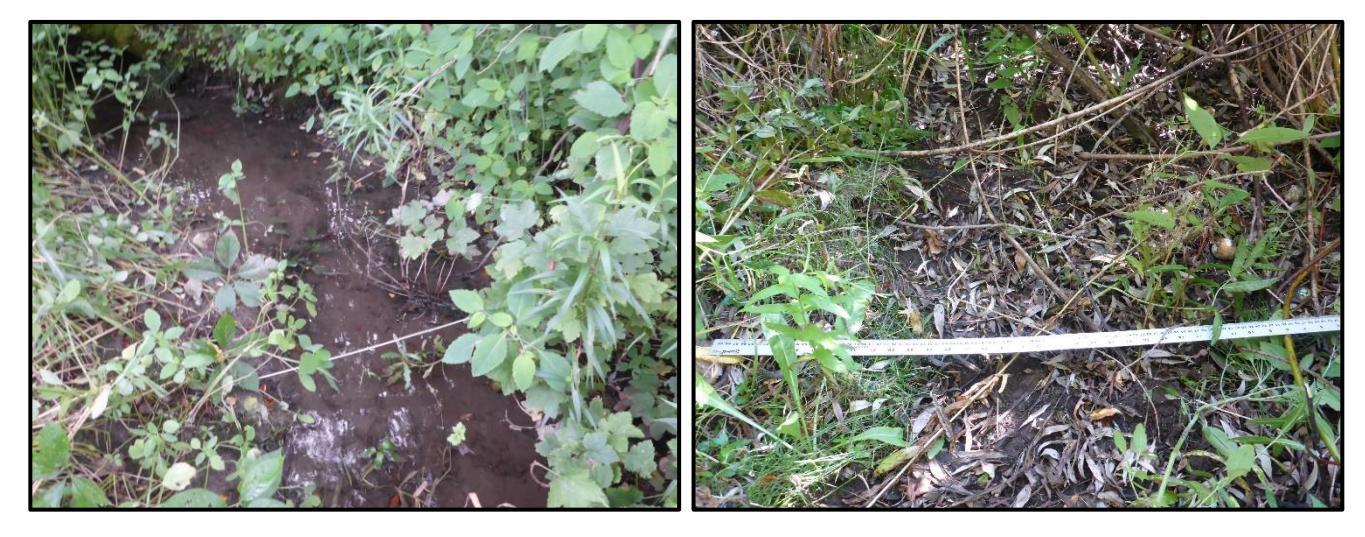
Photo 35 BR3-H2-S10: Downstream view of feature. Sample Event 2 (July 28, 2017)

Photo 36 BR3-H2-S10: Downstream view of feature. Note dry conditions. Sample Event 3 (September 21, 2017)

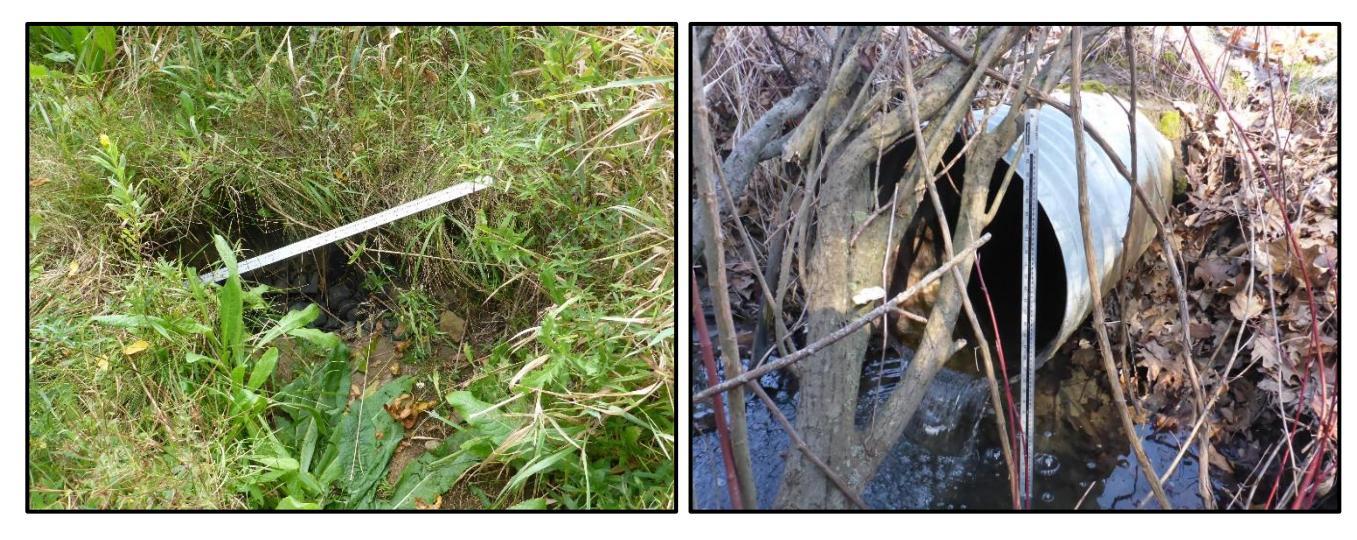
Photo 38 BR3-H2-S11: Upstream view of pipe outlet. Corrugated pipe is cracked/leaking Note iron staining. Sample Event 2 (July 28, 2017)

Photo 39 BR3-H2-S11: Upstream view of pipe outlet. Note dry conditions. Sample Event 1 (March 9, 2017)

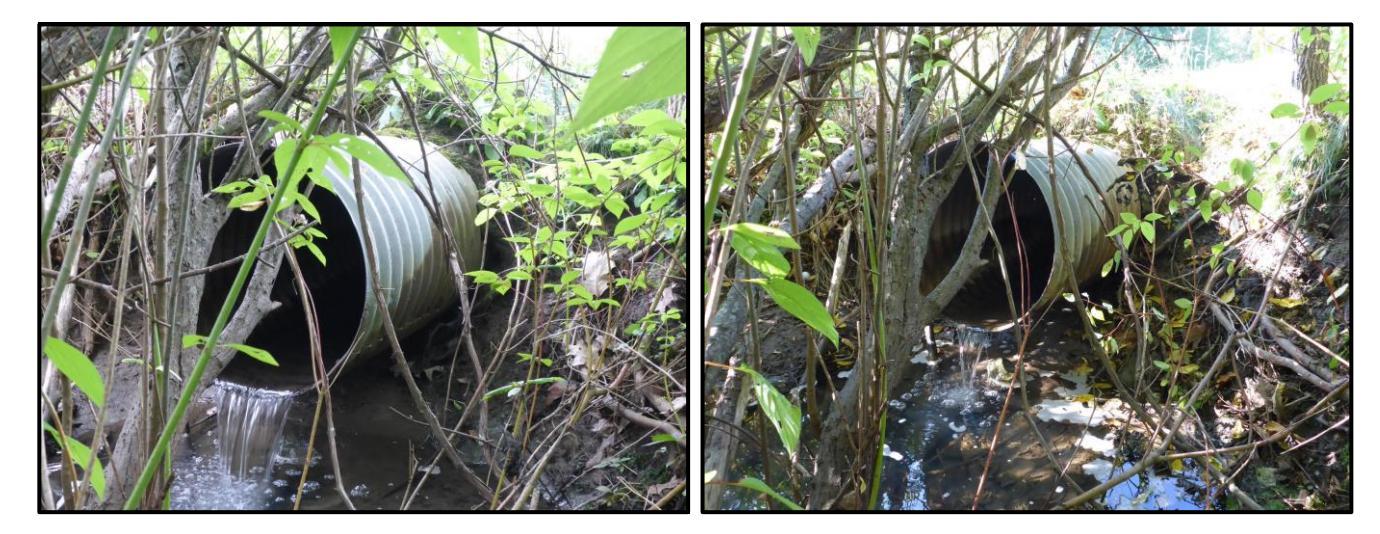
Photo 41 BR3-H2A-S1: Downstream culvert extent. Sample Event 2 (July 28, 2017)

Photo 42 BR3-H2A-S1: Downstream culvert extent. Sample Event 3 (September 21, 2017)

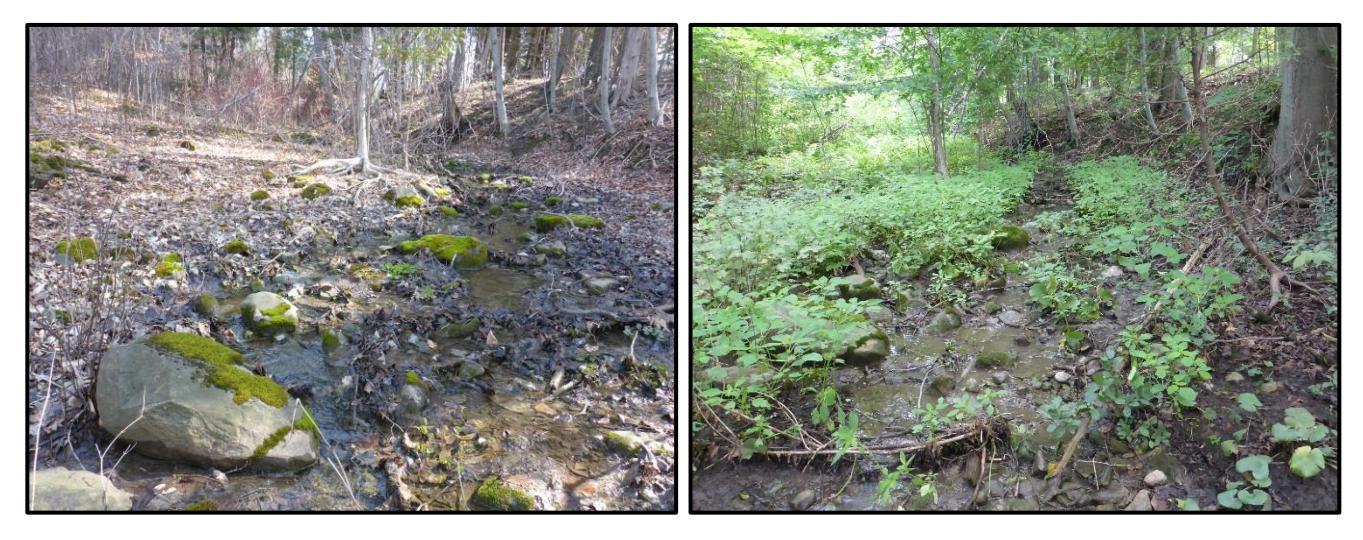
Photo 43 BR3-H2A-S2: Upstream view of feature from reach BR3-H2A-S2: Upstream view of feature from reach break. Sample Event 1 (April 13, 2017)

Photo 44 break. Sample Event 2 (July 28, 2017)

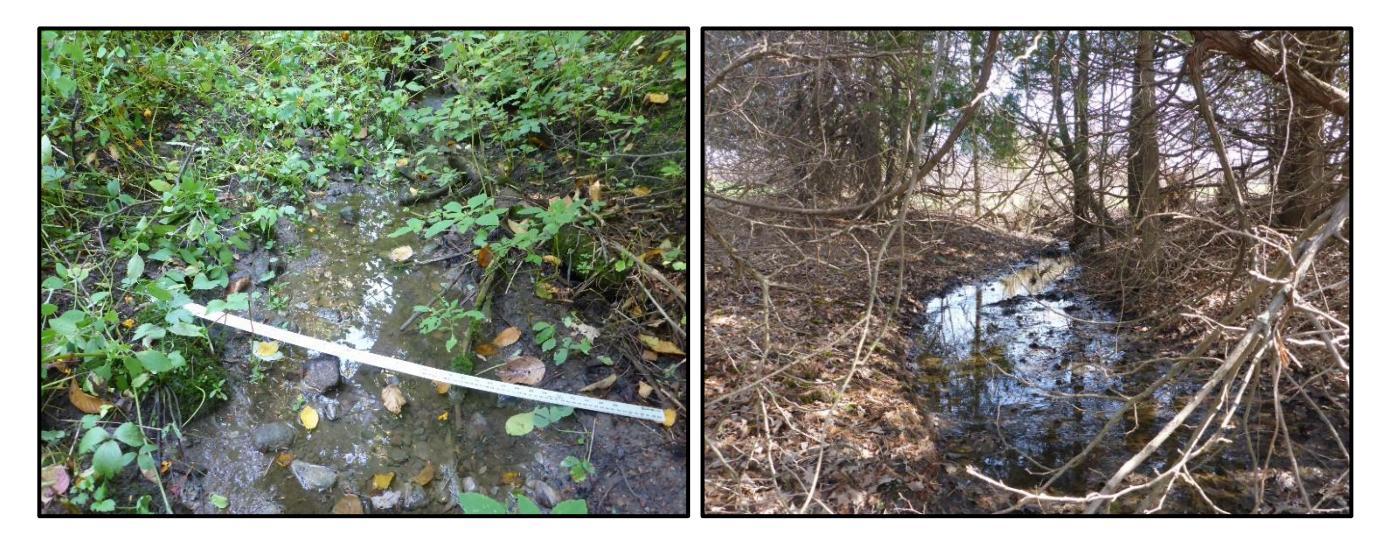
Photo 45 BR3-H2A-S2: Upstream view of feature. Sample Event 3 (September 21, 2017)

Photo 46 BR3-H2A-S3: Upstream view of feature. Sample Event 1 (April 13, 2017)

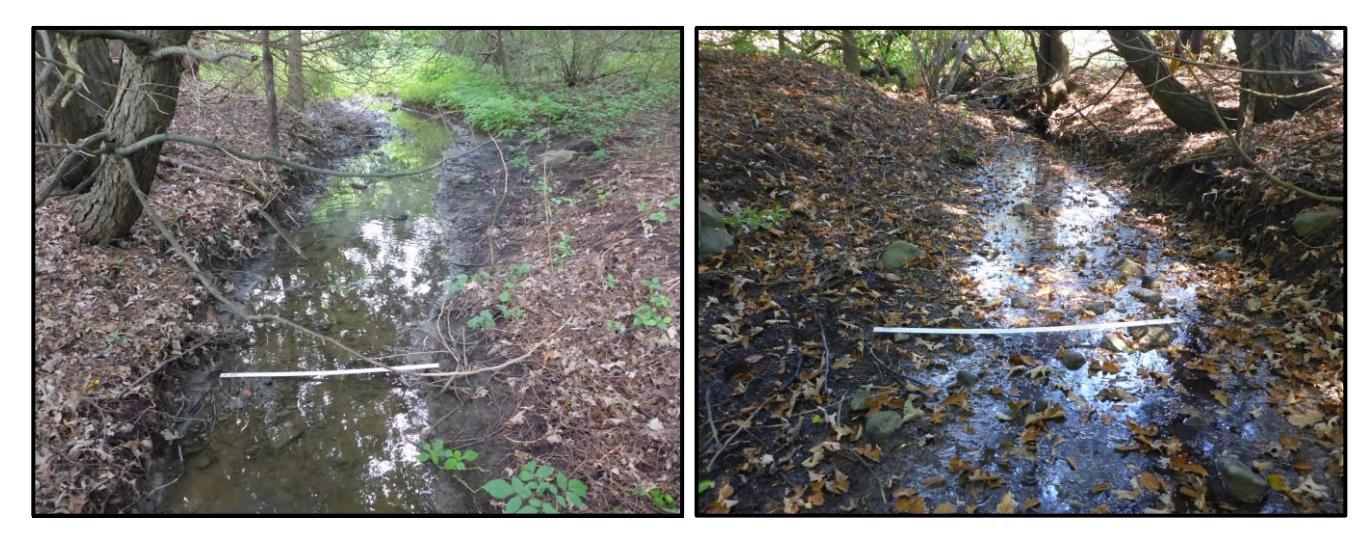
Photo 47 BR3-H2A-S3: Downstream view of feature. Sample Event 2 (July 28, 2017)

Photo 48 BR3-H2A-S3: Upstream view of feature. Sample Event 3 (September 21, 2017)

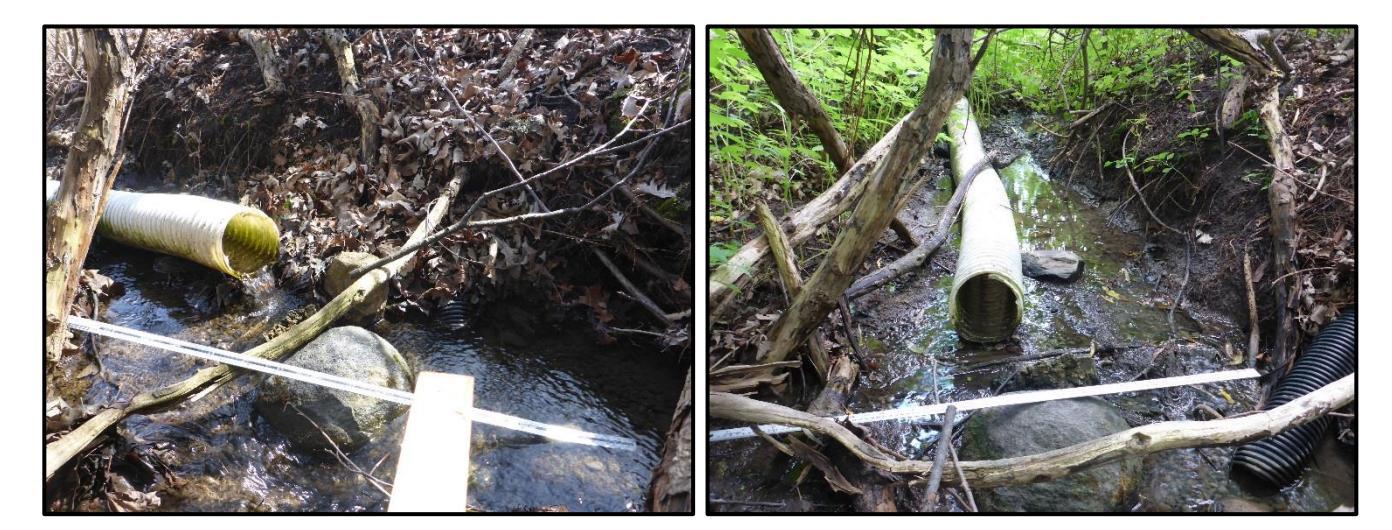
Photo 49 BR3-H2A-S4: Upstream view of tile outlet. Sample Event 1 (April 13, 2017)

Photo 50 BR3-H2A-S4: Upstream view of tile outlet. Sample Event 2 (July 28, 2017)

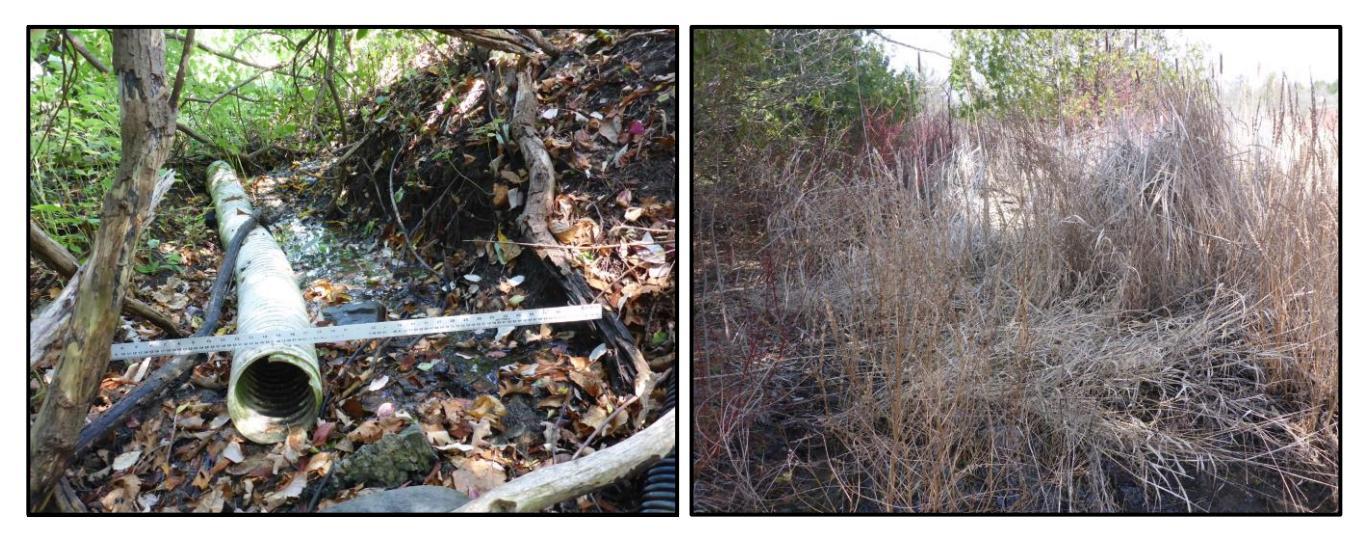
Photo 51 BR3-H2A-S4: Upstream view of tile outlet. Sample Event 3 (September 21, 2017)

Photo 52 BR3-H2A-S5: Downstream view of wetland feature. Sample Event 1 (April 13, 2017)

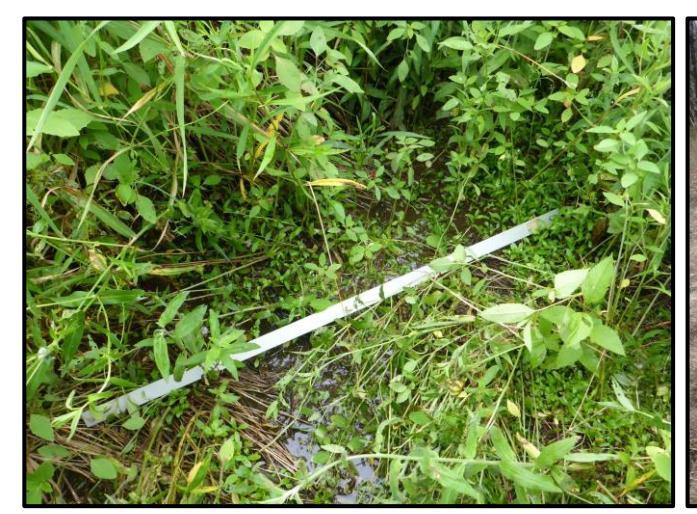
Photo 53 BR3-H2A-S5: Upstream view of wetland feature; standing water. Sample Event 2 (July 28, 2017)

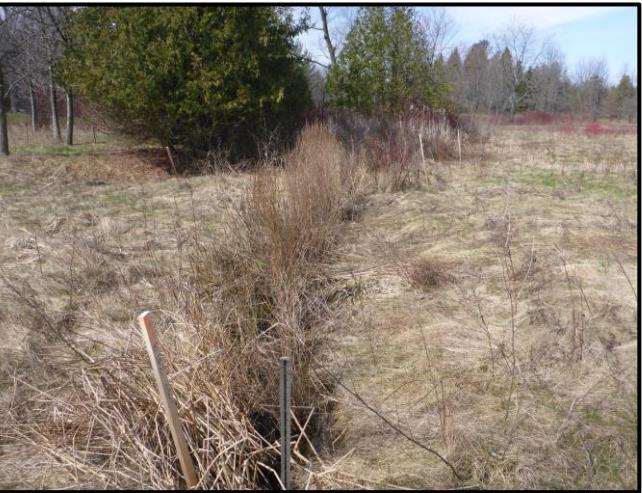
Photo 54 BR3-H2A-S6: Downstream view of feature from upstream extent. Sample Event 1 (April 13, 2017)

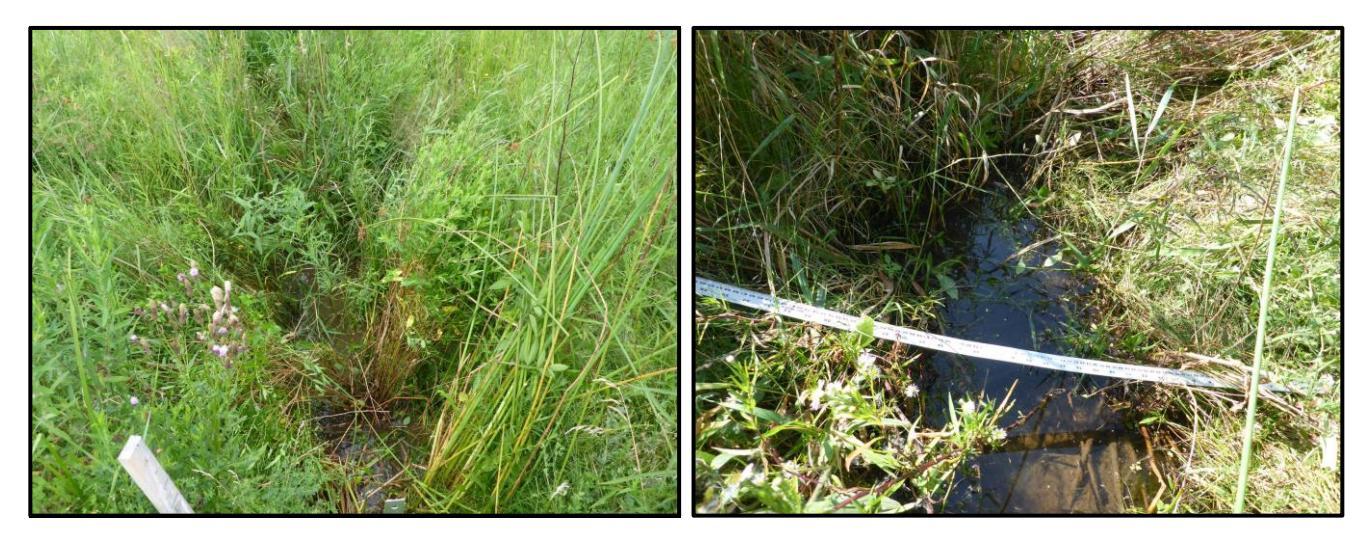
Photo 55 BR3-H2A-S6: Downstream view of feature from upstream extent. Sample Event 2 (July 28, 2017)

Photo 56 BR3-H2A-S6: Downstream view of feature from upstream extent. Sample Event 3 (September 21, 2017)

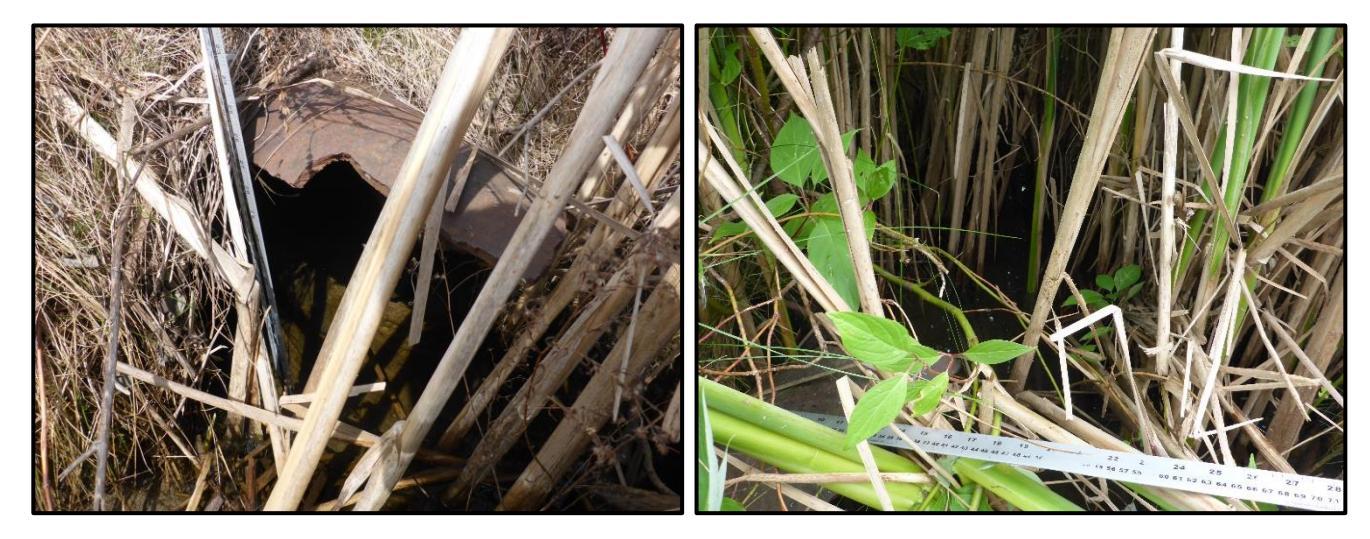
Photo 57 BR3-H2A-S7: Upstream view of culvert at downstream extent. Sample Event 1 (April 13, 2017)

Photo 58 BR3-H2A-S7: Downstream view from culvert at downstream extent. Sample Event 2 (July 28, 2017)

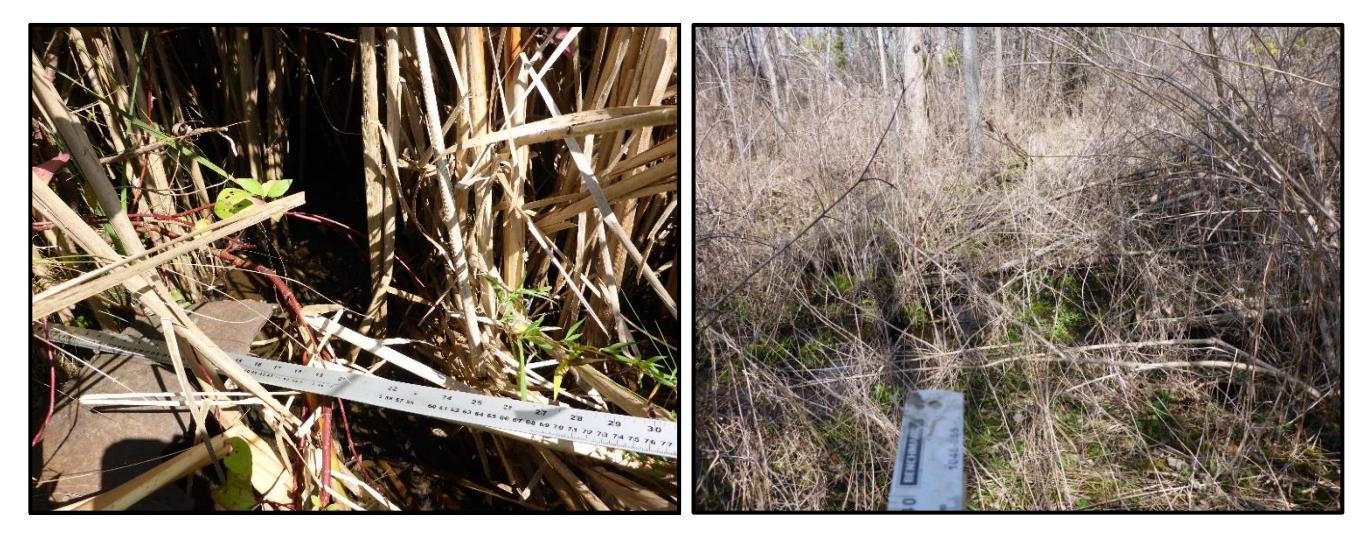
Photo 59 BR3-H2A-S7: Downstream view of feature from upstream extent. Sample Event 3 (September 21, 2017)

Photo 60 BR3-H2A-S8: Upstream view of feature. Sample Event 1 (April 13, 2017)

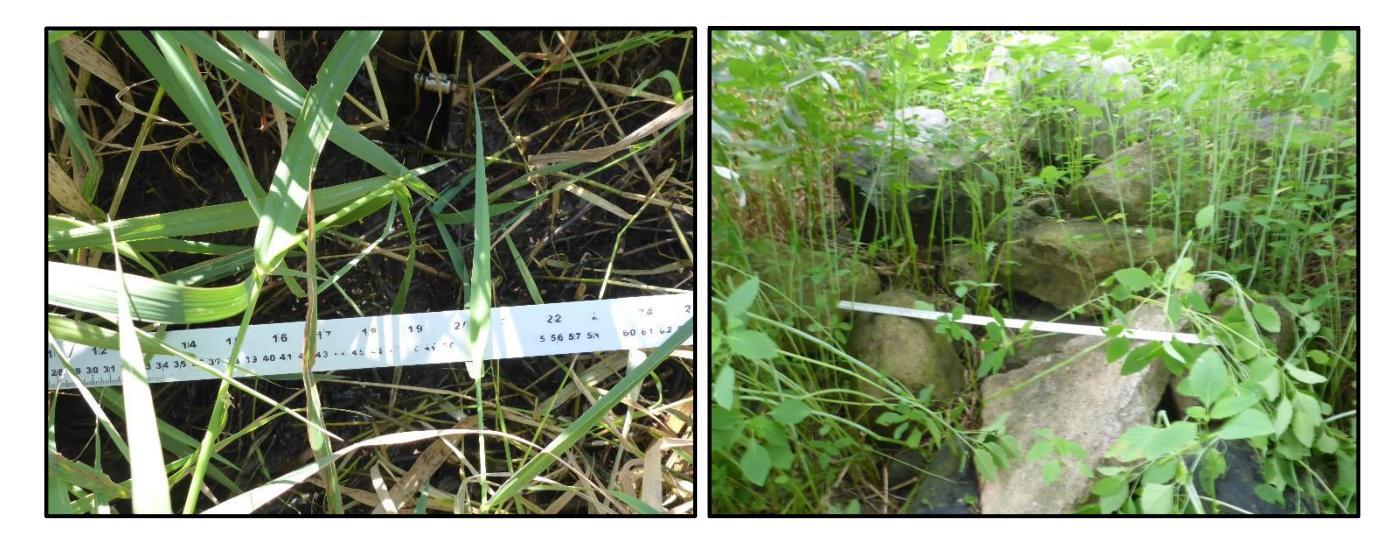
Photo 65 BR3-H2B-S1: Upstream view of feature; interstitial BR3-H2B-S2: Upstream view of riprap near outlet. flow. Sample Event 3 (September 21, 2017)

Photo 66 Sample Event 2 (July 28, 2017)
