## Headwater Drainage Feature Assessment

4134 16<sup>th</sup> Avenue

Sixteenth Land Holdings Inc.

October 2017 215200

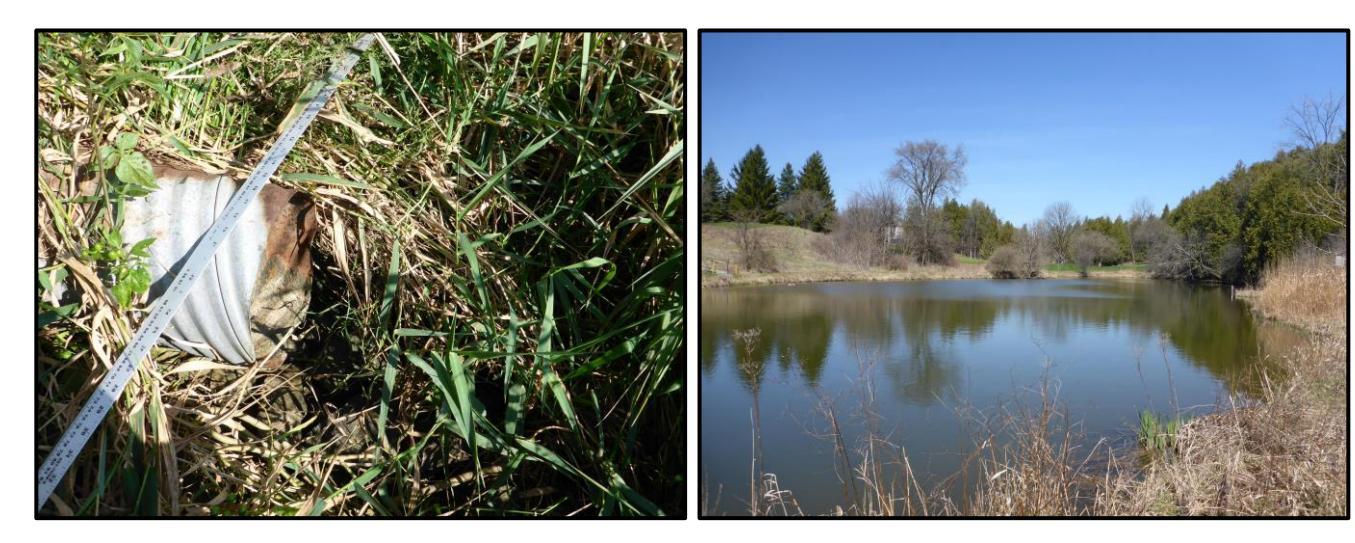
Photo 105 BR5-H1-S3: Upstream view of pipe outlet; dry conditions. Sample Event 3 (September 21, 2017)

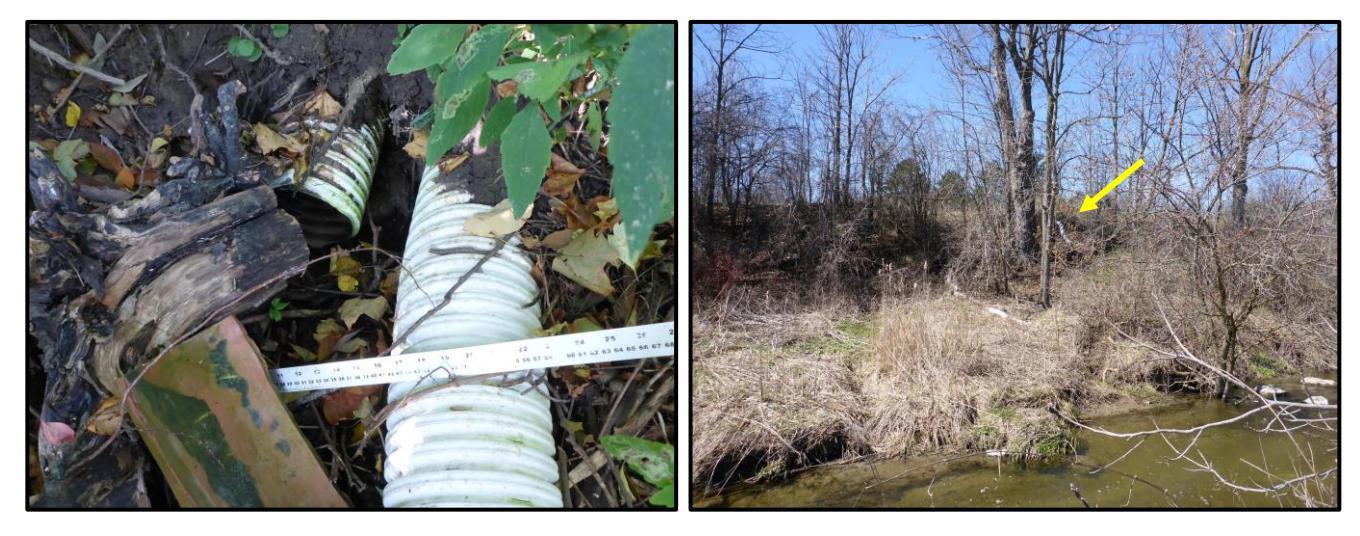
Photo 119 BR5-H4-S1: View of tile outlet on valley wall slope; BR5-H5-S1: View of tile outlet on valley wall slope Flowing at time of assessment. Sample Event 3 (September 21, 2017)

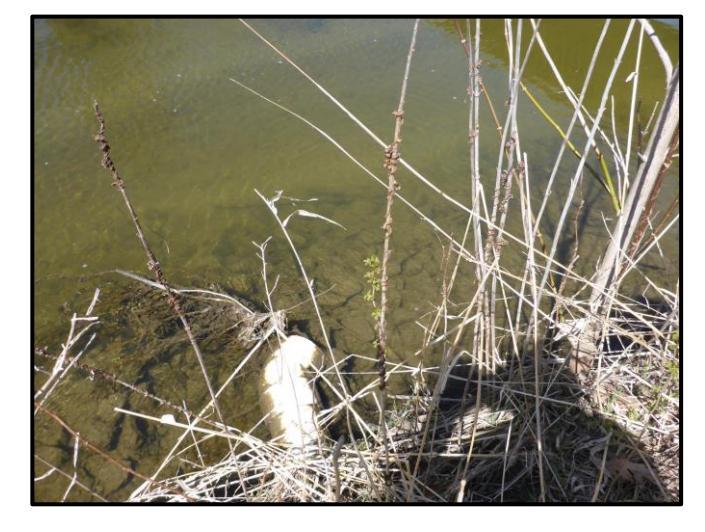
Photo 123 BR5-H6-S1: View of pipe within Bruce Creek (note this is facing upstream. Flow conditions could not be determined. Sample Event 1 (April 13, 2017)
