GUIDING SOLUTIONS IN THE NATURAL ENVIRONMENT

Fluvial Geomorphology Report in support of a Master Environmental Servicing Plan 4134 16th Avenue, City of Markham

Sixteenth Land Holdings Inc.

September 2016 215200.1

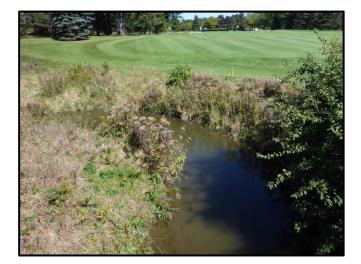
Photo 29 (Location 28) BR-4. Looking upstream from golf cart path crossing at meander bend. Note manicure grass riparian vegetation.

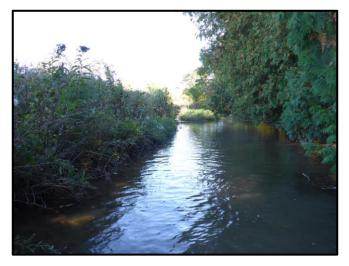
Photo 32 (Location 31) BR-5. Looking downstream at general conditions. Note vegetated island within the channel and degree of entrenchment.

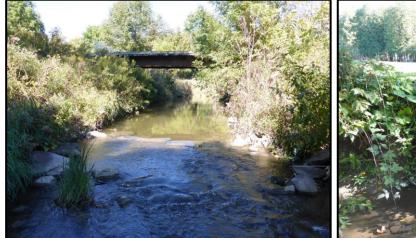
Photo 37 (Location 35) BR-5. Looking upstream at golf cart path crossing. Note riffle substrate size.

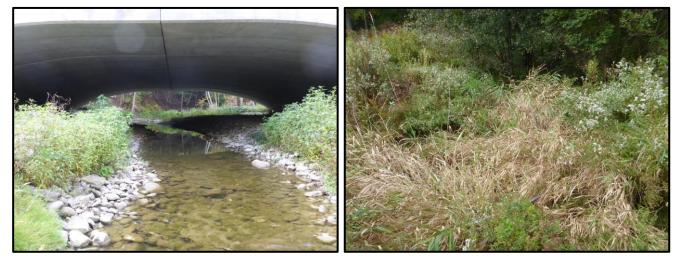
Photo 58 (Location 56) BER-6. Looking upstream at boulder step-pool. Note outer bank erosion on meander bend in background.

Photo 59 (Location 57) BER-6. Looking upstream at Warden Avenue crossing.

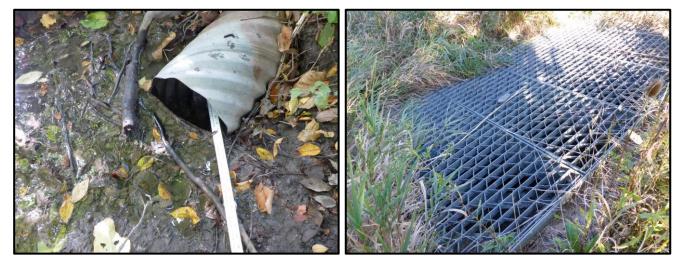
Photo 65 (Location 63) SDF-C. Looking upstream at perched culvert under golf cart path. Note scour pool immediately downstream.

Photo 67 (Location 65) SDF-C. Embedded 300 mm CSP culvert.

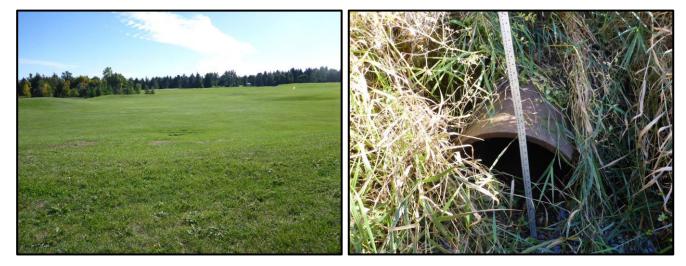
Photo 68 (Location 66) Catch basin adjacent to pond H.

Photo 69 (Location 67) Southern view of driving range golf green overtop of piper drainage.

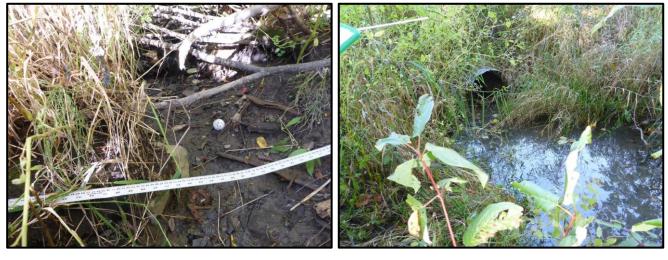
Photo 70 (Location 68) Enclosed water supply outlet pipe.

Photo 71 (Location 69) SDF-B. Looking upstream at poorly defined flow path.

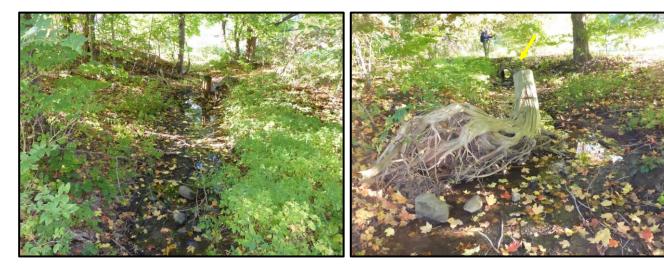
Photo 73 (Location 71) SDF-B. Looking downstream at flow path with standing water.

Photo 74 (Location 72) SDF-B. Looking upstream at poorly defined flow path towards culvert under golf cart path.

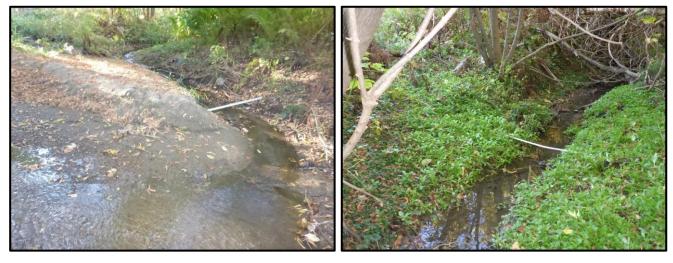
Photo 79 (Location 77) SDF-BC. Looking upstream confluence with BR-3. Note medial bar formation.

Photo 80 (Location 78) SDF-BC. Looking downstream flow path.

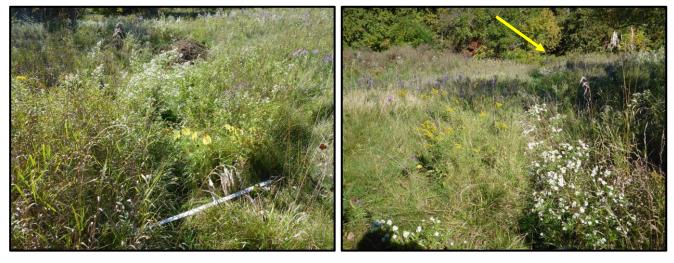
Photo 83 (Location 81) SDF-D. Looking upstream at depression within the meadow adjacent to the golf green.

Photo 84 (Location 81) SDF-D. Looking downstream at depression within the meadow adjacent to the golf green. Note start of the forested segment.

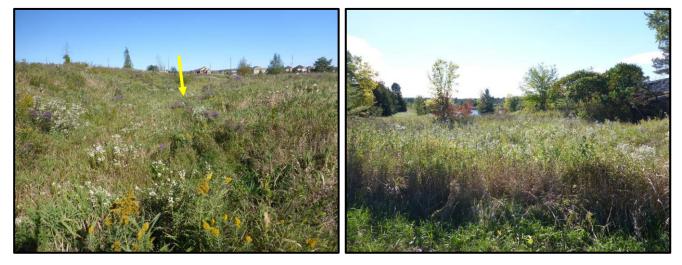
Surface Drainage Feature D (SDF-D) is a small gully feature that outlets from a culvert at the edge of the wooded area at the top of the valley slope to Bruce Creek (Reach BR-5) near the northwest boundary of the subject property (refer to **Figure 2**, **Photo Location #82**). The feature exhibited evidence of active erosion (widening and incision) within the gully portion along the valley slope.

Photo 86 (Location 82) SDF-D. Looking downstream at the gully feature towards the confluence with the creek. Note tile drain pipe which outlets to the creek at the confluence.

Photo 87 (Location 83) SDF-A. Looking upstream at depression within the SDF-A. Looking downstream at depression within meadow adjacent towards Kennedy Road.

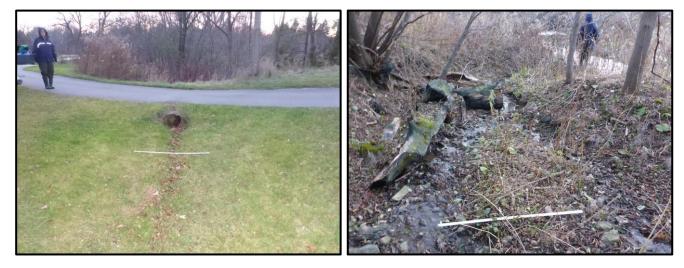
Surface Drainage Feature E (SDF-E) was characterized as a gully feature that originates on the west side of a golf cart trail. Surface drainage from the golf course is conveyed under the trail via a small CSP culvert which outlets into the gully feature that connects to Berczy Creek (refer to **Figure 2**, **Photo Location #85**). The channel is approximately 20 m long, poorly vegetated, and exhibits evidence of active erosion. Stone protection (cobble and small bounders) has been placed around the outlet, presumably in an effort to mitigate this erosion.

Photo 89 (Location 85) SDF-E. Looking downstream at feature upstream of golf green and cart culvert crossing.

Photo 90 (Location 86) SDF-E. Looking upstream at feature towards the golf green.

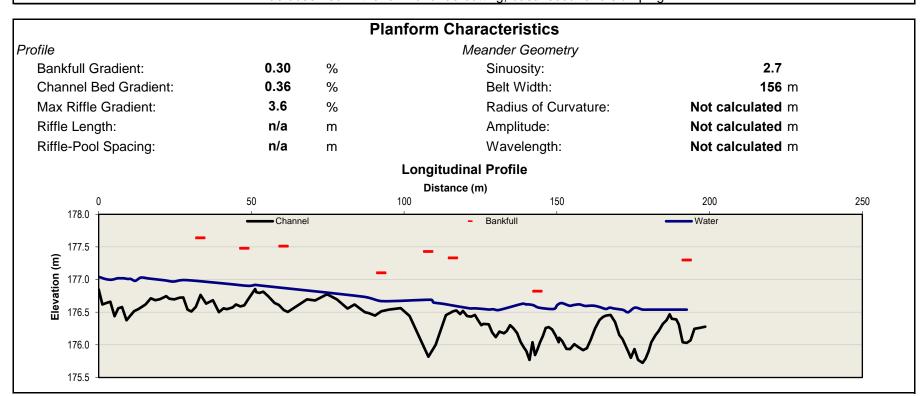
Reach BER-3 was characterized as a historically modified (channelized) watercourse flowing within a partially-confined valley setting. The reach exhibited evidence of widening, with degradation, planimetric form adjustment and aggradation as secondary processes. Evidence of active erosion was observed in the form of undercutting, basal scour and slumping.

Bank Character
	Minimum	Maximum	Average
Bank Height (m):	0.80	1.60	1.21
Bank Angle (degrees):	45	90	82
Root Depth (m):	0.05	0.50	0.28
Root Density (%):	0	90	33
Undercut Banks (%)		20	
Depth of Undercut (m):	0.11	0.25	0.17
Bank Strength:			
Torvane Value (kg/cm ²):	0.07	0.20	0.13
Penetrometer Value (kg/cm ²):	0.73	1.25	0.97
Bank Material (range): silt - gravel and till with some cobble, boulde
