Arborist Report

Highway 404 North Collector Roads

C11-08 - B000801

City of Markham

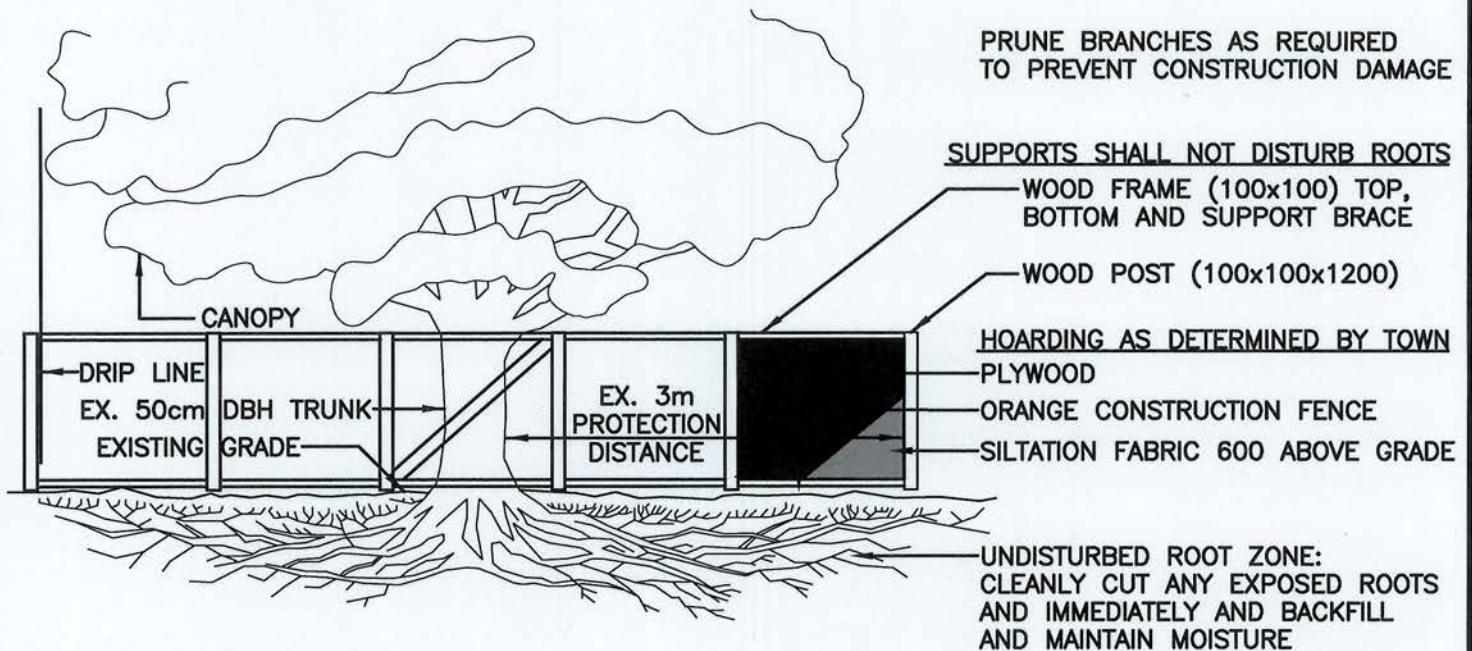
MINIMUM TREE PROTECTION DISTANCE FROM TRUNK:

< 10cm DBH	1.2m
10-29cm DBH	1.8m
30-40cm DBH	2.4m
41-50cm DBH	3.0m
51-60cm DBH	3.6m
61-70cm DBH	4.2m
71-80cm DBH	4.8m
81-90cm DBH	5.4m
91-100cm DBH	6.0m
> 100cm DBH	6cm/1cmØ

TREE PRESERVATION DETAIL
