GUIDING SOLUTIONS IN THE NATURAL ENVIRONMENT

Natural Environment Report/ Environmental Impact Study

in support of a Master Environmental Servicing Plan 4134 16th Avenue

Beacon Environmental Limited

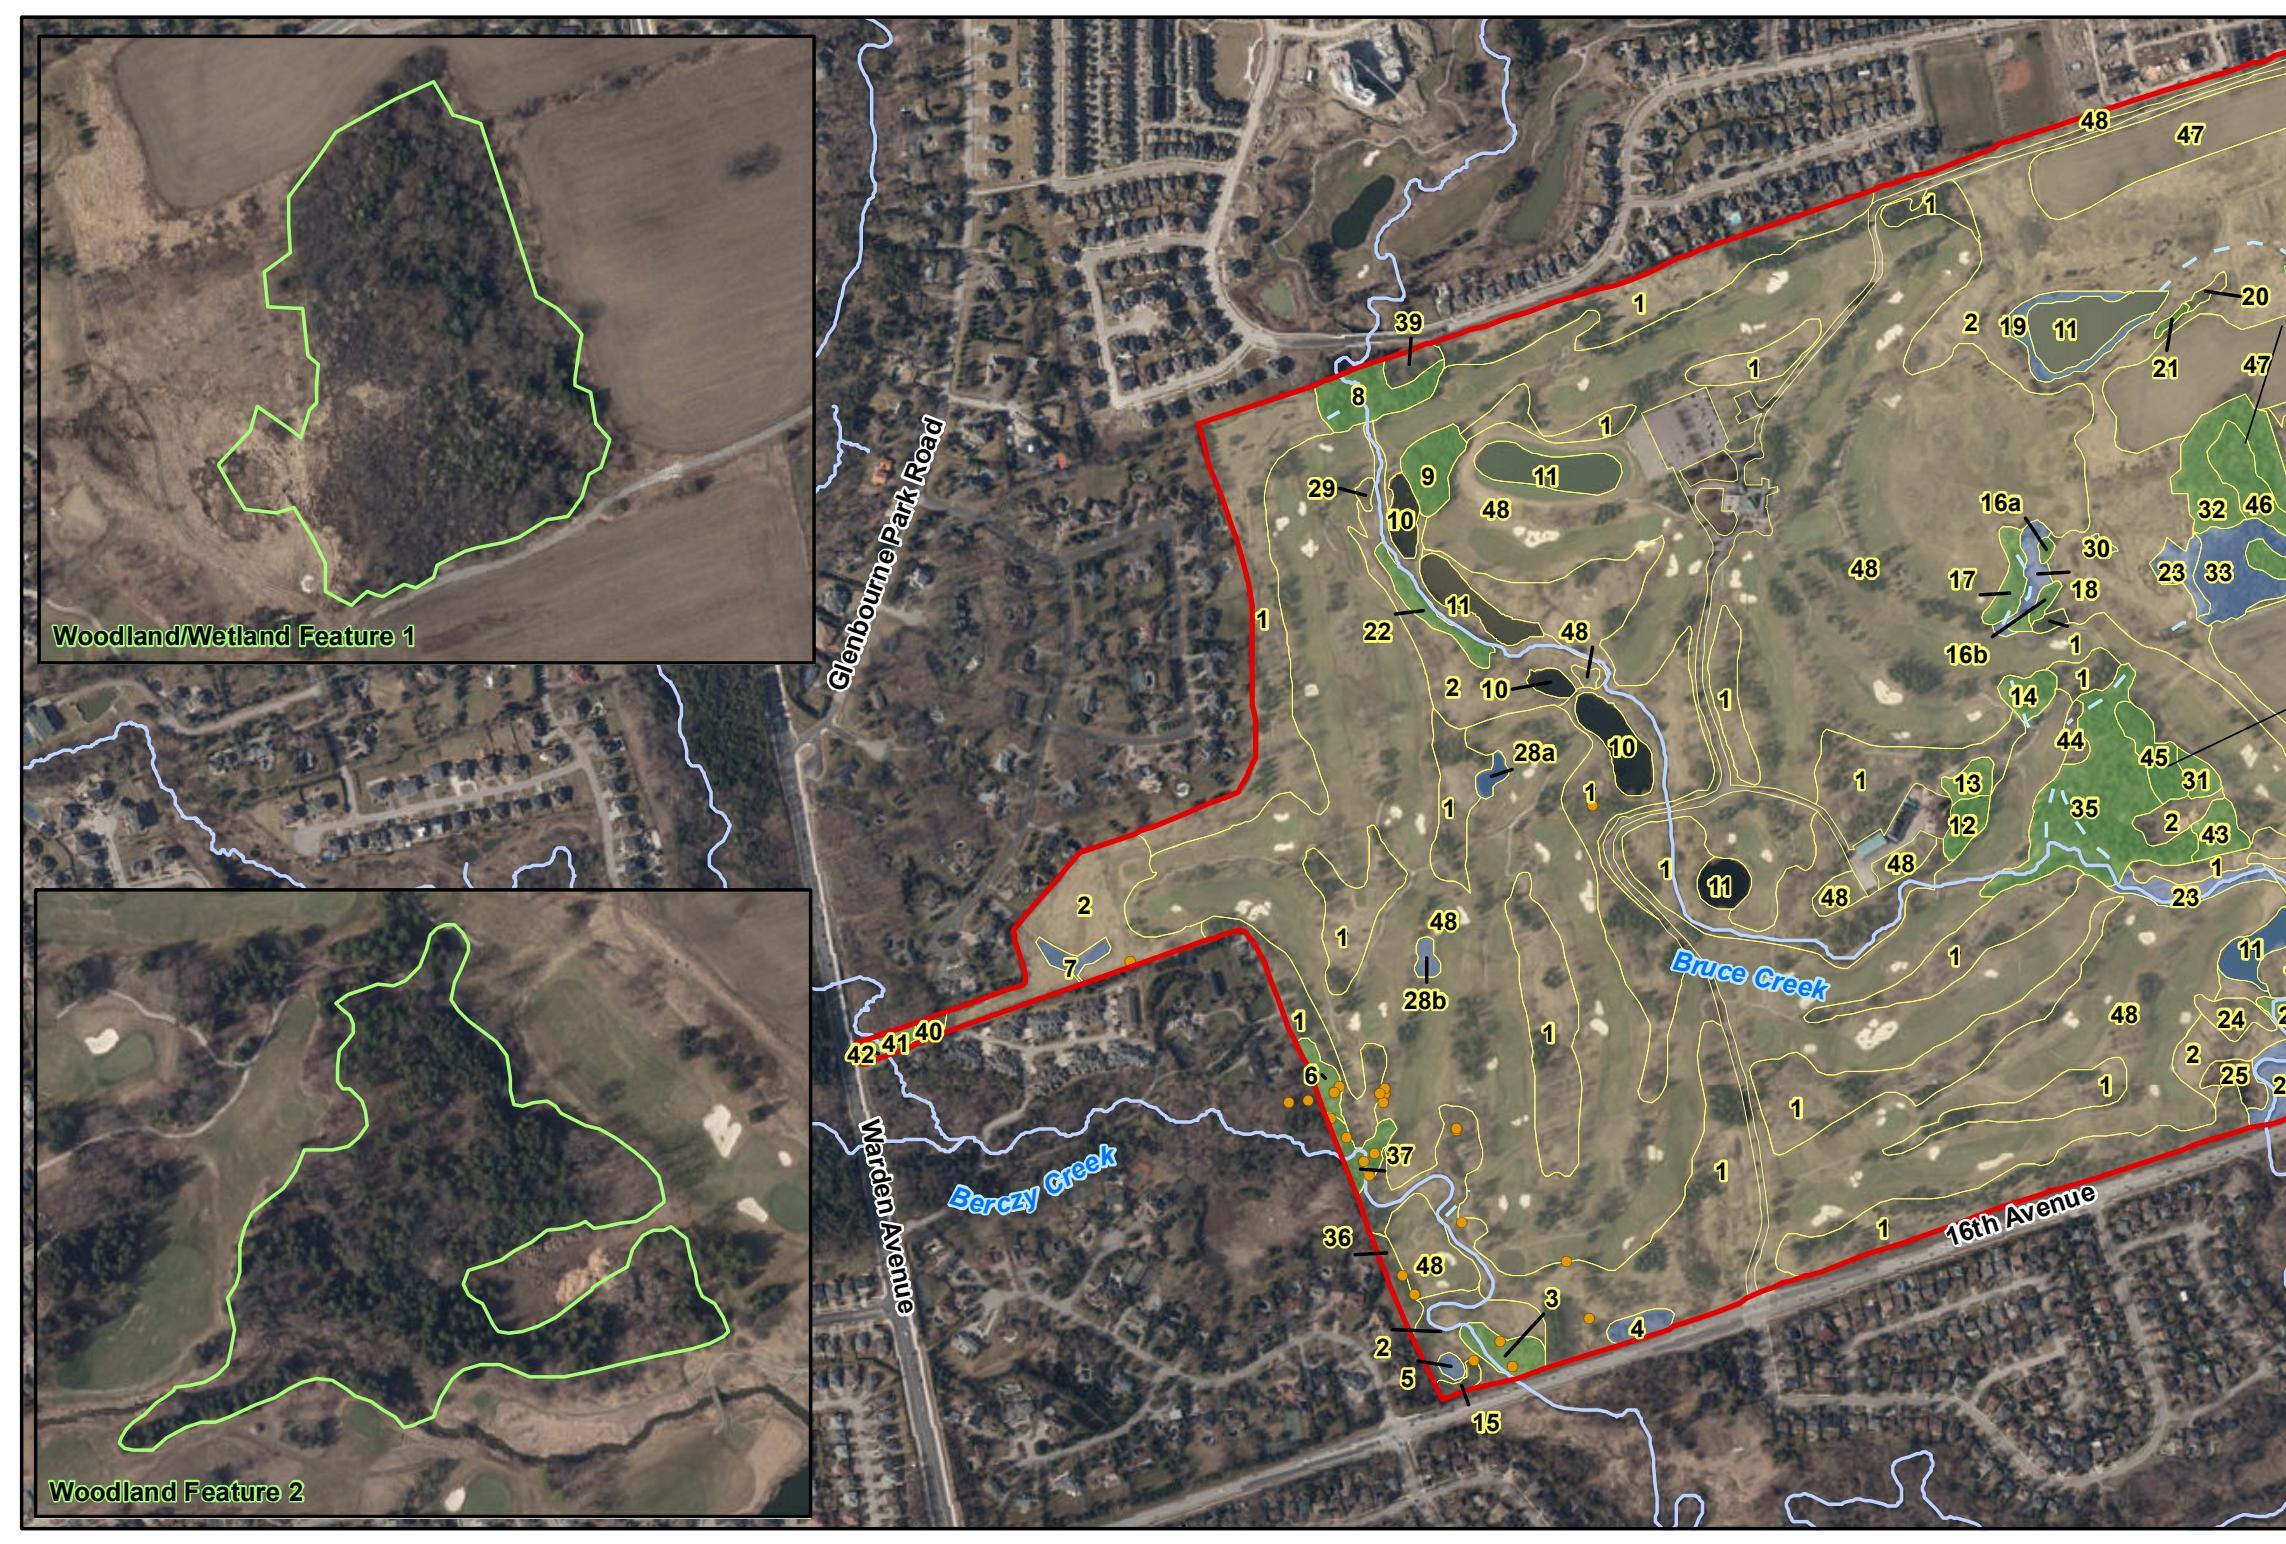
FIGURE 2: Existing Conditions Terrestrial

A total of 31 vegetation community types were identified on the subject property. The communities can be broadly categorized as forest, wetland, and semi-natural/cultural. Semi-natural/cultural communities include old field meadows, plantations, successional thickets and woodlands, and managed areas (e.g. golf course greens, agriculture). Large areas of the subject property fall into the semi-natural/cultural category. Natural forests and wetlands on the property tend to be rather small and are generally associated with the valleylands of Berczy Creek and Bruce Creek. The vegetation communities on the subject property are illustrated on **Figure 2** and described in detail below.

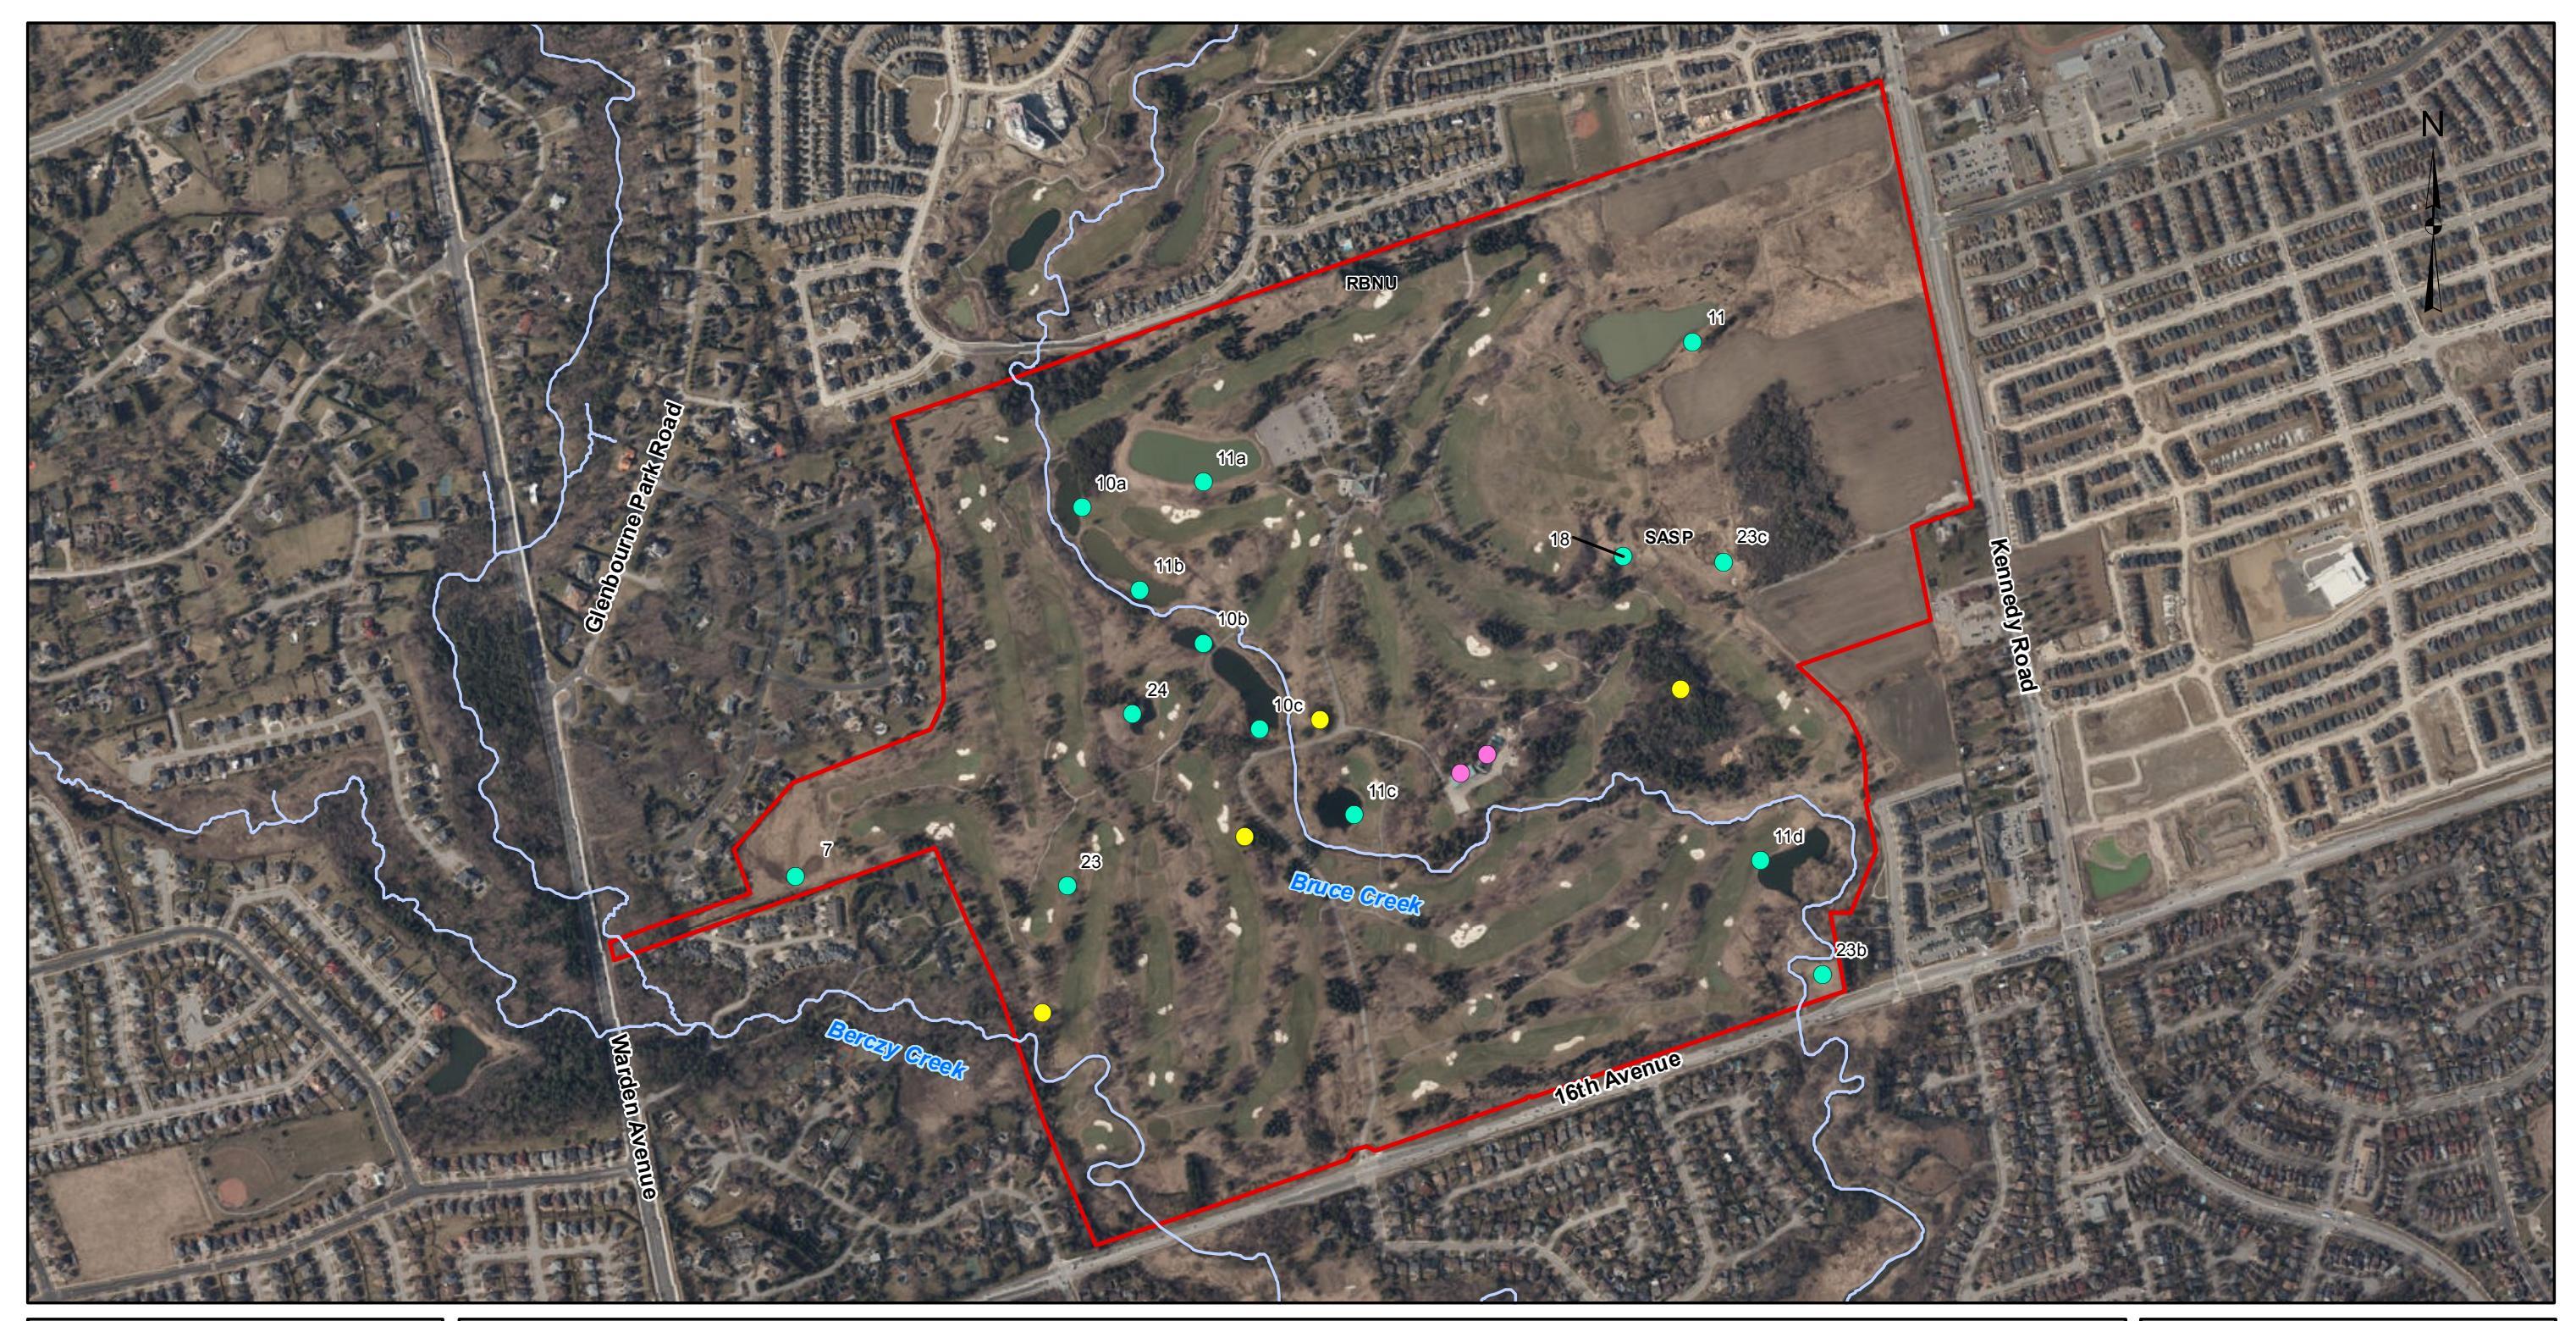
FIGURE 3: Existing Conditions Wildlife

Barn Swallow usually nests in built structures and forages in surrounding fields, meadows and wetland areas. Single nests were observed in two of the maintenance buildings in the central part of the site (**Figure 3**).

The Eastern Wood-Pewee is a provincial Special Concern species. Each of the three territories of Eastern Wood-Pewee that were observed were in different wooded areas across the property (**Figure 3**). Despite its status, the Eastern Wood-Pewee is very common across southern Ontario in various types of woodlands. The presence of one pewee in a wooded area is not sufficient evidence to constitute SWH.

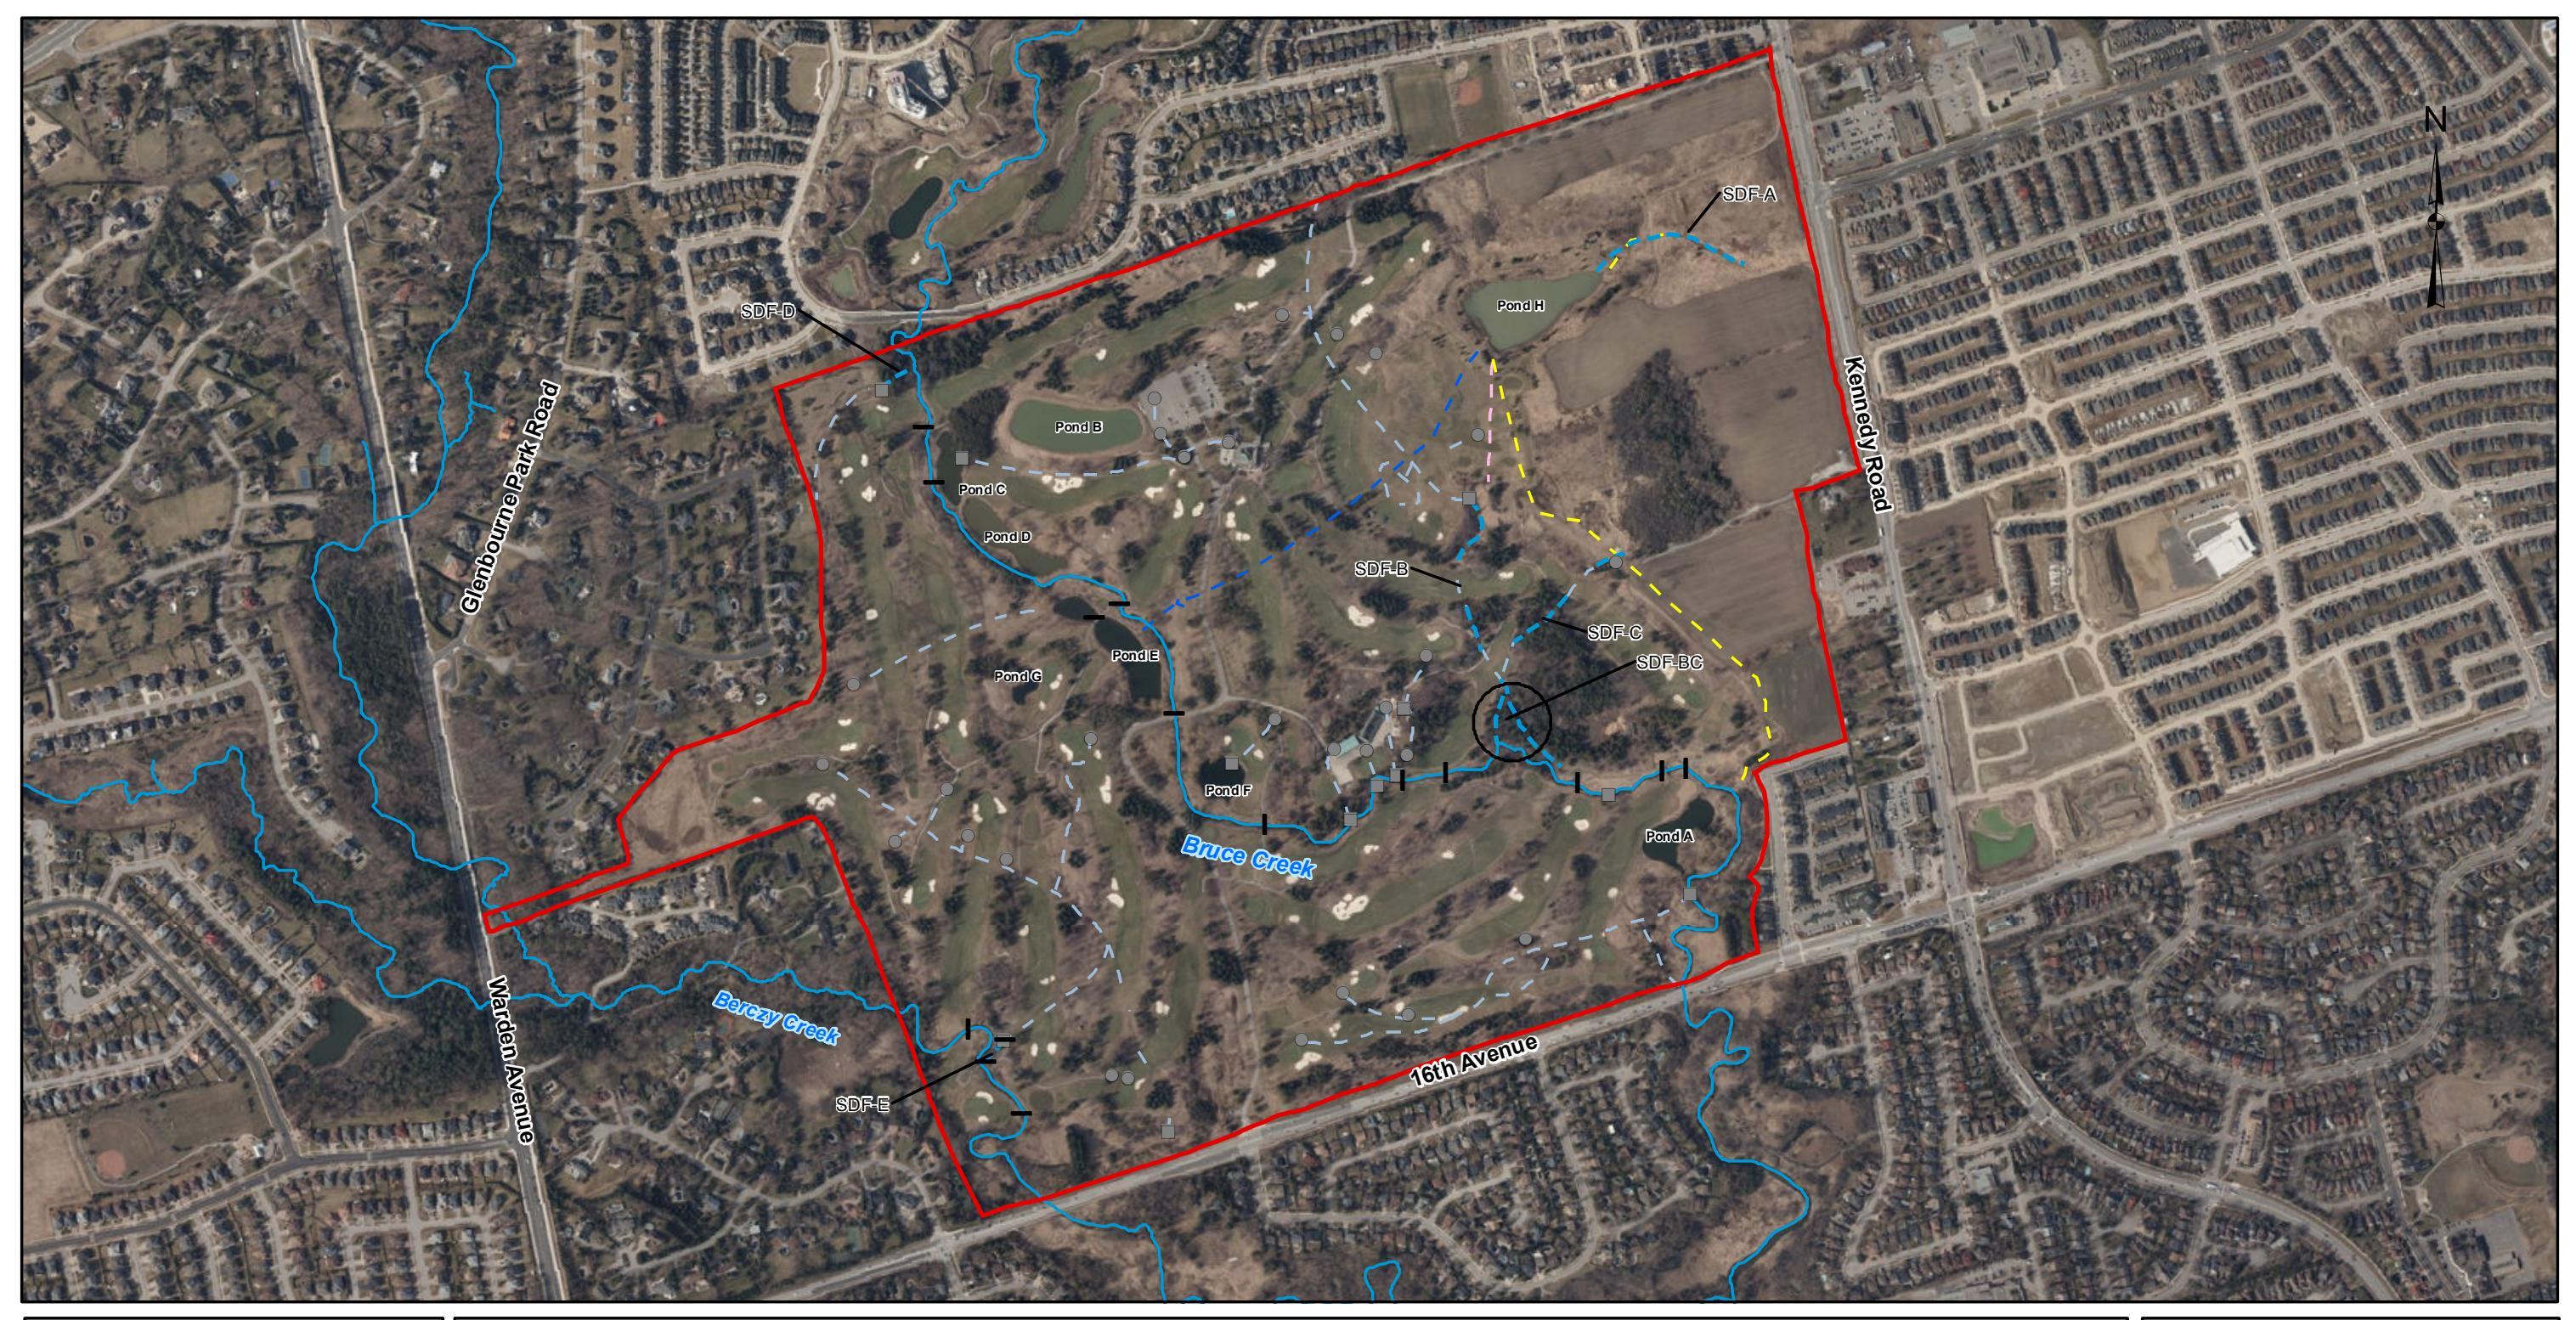
FIGURE 4: Existing Conditions Aquatic

There are a total of eight (8) ponds on the subject property, five of which are located within the Bruce Creek floodplain (Ponds C to F and Pond A). The remaining ponds are located in the northeast corner of the property (Pond H – existing SWM Pond), one near the clubhouse (Pond B) and a smaller pond within the golf course (Pond G).

Fish habitat assessments were completed to identify and assess water body characteristics that provide habitat for the critical life processes as outlined in the federal *Fisheries Act*. The habitat assessments detail the characteristics and major physical attributes of the water body. Eleven transects were completed at existing crossings along the main branch of Bruce Creek and three along Berczy Creek (**Figure 4**). Stream physical conditions were inspected and documented with photographs.

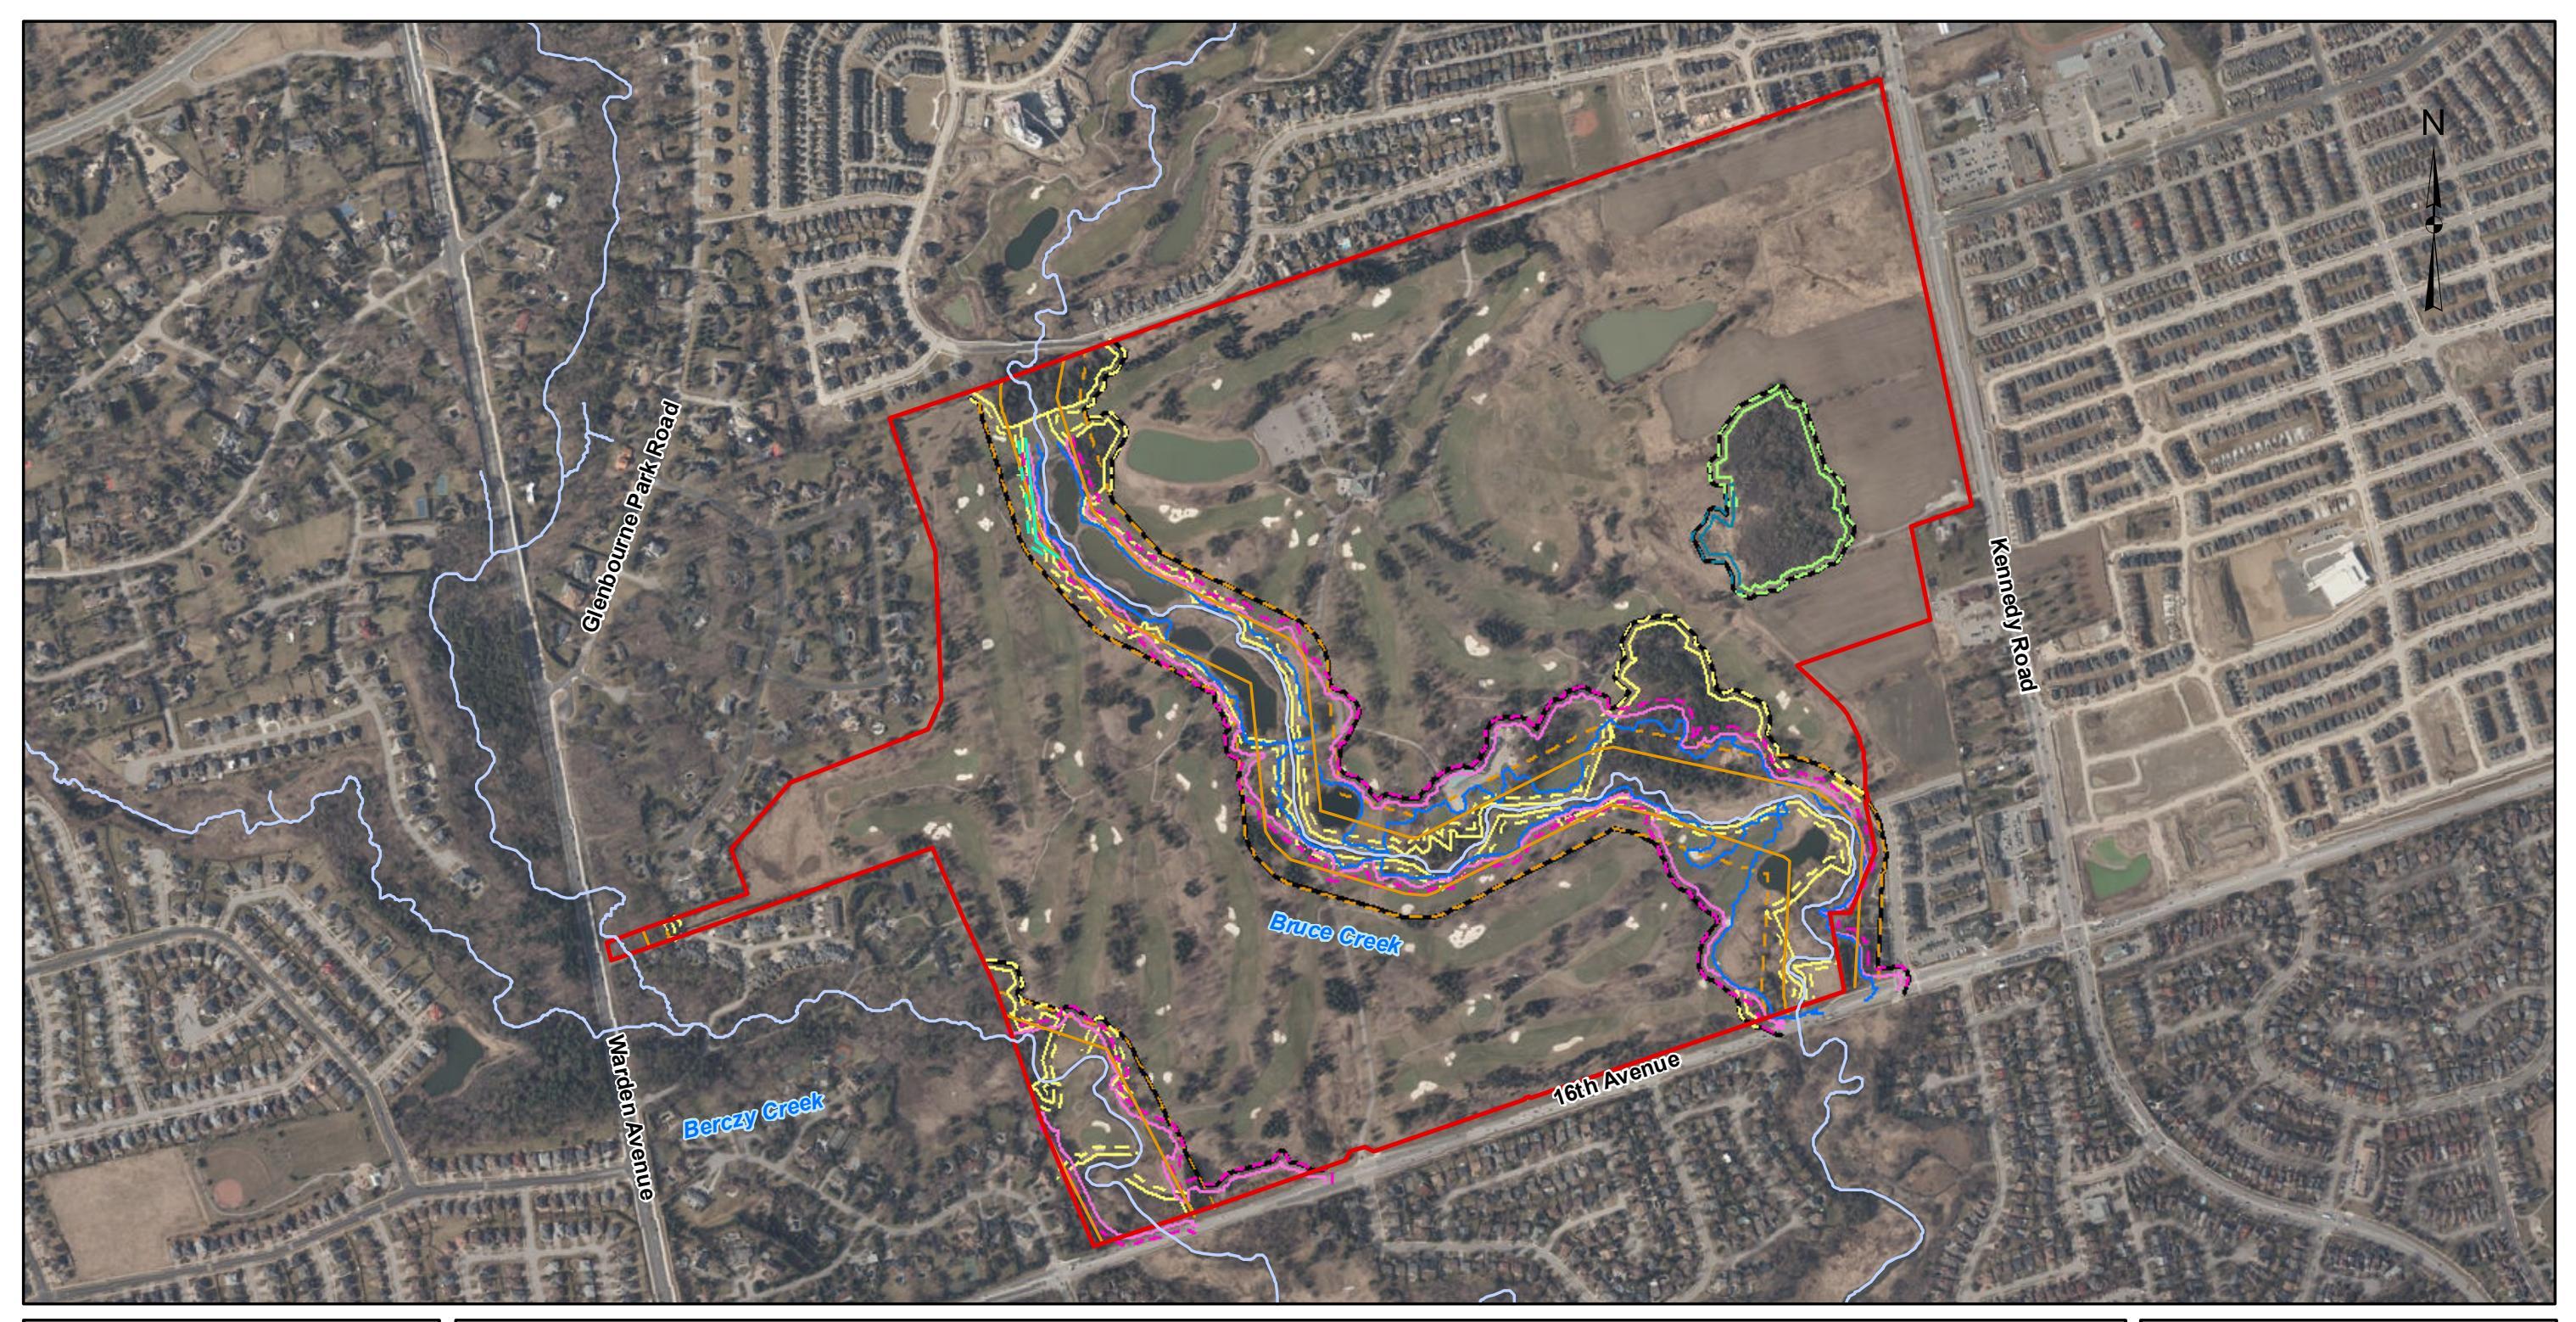
- Subject Property
- Ultimate Constraint
- Watercourse
- Long Term Stable Top of Slope + 10 m setback (Golder, 2016)
- Long Term Stable Top of Slope (Golder, 2016)

- Meander Belt Width
- - Limit of Redside Dace Habitat - Staked Wetland +10m
- - Regional Floodline + 10 m
- 100 Year Floodline (Stantec)
- Regional Floodline (Stantec)
- Staked Wetland Limits (Beacon Only)
- Staked Top of Slope/Dripline (TRCA, March 2016)
- Staked Top of Slope/Dripline 10 m Buffer
- Staked Dripline (City of Markham, TRCA March 2016)
- Staked Dripline 10 m Buffer

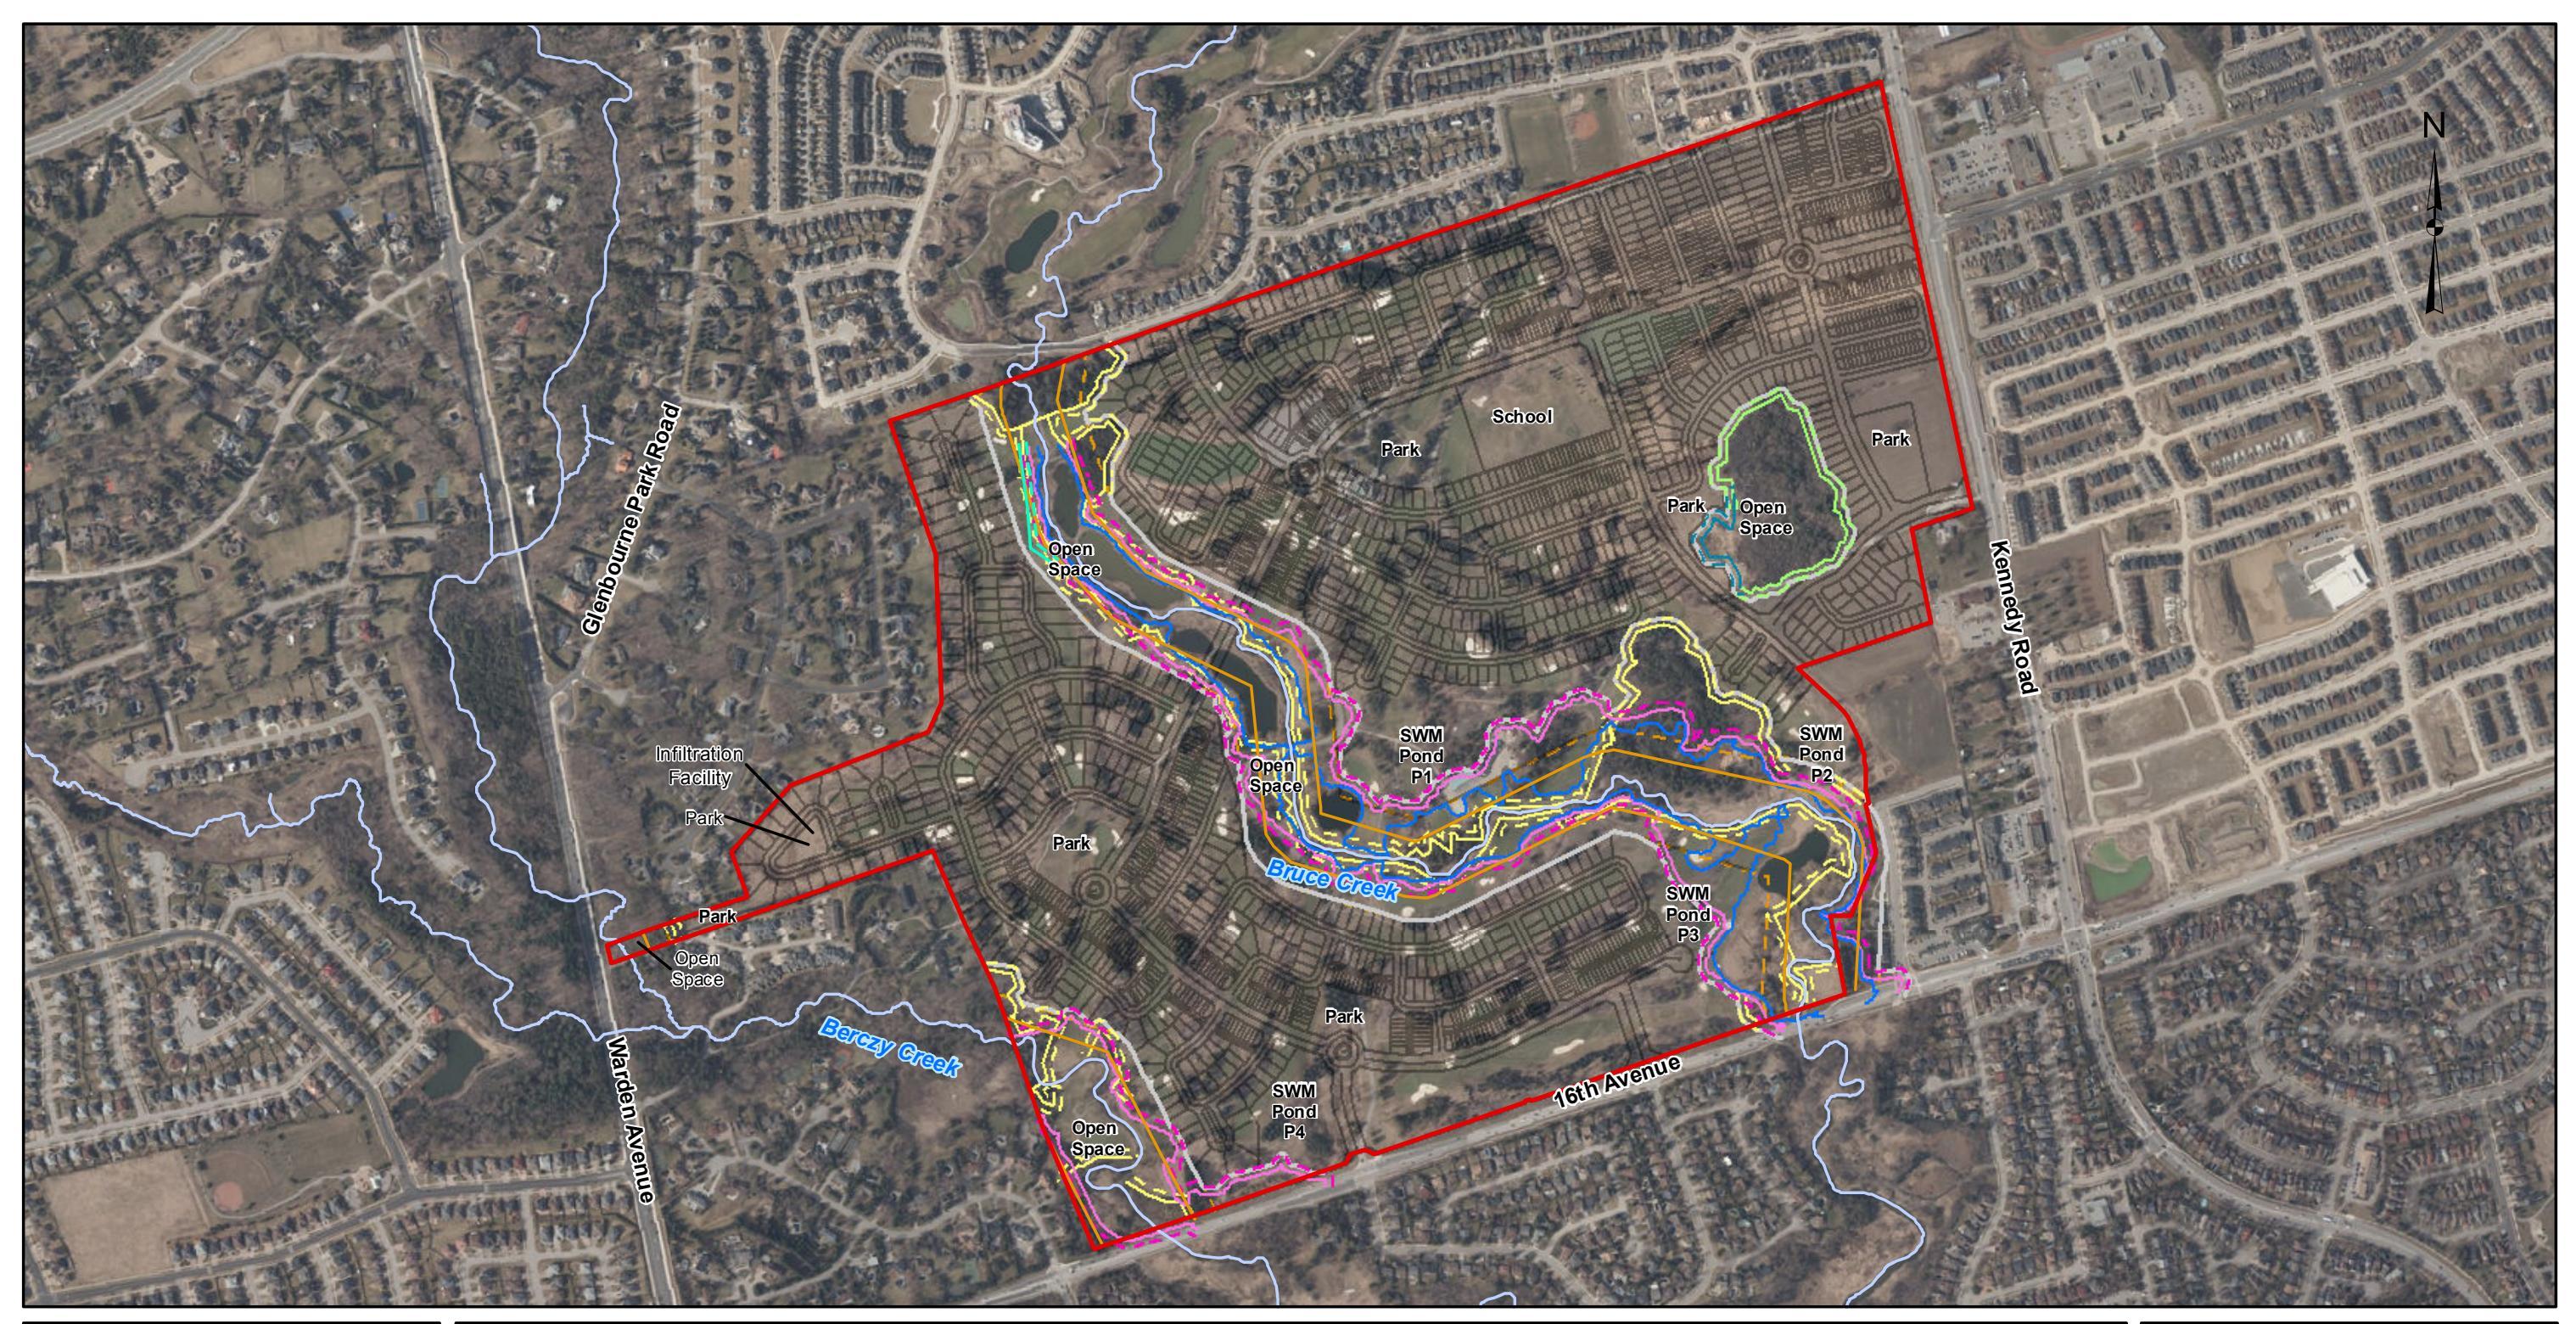
- Subject Property
- Watercourse
- Development Plan (August 22, 2016)
- Development Constraint
- Long Term Stable Top of Slope + 10 m setback (Golder, 2016)
- Long Term Stable Top of Slope (Golder, 2016)

- ---- Meander Belt Width
- - Limit of Redside Dace Habitat
- 100 Year Floodline (Stantec)
- Regional Floodline + 10 m ----- Staked Wetland Limits (Beacon Only)
- - Staked Wetland +10m
